**FINAL REPORT**

**A STUDY OF COMPONENTS  
INFLUENCING THE DETERIORATION OF  
VEHICLE EMISSION CONTROL SYSTEMS**

SEPTEMBER 1982  
Agreement A0-104-32

CALIFORNIA AIR RESOURCES BOARD  
1800 - 15th Street  
Sacramento, California 95814

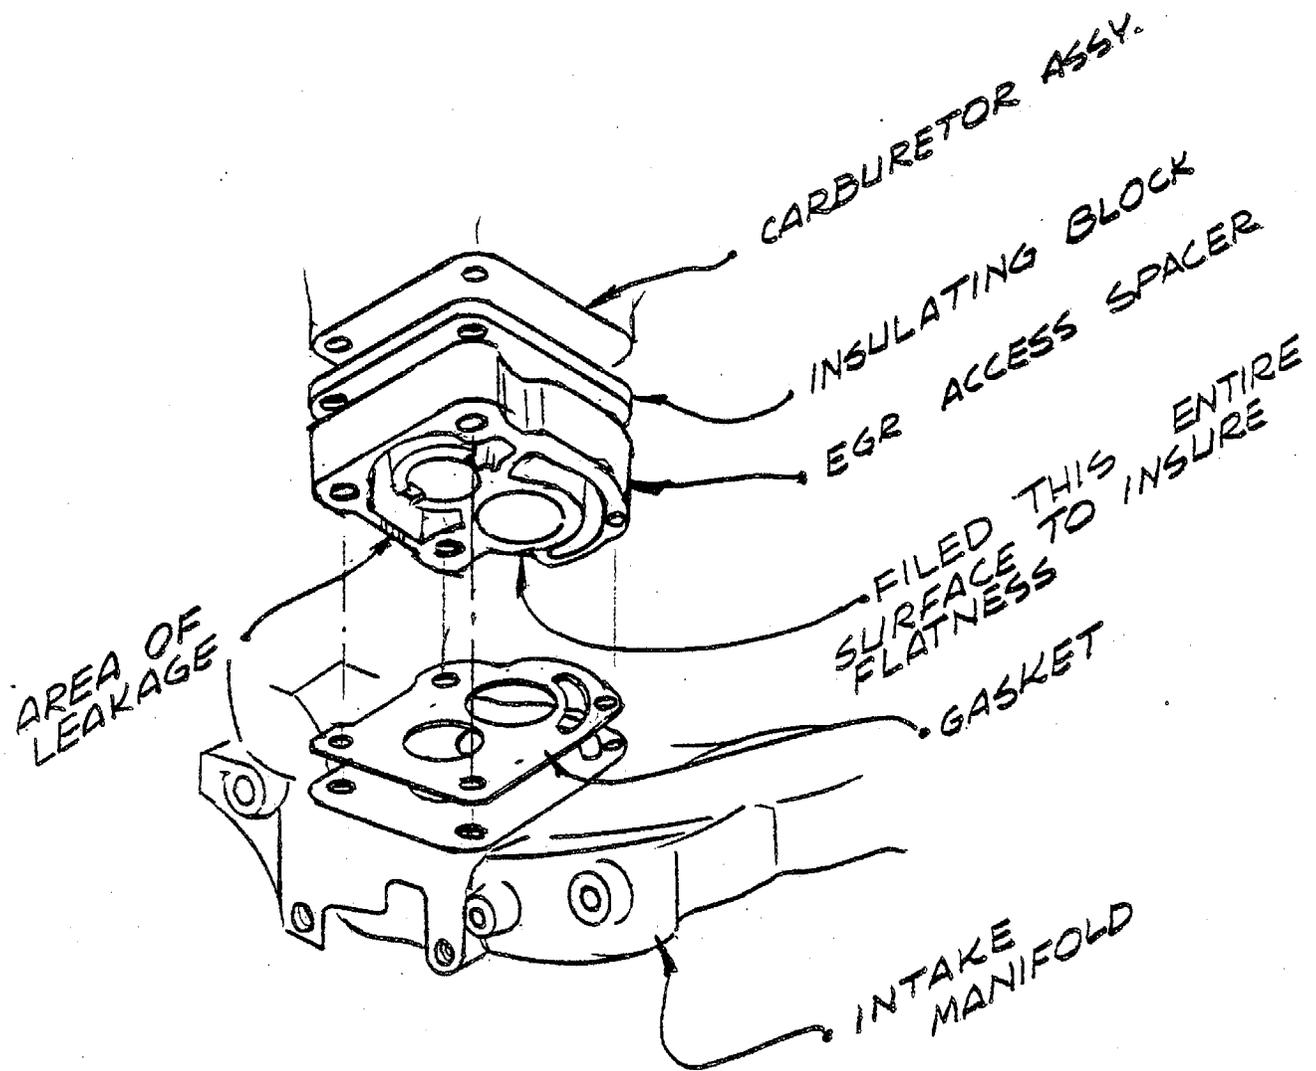
Olson Engineering, Inc.		
DRAWN <i>JRM</i>	SIZE <b>A</b>	FSCM NO.	DWG. NO. Figure B-1	REV. <i>-</i>		
ISSUED <i>6-4-82</i>	SCALE <i>NONE</i>	B-25	SHEET <i>1 OF 1</i>

An AFR test was then run and the data superimposed on the carburetor flow curve (see Appendix C). The results were generally outside the performance windows, on the lean side, for both the 10% and 90% duty cycles. The AFR results are an approximate though significant indication that there were problems in the carburetor.

After consultation with the CARB project engineer, it was decided to remove the carburetor, remove the adjustment plugs and check the carburetor adjustments. While the carburetor was off, the EGR block and intake manifold were also removed to check for any sign of vacuum leaks. There were no signs of leakage or cracks in the intake manifold. Figure B-1 shows a pictorial view of an area of suspected leakage. The base of the EGR block was filed to ensure flatness and the manifold and EGR block reinstalled using new gaskets.

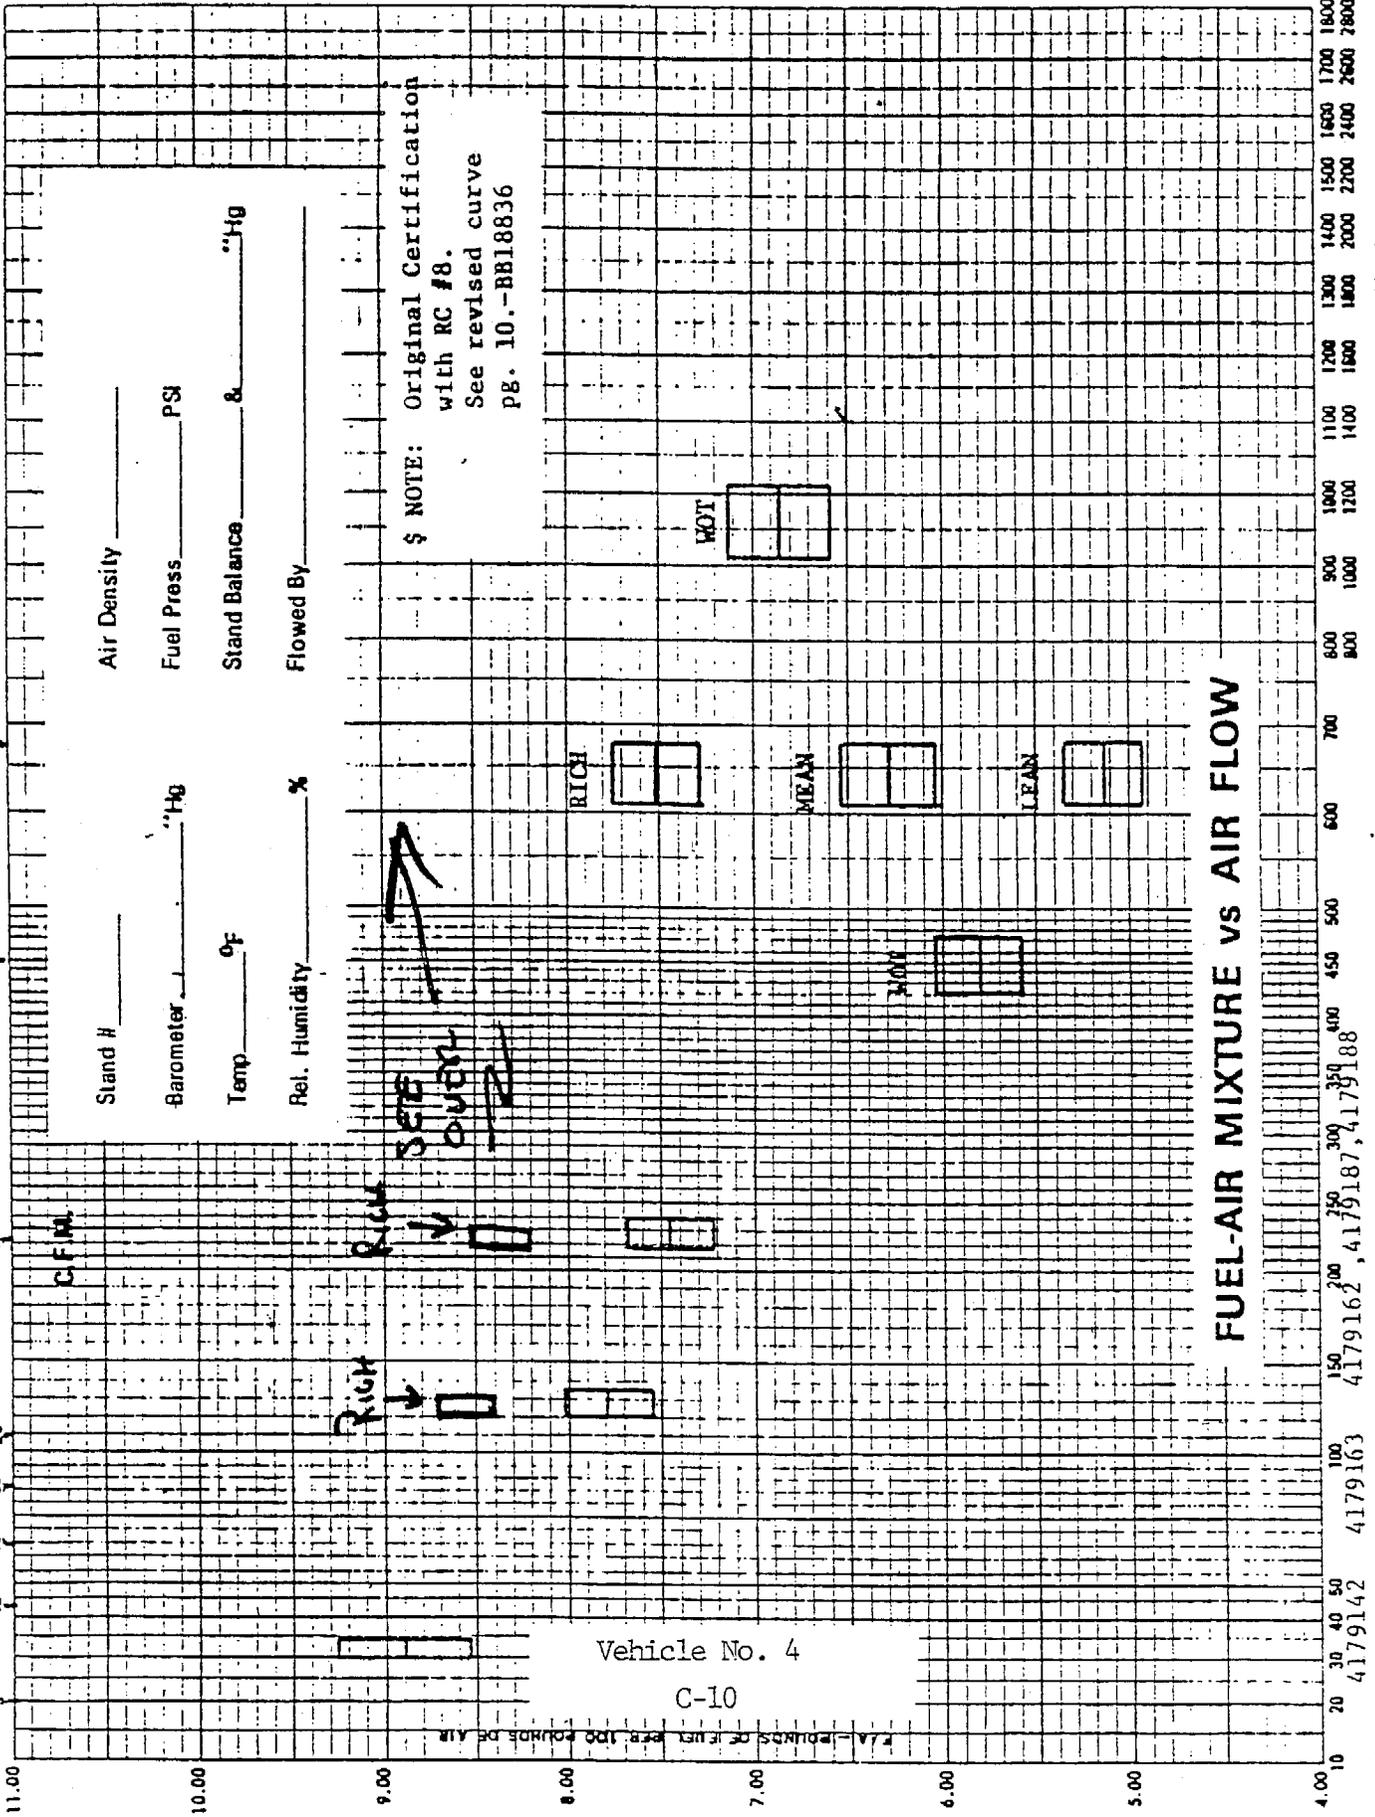
VEHICLE NO. 4

Car was quite rich off idle and transition to main circuit.
