Mail-Out #MSC 98-01

January 22, 1998

RE: ON-BOARD DIAGNOSTIC II COMPLIANCE GUIDELINES

OBD II Misfire Detection Fault Handling Flow Charts

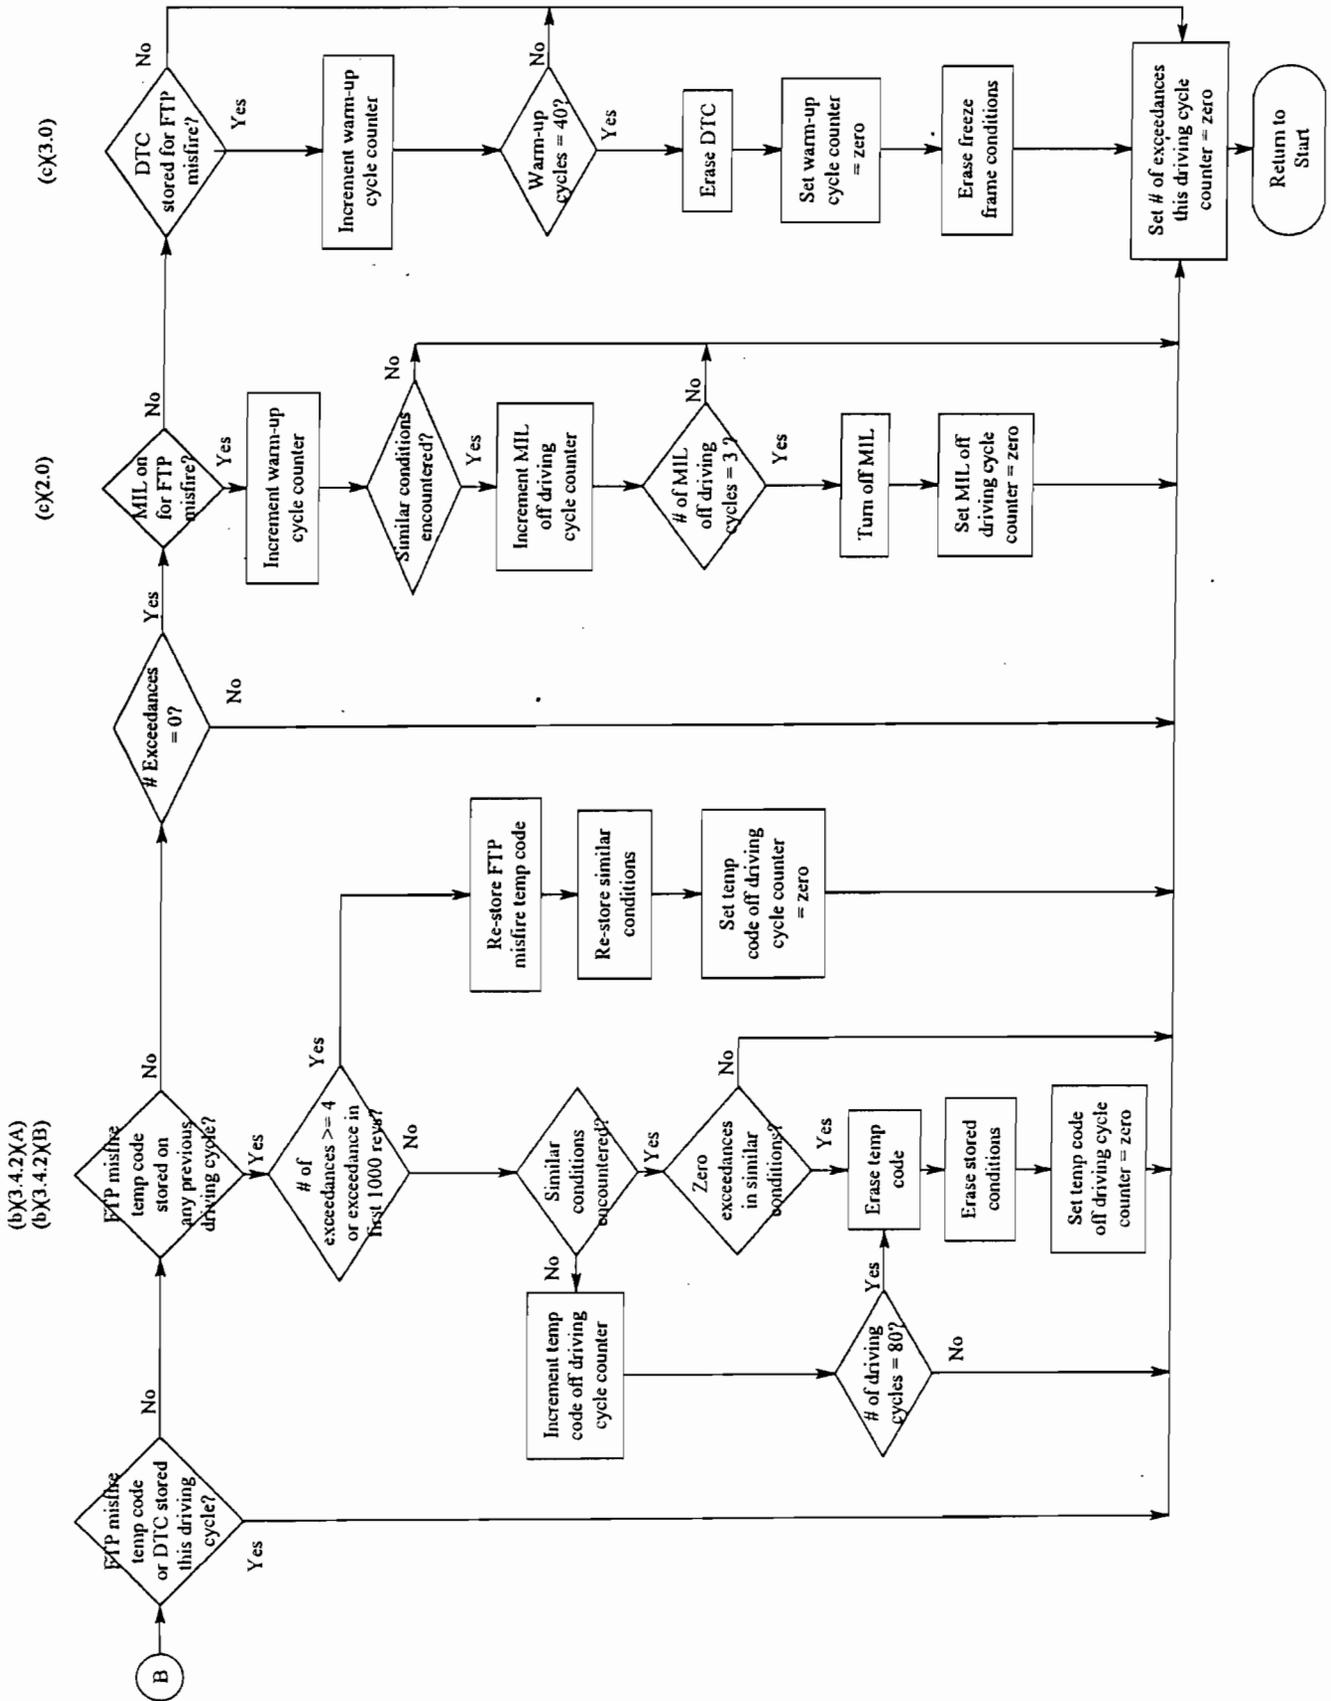
Code/MIL Clearing for FTP Misfire Rates

To facilitate proper implementation under the regulations, attached are flow charts detailing proper MIL illumination and fault code storage logic for misfire monitoring. The ARB will also accept reasonable variations with respect to this logic; however, the staff requests manufacturers to submit any alternate logic that it proposes to use to the ARB for review to ensure that the requirements of the regulation are being met. To highlight one important point illustrated in the flowcharts, if misfire is detected on consecutive driving cycles, regardless of whether similar conditions have been encountered, the regulation requires illumination of the MIL.
