**CUMMINS B5.9L PROPANE ENGINE  
ARB "HD-10" LPG DURABILITY TEST  
TRIBOLOGICAL OIL ANALYSIS**

**Prepared for**  
**The ADEPT Group, Inc.,**  
**Los Angeles, CA USA**  
**by**  
**P. B. Hertz, P.Eng.,**  
**Hertz Mechanical Engineering**  
**Saskatoon, SK Canada**  
**December, 1999**

The durability of a prototype Cummins B5.9L propane engine was evaluated in a 500-hr full-load dynamometer test using California Air Resources Board "HD-10" LPG fuel. Tribological oil analysis techniques were used to infer metal wear rates by spectrometry, ferrography, magnetic-iron particle counts and oil filter debris examination.

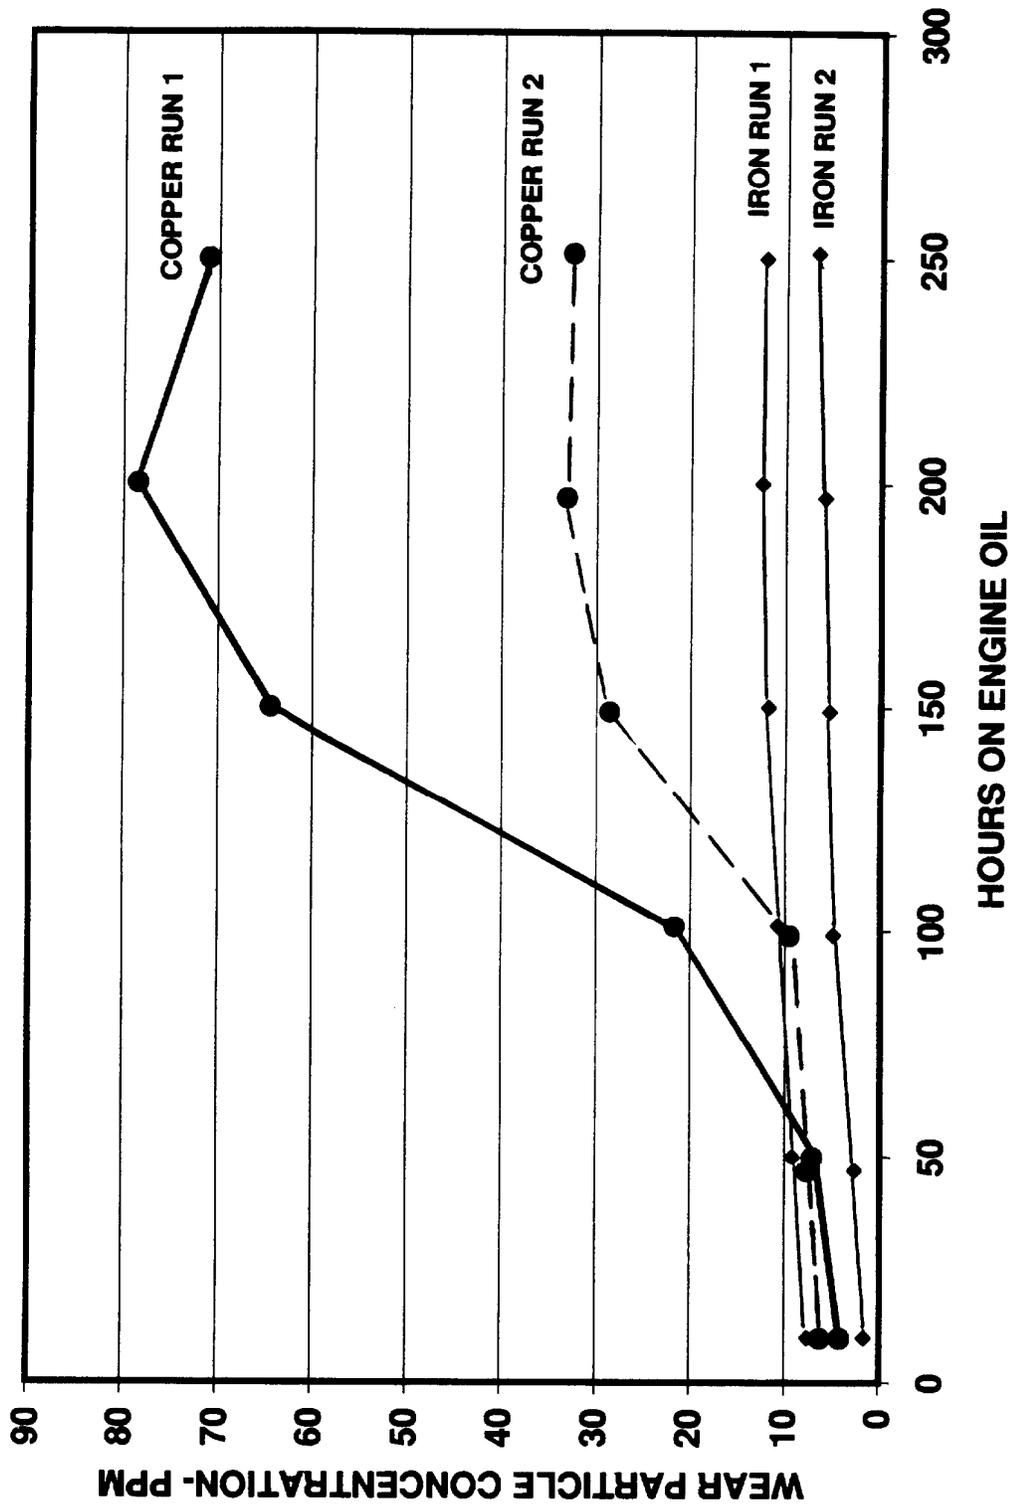
Figure 1- Graph of Spectrometry Copper and Iron concentrations for Runs 1 and 2.

**Figure 1-** Graph of Spectrometry Copper and Iron concentrations for Runs 1 and 2.

Copper peaks at 78.5 ppm in Run-1. The drops in indicated Cu ppm for the last samples in both runs are due to make-up oil dilution of the wear debris. Note the lower Cu concentration (33.2 ppm) in Run-2.

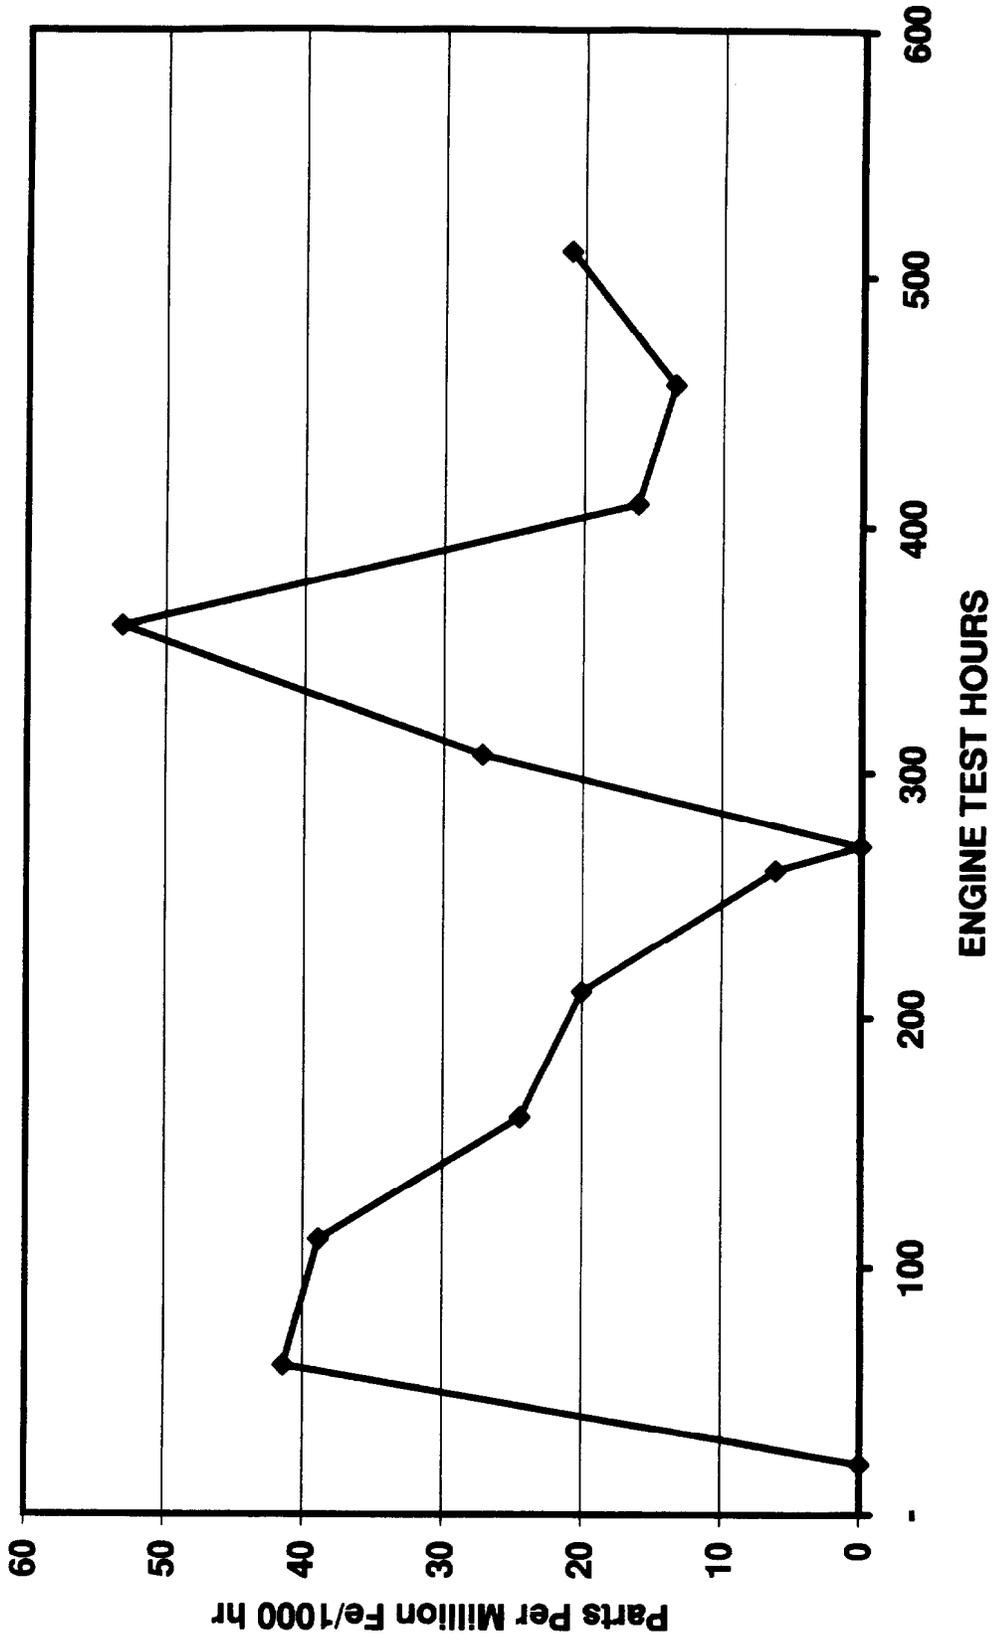
Figure 3 -- Graph of Fe True Wear Rate versus Engine Hours.

Average Fe wear rate is normal (25 ppm/1000hr), and rises only slightly (3%) in the second run.

**Figure 3** - Graph of Fe True Wear Rate versus Engine Hours.

Cylinder wall normal wear particles are the main source of ICPS iron.

Other wear metal wear rates were normal but somewhat sporadic during these durability tests. The true iron wear-rate averaged 25 ppm Fe/khr which is typical. Chromium averaged 7.5 ppm/khr, while lead indicated 36 ppm/khr. These levels are well within accepted wear-rates for their respective main sources such as cylinder walls, piston rings, and babbitt-coated bearings. Some evidence of cylinder wall scratching was reported in addition to the main bearing abrasion, presumably from hard upper-cylinder introduced debris. The release of internal spark plug porcelain insulator fragments or burned copper fragments could explain the misfiring and account for the abrasion grooves in the cylinder walls and bearings. Pieces of hard chromium from the top-rings could also cause this damage but larger chrome particles were not observed until near the end of the last run.

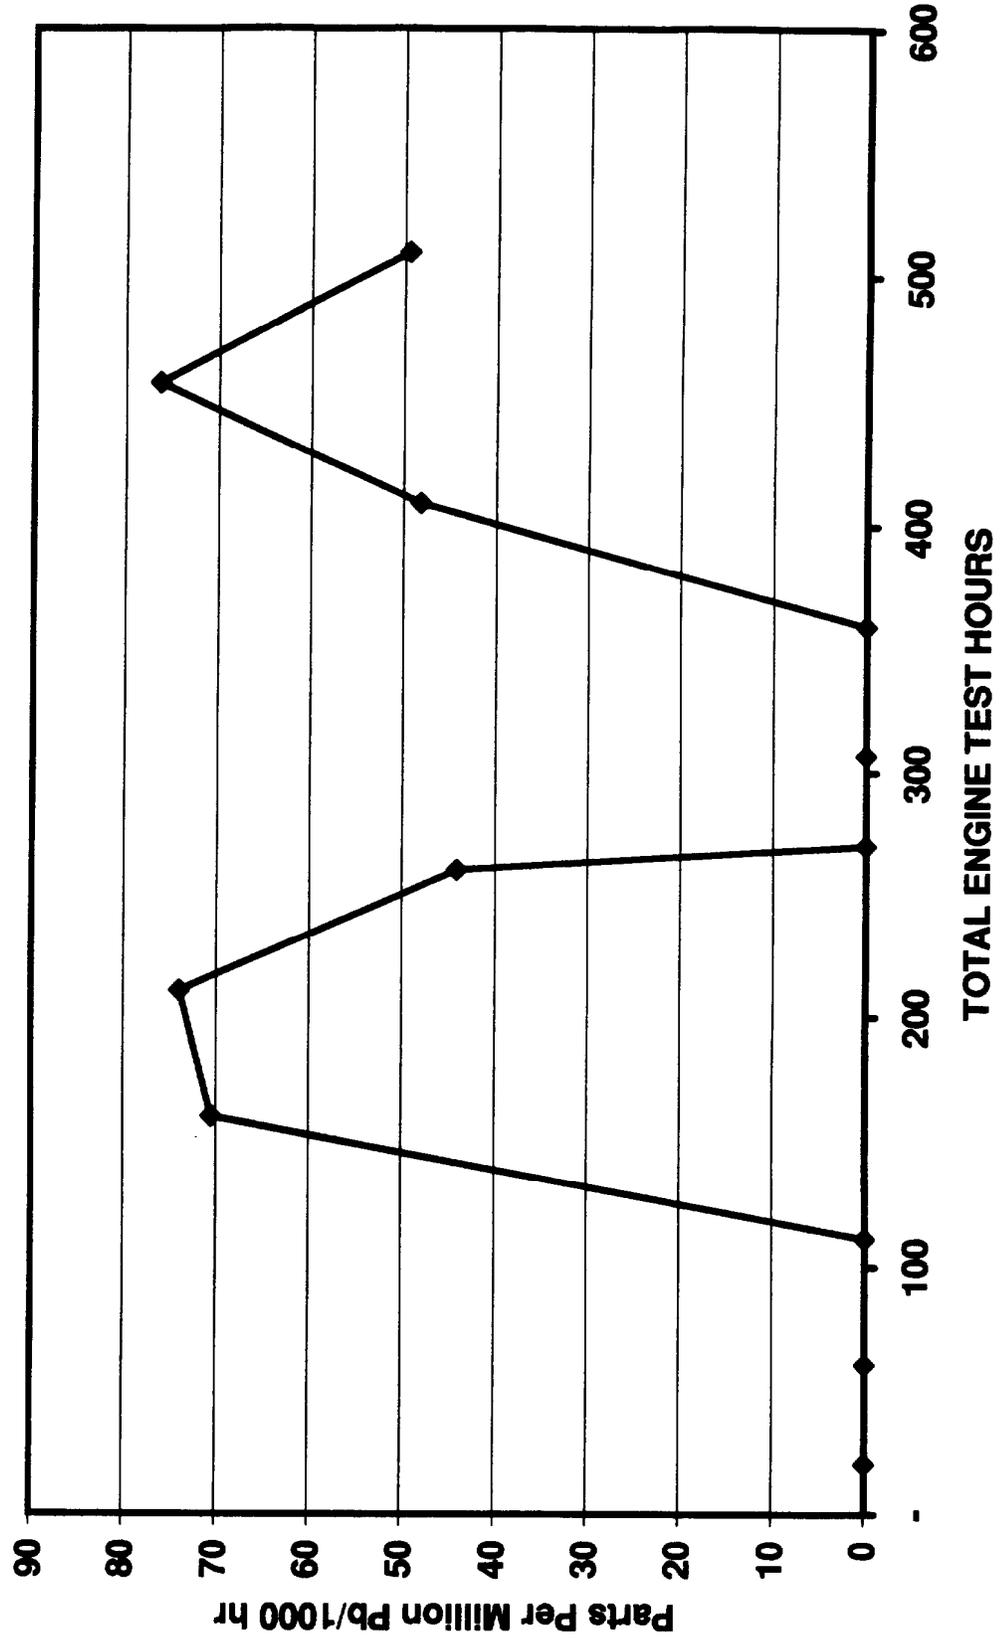
**Figure 4 – Graph of Lead metal True Wear Rate versus Engine Hours.**

**Table V** - "True Wear" Lead particle wear-rates for Runs 1 and 2. Lead ICPS detection is more difficult, but averaged about 35 ppm/khr dropping 7% in Run-2.

**Figure 4** - Graph of Lead metal True Wear Rate versus Engine Hours.

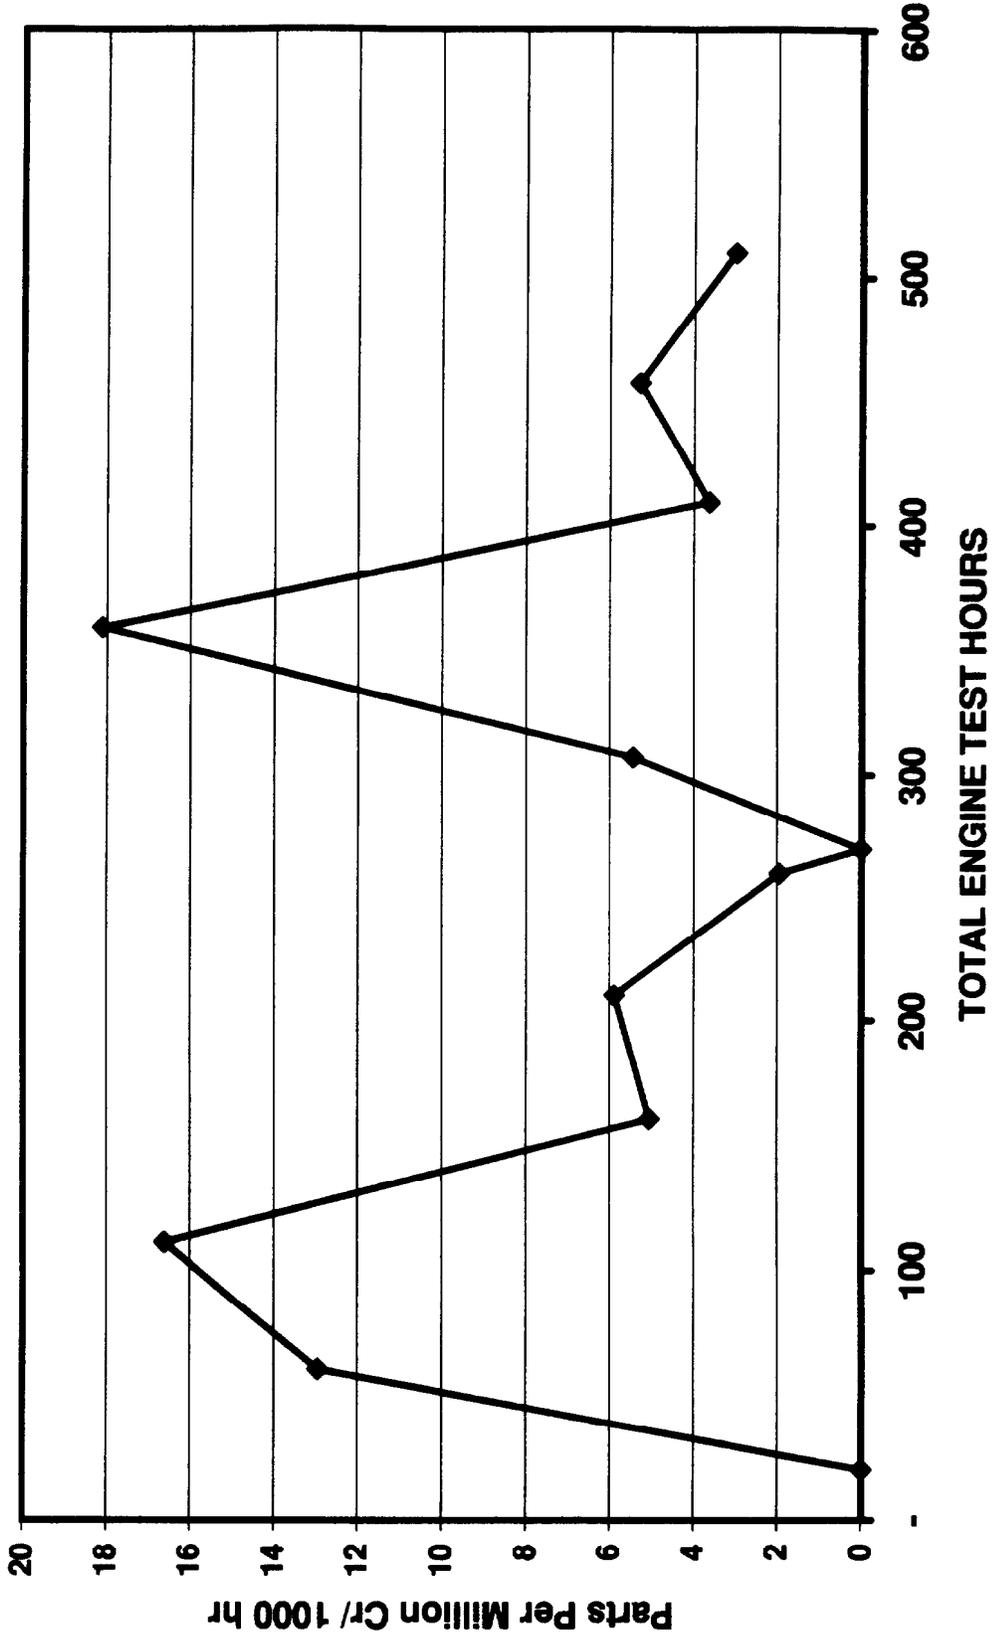
**Figure 5 – Graph of Chromium true wear rate versus Engine Hours.**

Chrome wear levels dropped 13%, from 8.0 ppm/khr in Run-1 to 7.0 ppm/khr in Run-2.

**Figure 5** - Graph of Chromium true wear rate versus Engine Hours.

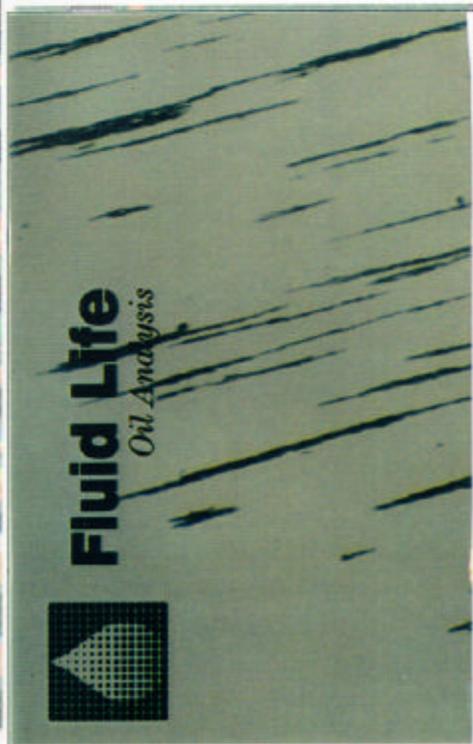
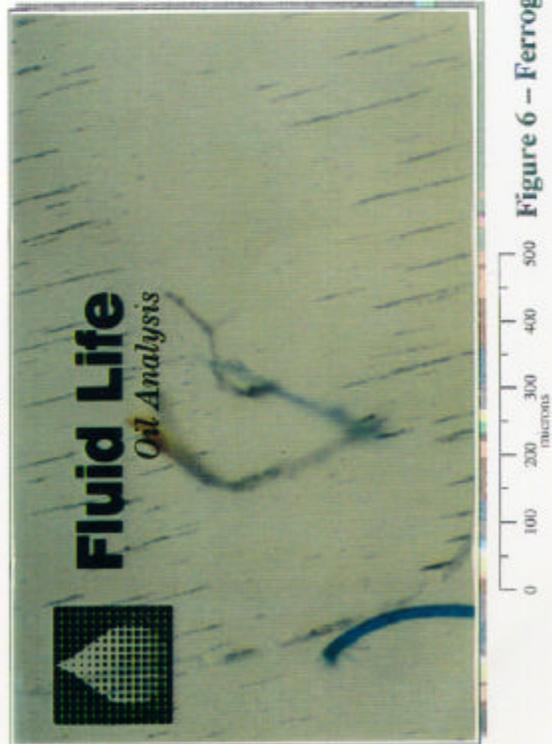
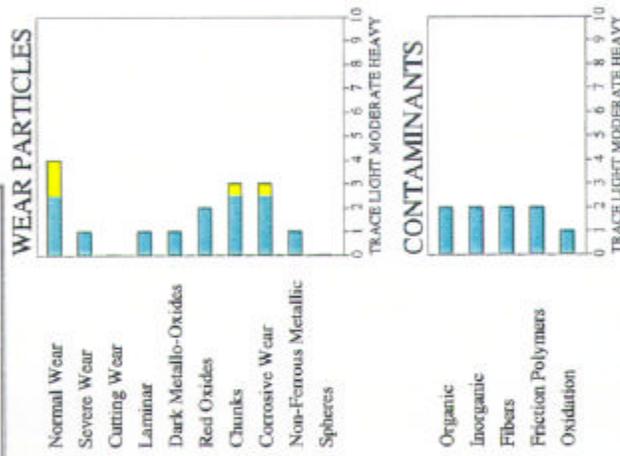
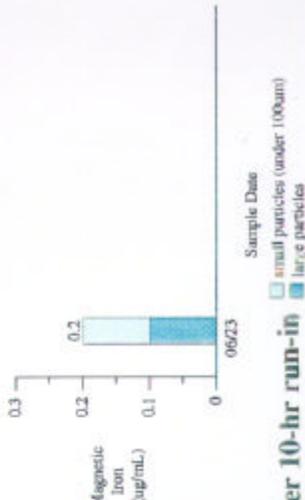
Figure 6 -- Ferrographic Analysis of used oil at "0" hours, after 10-hr run-in

Note photographs of low and medium alloy steel debris aligned with magnetic field. Traces of copper/copper alloy particles up to 65  $\mu\text{m}$  (0.0026 in.) in size were detected. Magnetic Iron was at 0.2  $\mu\text{g/mL}$ . Morphology of other wear and contaminant particle classes and concentrations are shown by the centrally located bar graphs.

Most metal particles are low and medium alloy steel showing rubbing/sliding wear.  
 Traces of copper/copper alloy particles (up to 65 microns) present in sample.

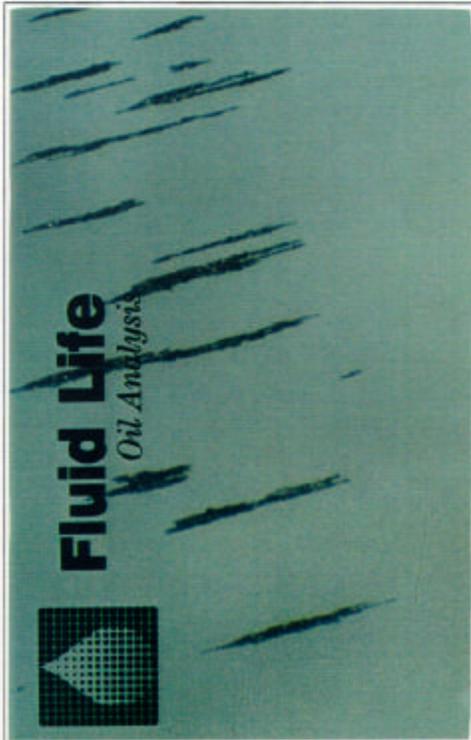
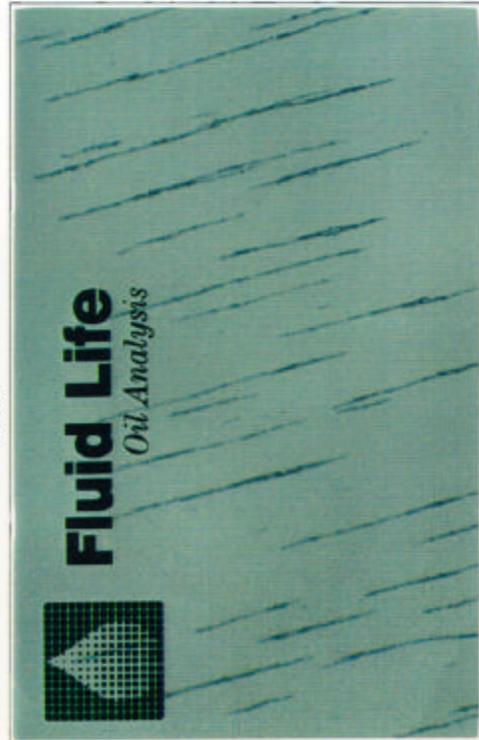
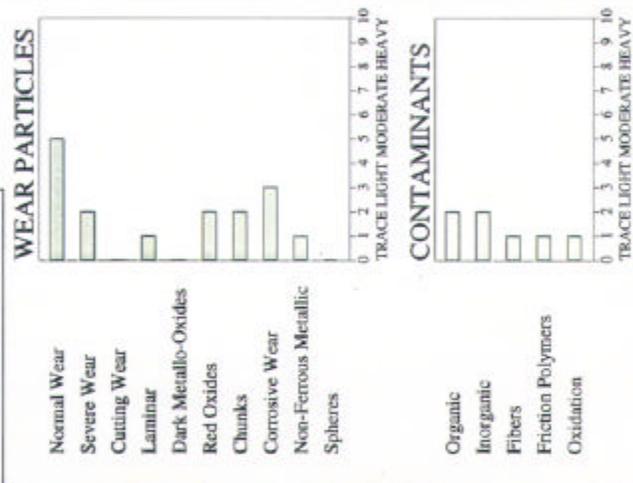
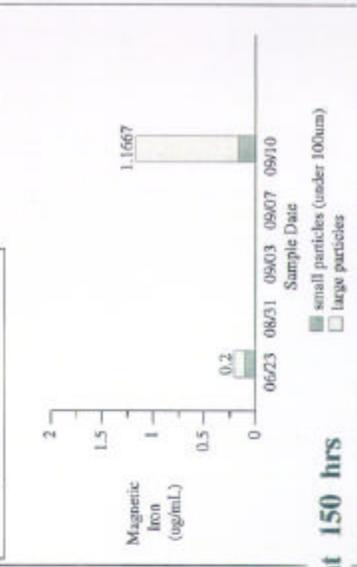
Figure 7- Ferrographic Oil Analysis during Run-1 at 150 hrs

**Figure 7-** Ferrographic Oil Analysis during Run-1 at 150 hrs under full load. Normal wear particles of low and medium alloy steel show rubbing/sliding, rated at level 5 (moderate). Traces of bearing babbitt up to 30  $\mu\text{m}$  in size were found. Magnetic iron was now measured at 1.17  $\mu\text{g/mL}$ .

**Comments**  
 Most metal particles are low and medium alloy steel showing rubbing/sliding wear.  
 Traces of babbit (up to 30 microns) found in debris.

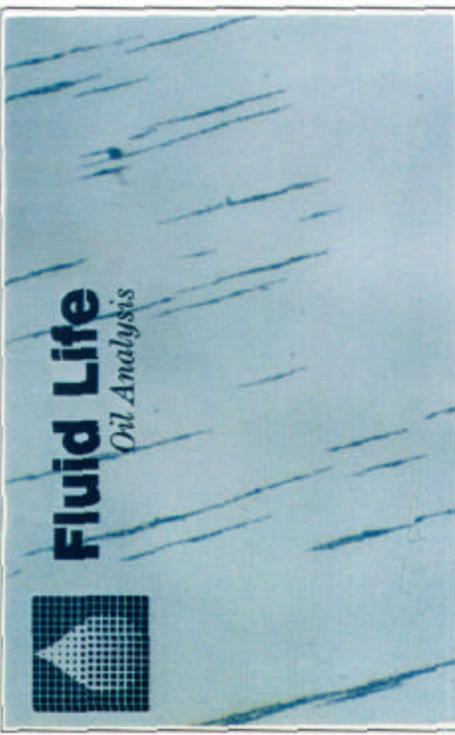
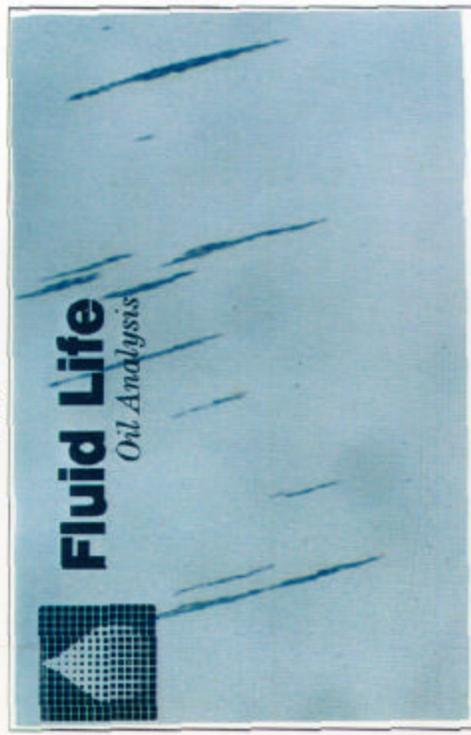
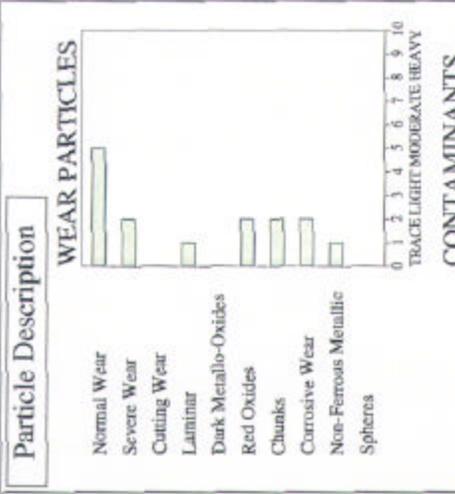
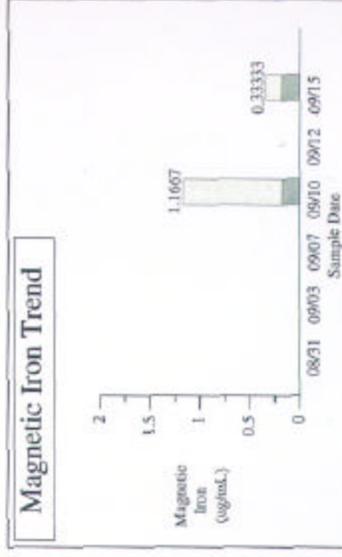
Figure 8 - Ferrographic Analysis at 250 hrs, end of Run-1

**Figure 8** – Ferrographic Analysis at 250 hrs, end of Run-1. Debris morphology is similar to 150 hr, mostly low and medium alloy steel. Normal wear still rated moderate at level 5. Magnetic iron has dropped to 0.33  $\mu\text{g/mL}$ , possibly due to oxidation.

**Comments**  
 Most metal particles are low and medium alloy steel showing rubbing/sliding wear.

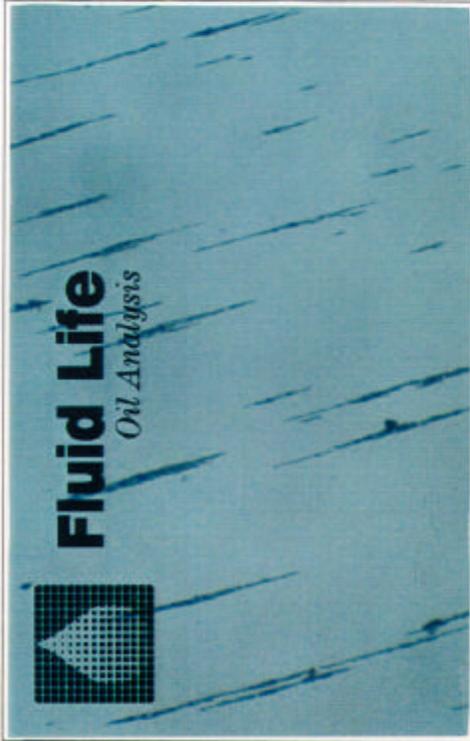
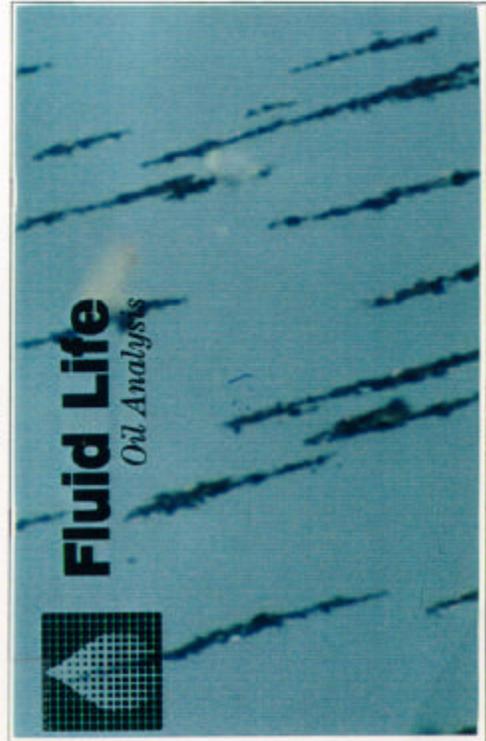
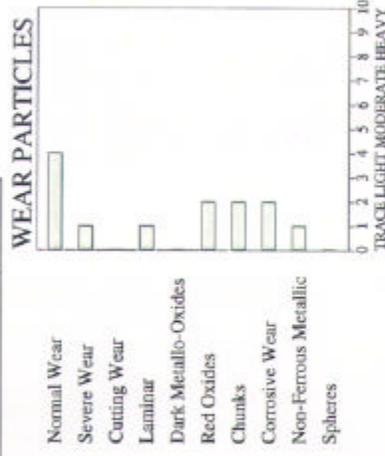
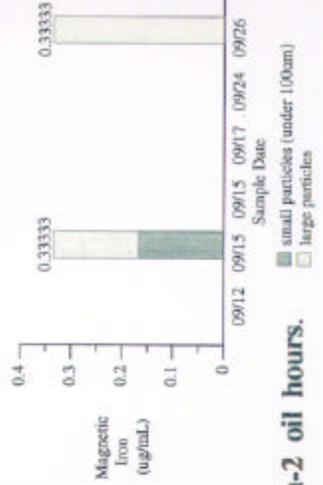
Figure 9 - Ferrographic Analysis at 400 engine test hr or 150 Run-2 oil hours.

**Figure 9** – Ferrographic Analysis at 400 engine test hr or 150 Run-2 oil hours. Normal wear is at level 4, identified as mostly rubbing/sliding low and medium alloy steel. Traces of 20  $\mu\text{m}$  babbitt particles were also present.

Most metal particles are low and medium alloy steel showing rubbing/sliding wear.  
 Traces of babbit material to 20 microns found in debris.

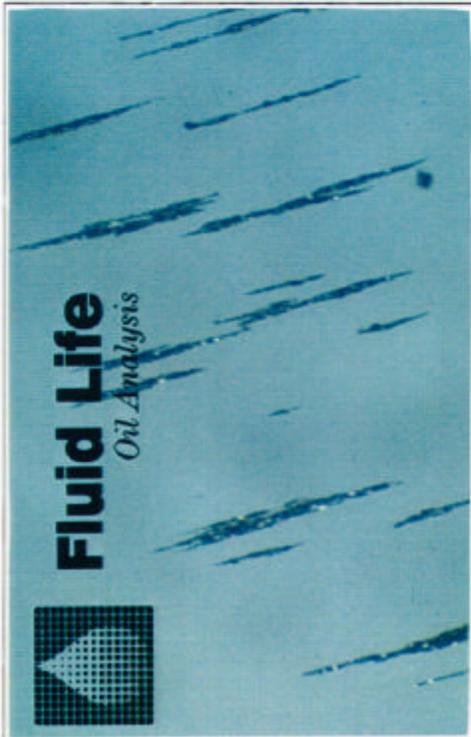
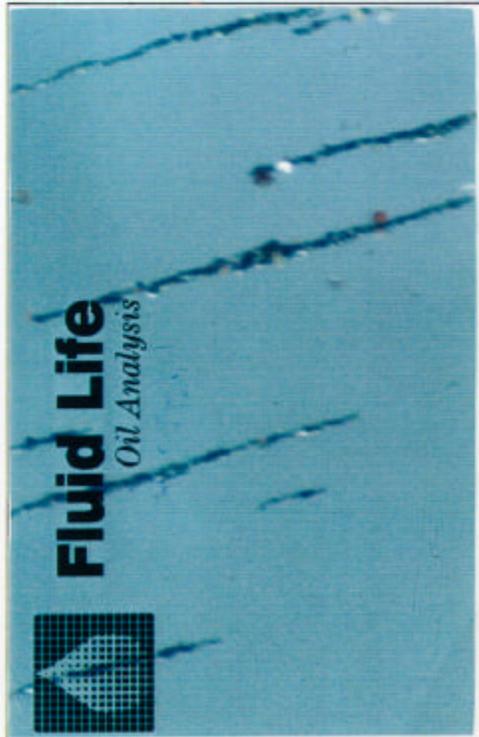
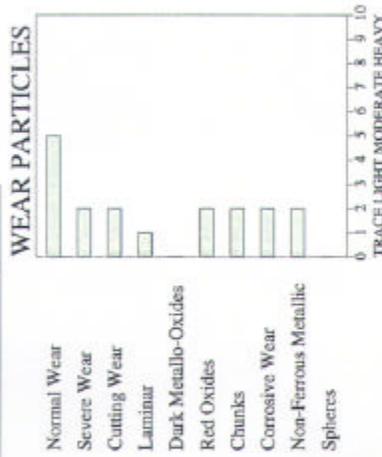
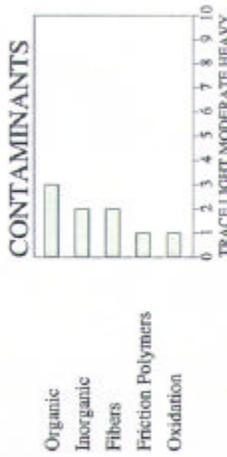
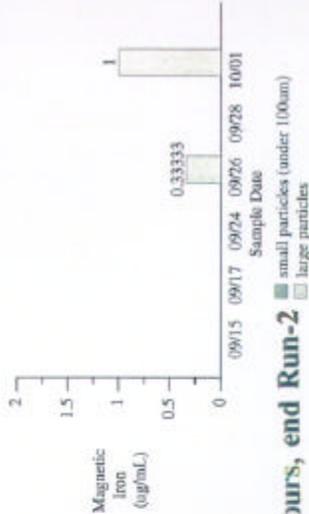
Figure 10 - Ferrographic Analysis at 500 engine test hr, 250 oil hours, end Run-2

**Figure 10** – Ferrographic Analysis at 500 engine test hr, 250 oil hours, end of Run-2. Normal wear at level 5, mostly steel showing the usual rubbing/sliding, magnetic iron at 1.0  $\mu\text{g/mL}$  with no large ( $>100 \mu\text{m}$ ) magnetic particles. Some copper particles, up to 20  $\mu\text{m}$  in size were present as shown in the lower microphotograph.

Most of the metal particles are low and medium alloy steel showing rubbing/sliding wear.

Traces of cutting wear also found in sample.

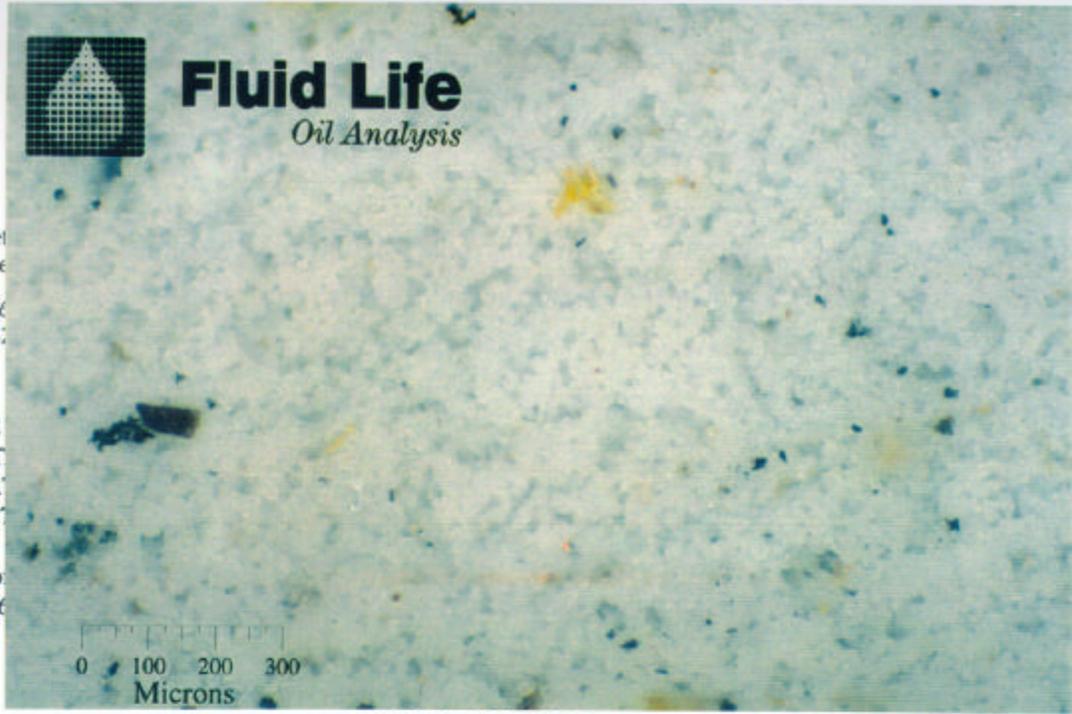
SAMPLE ID: New filter, 1999/06/24-268  
SAMPLE DATE: June 23, 1999  
MAJOR CONTAMINATION: Dirt/dust  
Fibers  
SPECTROGRAPHIC ANALYSIS: n/a  
COMMENTS: Filter debris consists of some dirt and a few fibers.

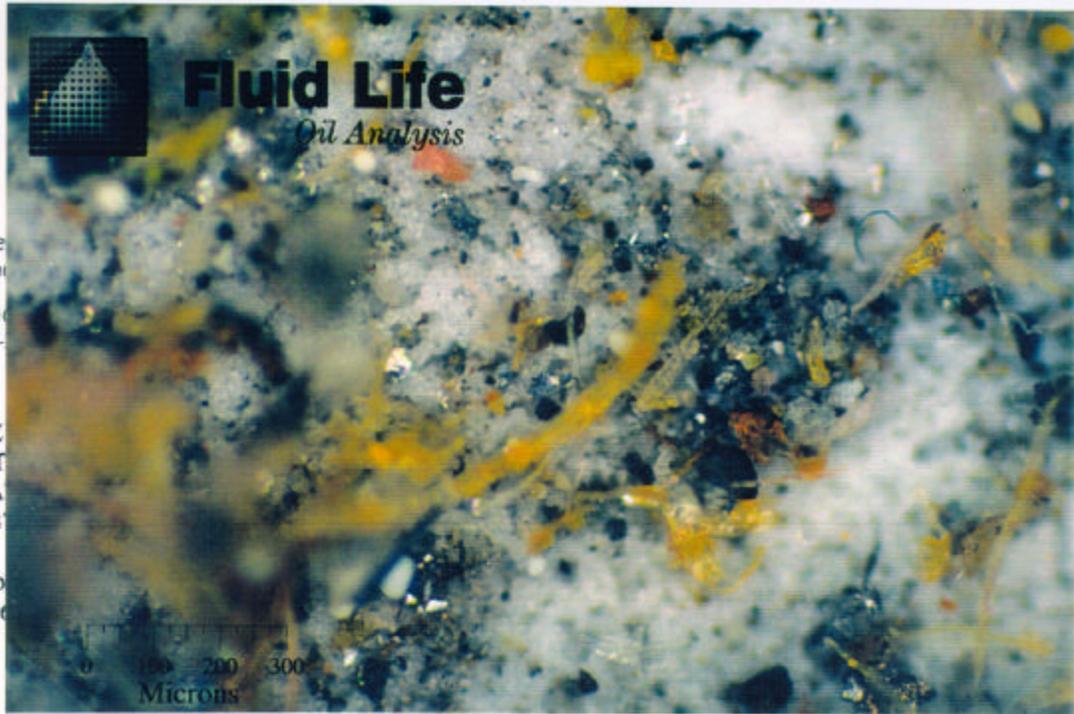
**Figure 12** – Filter report and debris photos for “0” hours, after 10 hour run-in. Note presence of 180  $\mu\text{m}$  size iron and 25  $\mu\text{m}$  copper particles, with dirt, fibers, and rust.

**MINOR CONTAMINATION:** Iron particles up to 180 microns  
Copper/copper alloy particles up to 25 microns  
Rust

**COMMENTS:** Most of the filter debris is typical of reservoir contamination.  
The fibers in debris matched those found in new filter debris.  
Debris is normal for a new system flush.

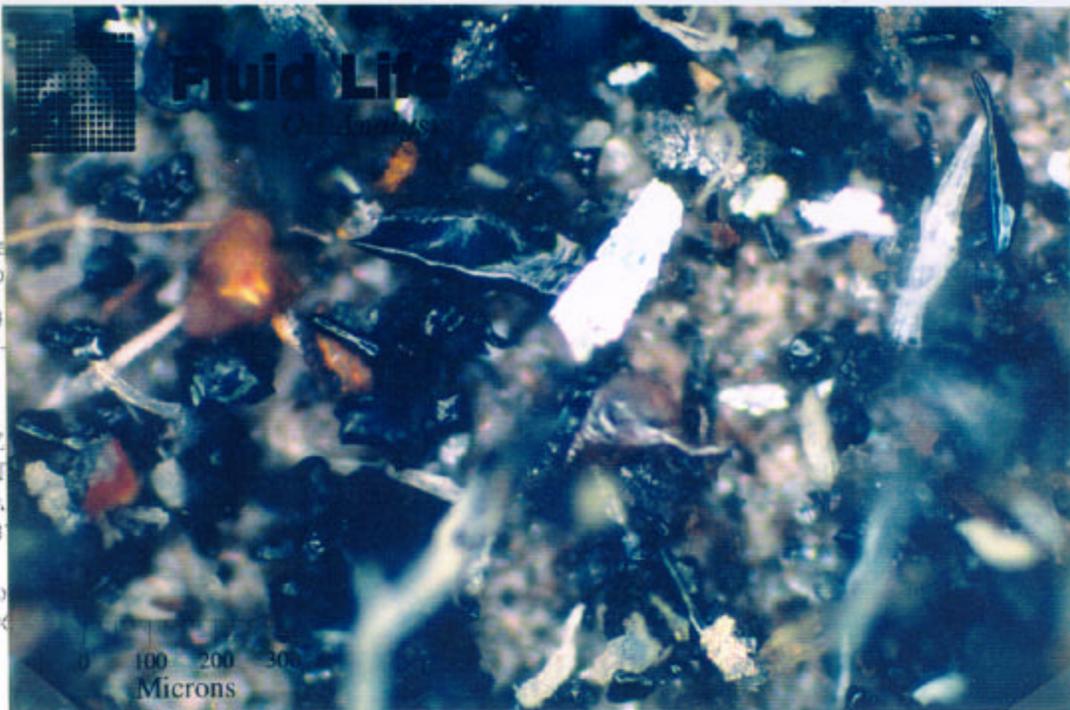
COMMENTS: Dirt/dust and carbon compounds make up most of the debris.  
Iron particles (up to 220 microns) show both sliding and laminar wear.  
Several large copper/copper alloy (up to 85 microns) show laminar wear.

Based on the tribological oil and filter analysis data, it would appear that the unusually high copper wear rates observed were the result of copper ground bar erosion of the Champion "Premium Gold 2095" spark plugs. Although the copper wear rates were becoming stable and lower as the tests proceeded, this was probably due to the installation of a new set of similar plugs. The 2095 plugs used were the coldest heat-range available. The abrasion scratches on cylinder walls and main bearings can be related to debris from the spark plug failures. Other wear metals including iron, lead and chromium were well within acceptable ranges for this type of engine under continuous full-load.

In hindsight, a more durable set of spark plugs based on platinum construction such as Champion "Double-Platinum 7346" could have alleviated the early failures observed in these tests and eliminated the most probable cause of elemental copper oil contamination. The Mobil Delvac Super Geo SAE 15W-40 oil change frequency at 250 hours should not be exceeded under the full-load test conditions employed in this study. Oil oxidation and acid neutralization ability begins to deteriorate after 150 hours and depends on make-up oil additions to avoid exceeding condemnation limits.

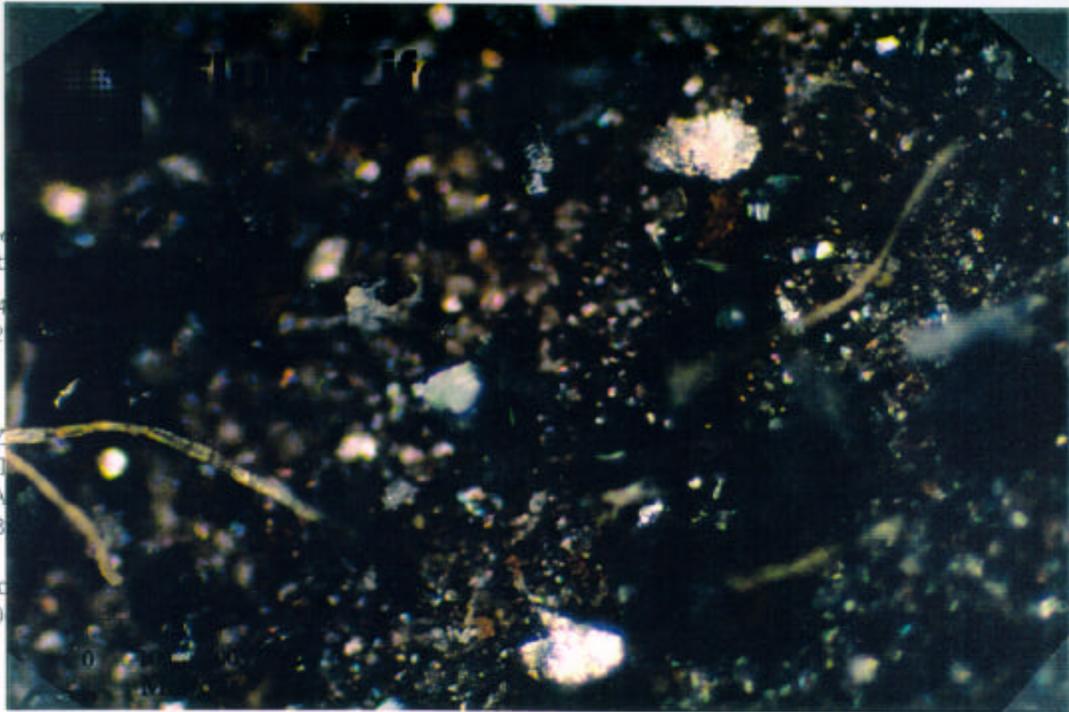
**Figure 14** – Filter report and debris photos for 500 hours, end of Run-2. Note dirt/dust, higher carbon/soot deposits, and darker brown coloration. Iron particles up to 250  $\mu\text{m}$ , some chrome indicating potential ring wear, more iron particles but no large copper particles.

Iron particles (up to 250 microns) show both sliding and laminar wear. Chrome is detected in latest filter possibly indicating ring wear.

The number of iron particles has increased while large copper/copper alloy particles were not found in this filter.

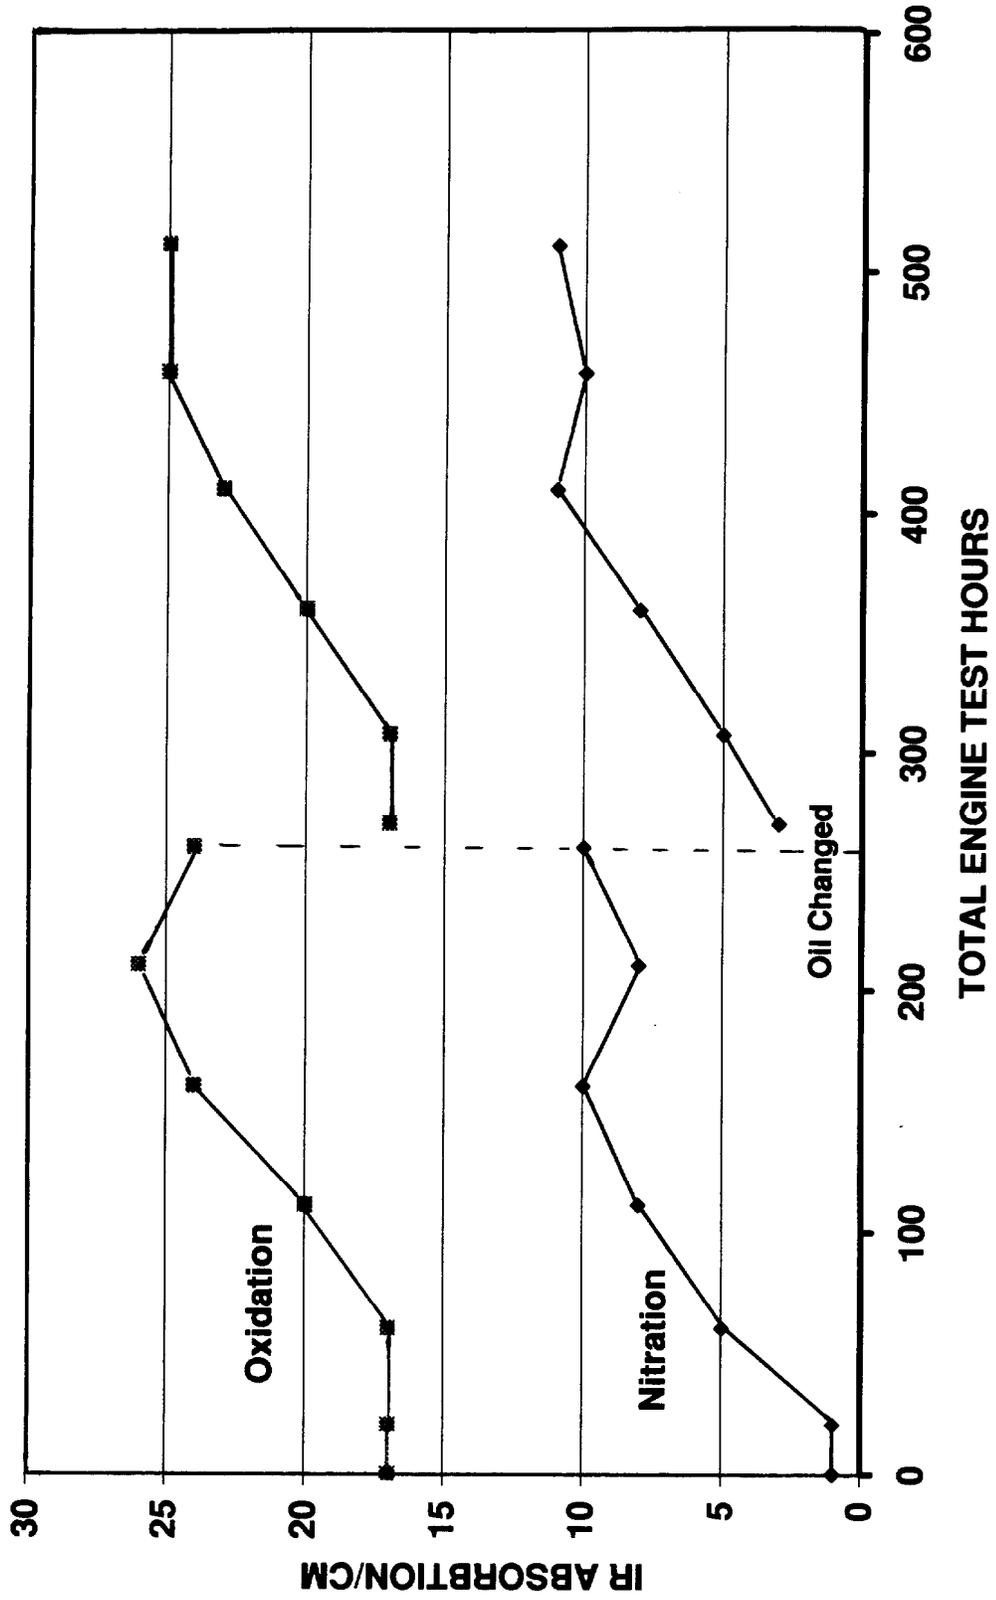
**Figure 15 – Graph of Oil Infrared Oxidation and Nitration versus Engine Hours**

The Total Base Numbers are depressed with time after each oil change while the oil acidity (TAN) rises to unacceptable high levels beyond 150 oil hours.
