**CUMMINS B5.9L PROPANE ENGINE
ARB "HD-10" LPG DURABILITY TEST
TRIBOLOGICAL OIL ANALYSIS**

**Prepared for
The ADEPT Group, Inc.,
Los Angeles, CA USA
by
P. B. Hertz, P.Eng.,
Hertz Mechanical Engineering
Saskatoon, SK Canada
December, 1999**

The durability of a prototype Cummins B5.9L propane engine was evaluated in a 500-hr full-load dynamometer test using California Air Resources Board "HD-10" LPG fuel. Tribological oil analysis techniques were used to infer metal wear rates by spectrometry, ferrography, magnetic-iron particle counts and oil filter debris examination.

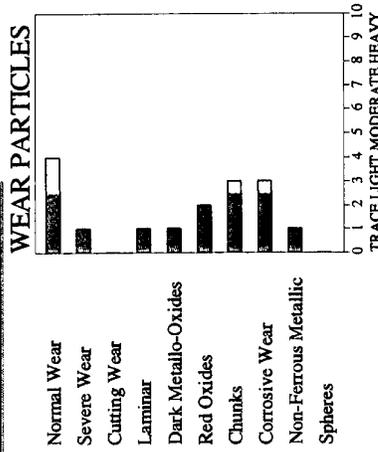
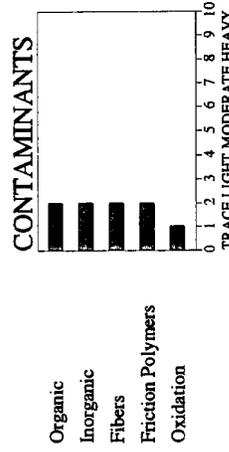
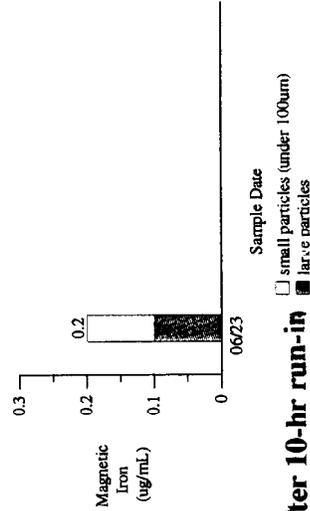
Figure 6 - Ferrographic Analysis of used oil at "0" hours, after 10-hr run-in

Most metal particles are low and medium alloy steel showing rubbing/sliding wear.
 Traces of copper/copper alloy particles (up to 65 microns) present in sample.

Note photographs of low and medium alloy steel debris aligned with magnetic field. Traces of copper/copper alloy particles up to 65 μm (0.0026 in.) in size were detected. Magnetic Iron was at 0.2 $\mu\text{g/mL}$. Morphology of other wear and contaminant particle classes and concentrations are shown by the centrally located bar graphs.

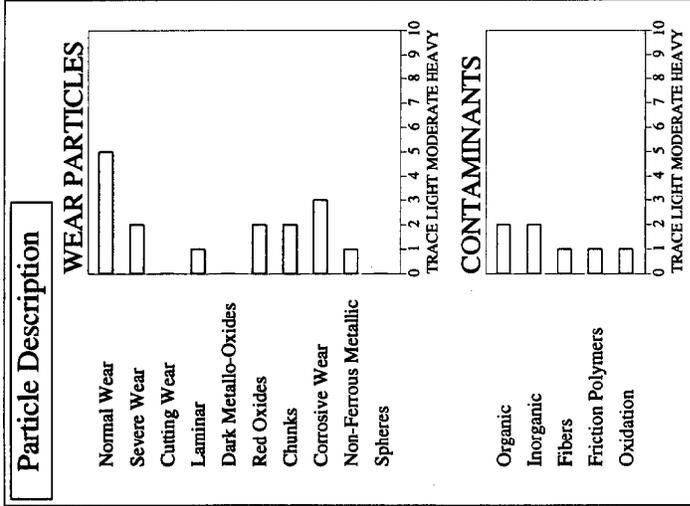
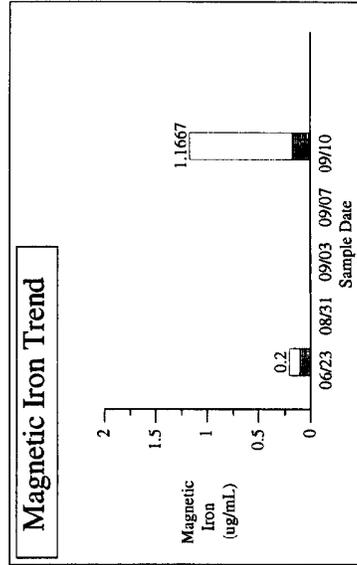
Most metal particles are low and medium ally steel showing rubbing/sliding wear.

Traces of babbit (up to 30 microns) found in debris.

Figure 7- Ferrographic Oil Analysis during Run-1 at 150 hrs under full load. Normal wear particles of low and medium alloy steel show rubbing/sliding, rated at level 5 (moderate). Traces of bearing babbitt up to 30 μm in size were found. Magnetic iron was now measured at 1.17 $\mu\text{g/mL}$.

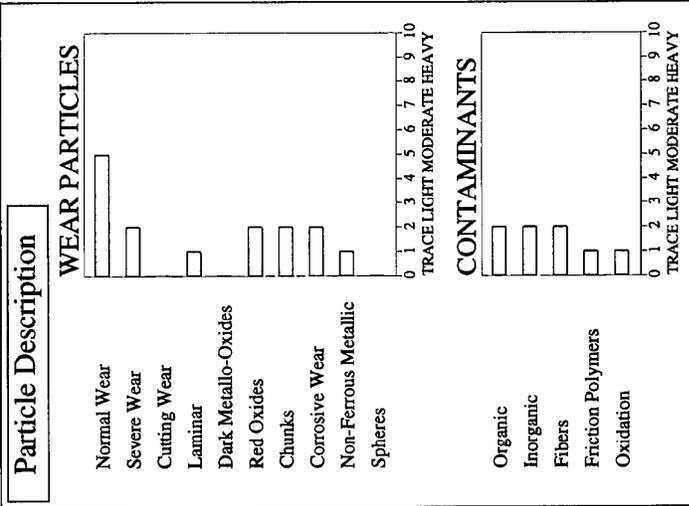
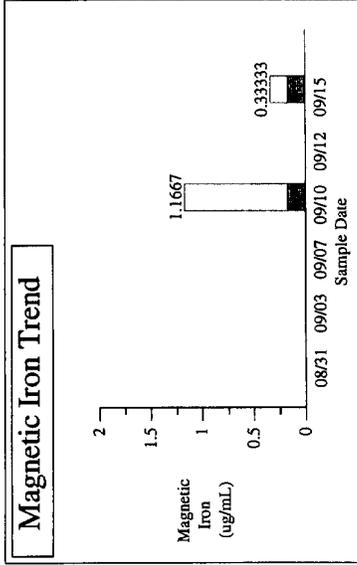
Figure 8 - Ferrography Analysis at 250 hrs, end of Run-1

Most metal particles are low and medium alloy steel showing rubbing/sliding wear.

Figure 8 – Ferrographic Analysis at 250 hrs, end of Run-1. Debris morphology is similar to 150 hr, mostly low and medium alloy steel. Normal wear still rated moderate at level 5. Magnetic iron has dropped to 0.33 $\mu\text{g/mL}$, possibly due to oxidation.

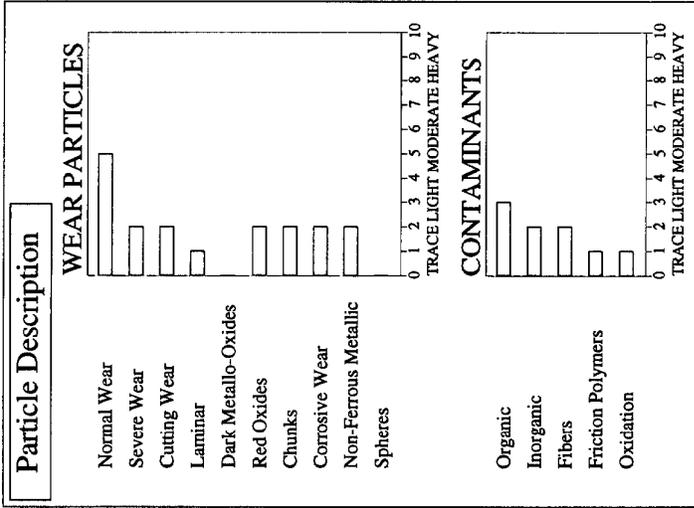
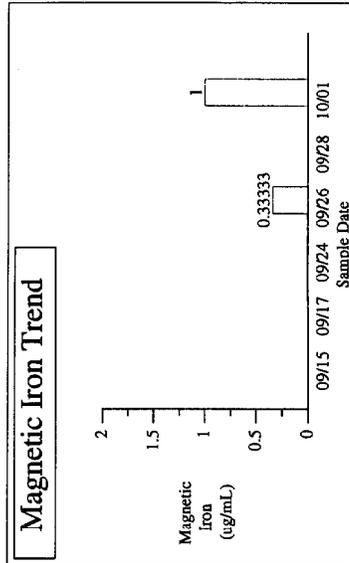
Figure 10 - Ferrographic Analysis at 500 engine test hr, 250 oil hours, end Run-2

Comments
 Most of the metal particles are low and medium alloy steel showing rubbing/sliding wear.
 Some copper/copper alloy particles to 20 microns present.
 Traces of cutting wear also found in sample.

Figure 10 – Ferrographic Analysis at 500 engine test hr, 250 oil hours, end of Run-2. Normal wear at level 5, mostly steel showing the usual rubbing/sliding, magnetic iron at 1.0 $\mu\text{g/mL}$ with no large ($>100 \mu\text{m}$) magnetic particles. Some copper particles, up to 20 μm in size were present as shown in the lower microphotograph.

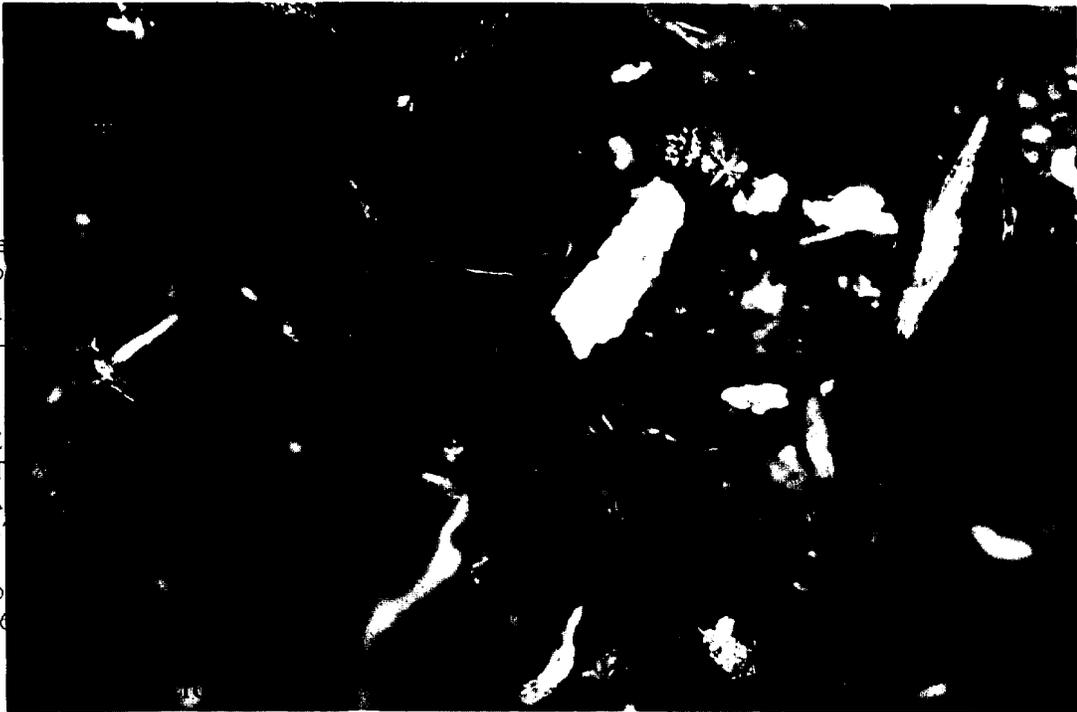
Iron particles (up to 220 microns) show both sliding and laminar wear.

Several large copper/copper alloy (up to 85 microns) show laminar wear.

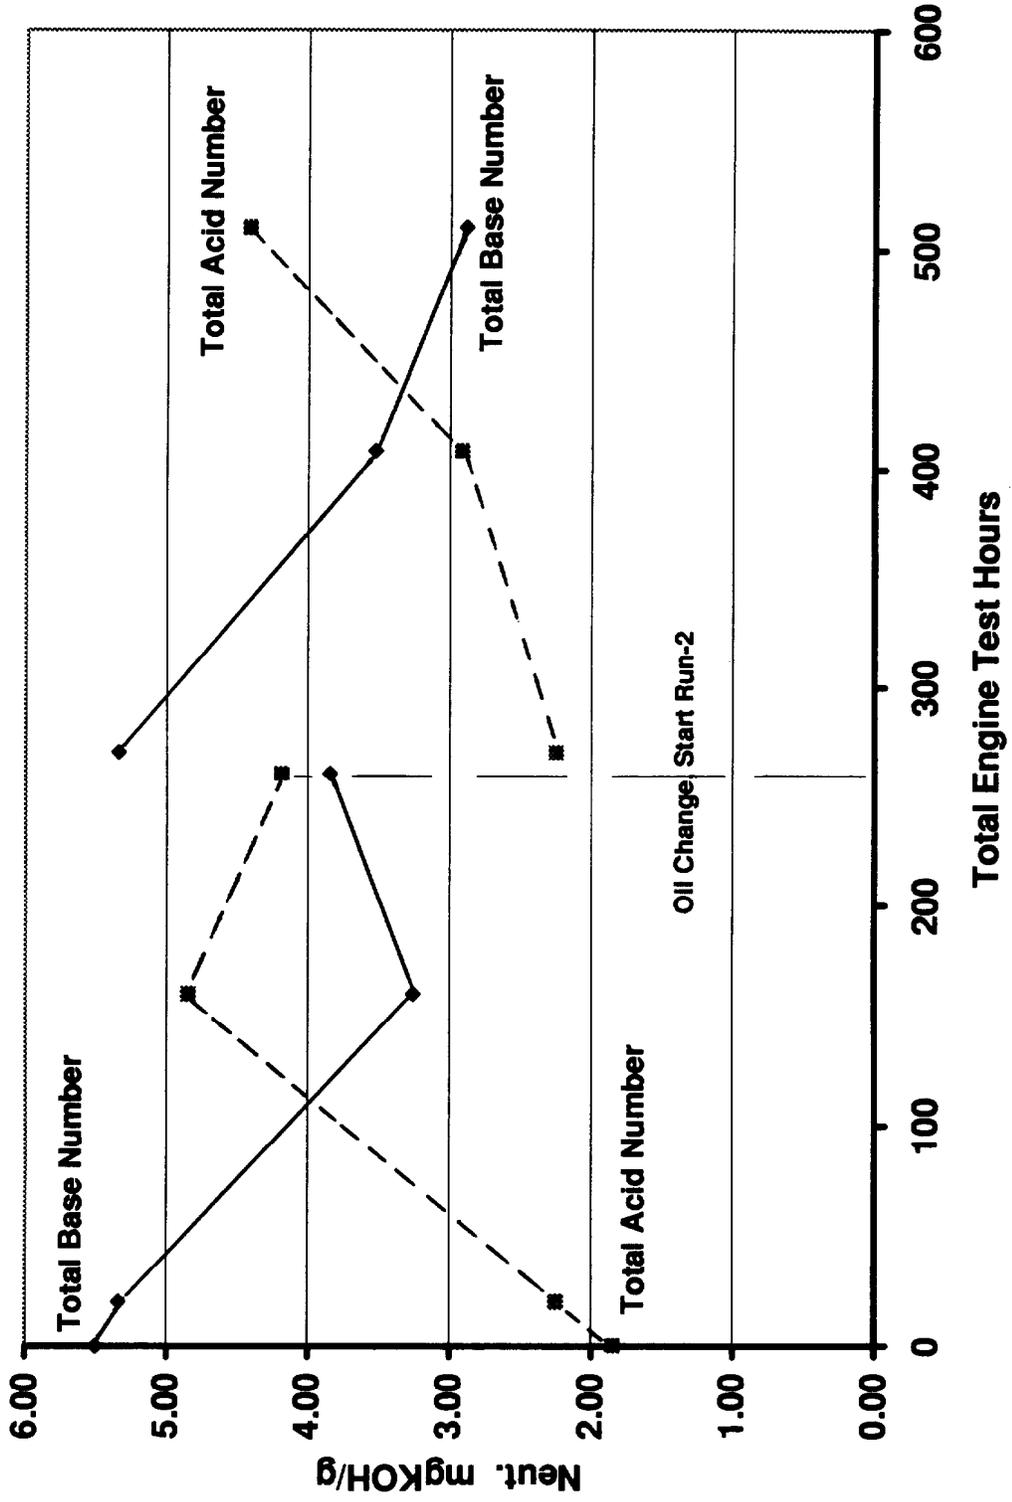
Figure 16 – Graph of Engine Oil TAN and TBN Neutralization Ability

The Total Base Numbers are depressed with time after each oil change while the oil acidity (TAN) rises to unacceptable high levels beyond 150 oil hours.
