California Air Resources Board
January 27, 2006
El Monte, CA

VTA-SAMTRANS ZEB
Demonstration Program

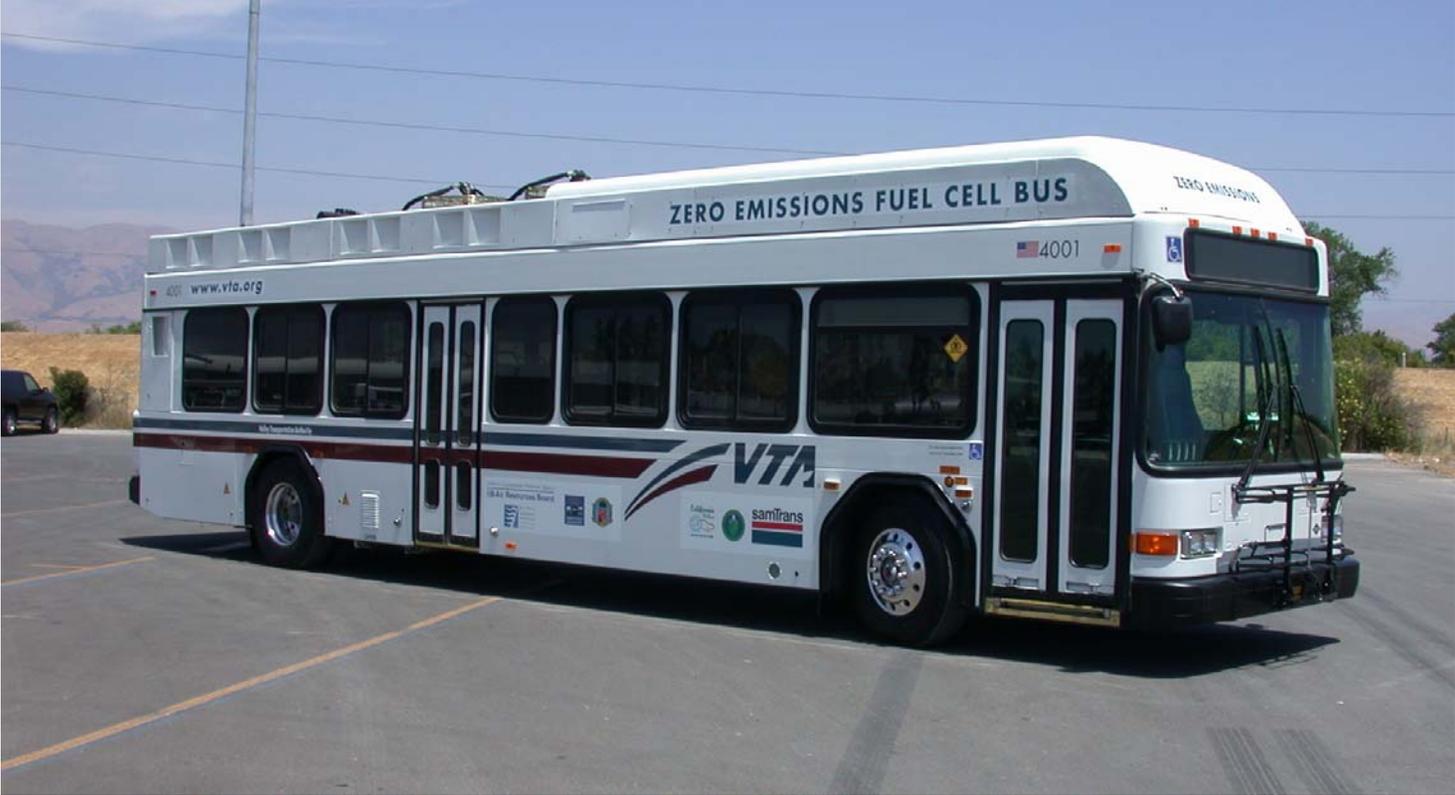
- Bus Manufacturer-Gillig
- Low Floor Model
 - Length - 40 feet
 - Width – 102 Inches
 - Height – 144 inches
 - Wheelbase – 284 inches
 - GVW – 40,600 lbs
 - Seating capacity – 37
 - AC – Thermo King with rotary compressor
 - Ramp Lift –U
- Fuel Cell - Ballard P5-2 300 Kw
- Traction Motor Reuland Electric
 - Model DC-55-13517F
 - Max torque 790 lbs.ft
 - Peak Power Output 225 Kw
 - Rated Speed 2100 rpm
 - Voltage 575 V

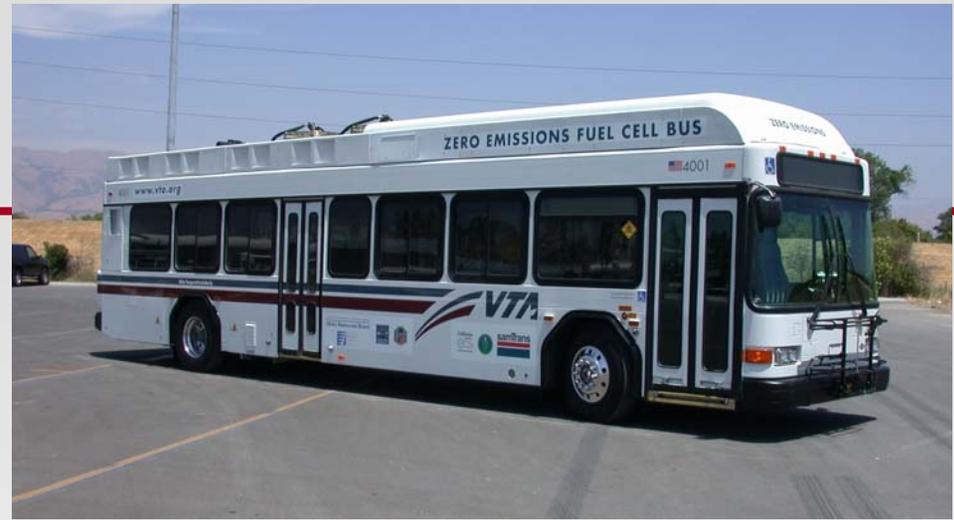
- Transmission - ZF model 6HP592
 - Automatic 6 speed with integral retarder
- Fuel System
 - Gaseous H₂ – 350 barr
 - Dynetek tanks
 - Dynecell Carbon Fiber
 - fueling CaFCP I/O
- Fire Detection system

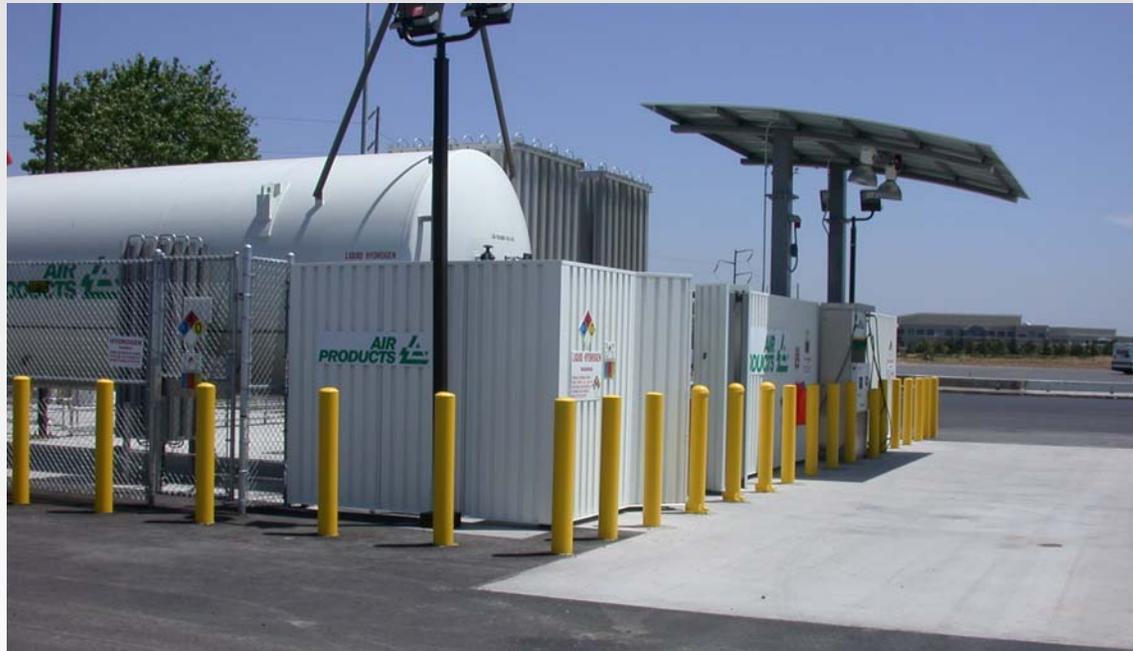
- Leased facility from APCI
- Liquid hydrogen delivery and storage
- Compressed to 6000 psi and vaporized for storage in cascade
- Similar to facility at Ca FCP
- Bus fueling capability goal of 8 minute fill with communications

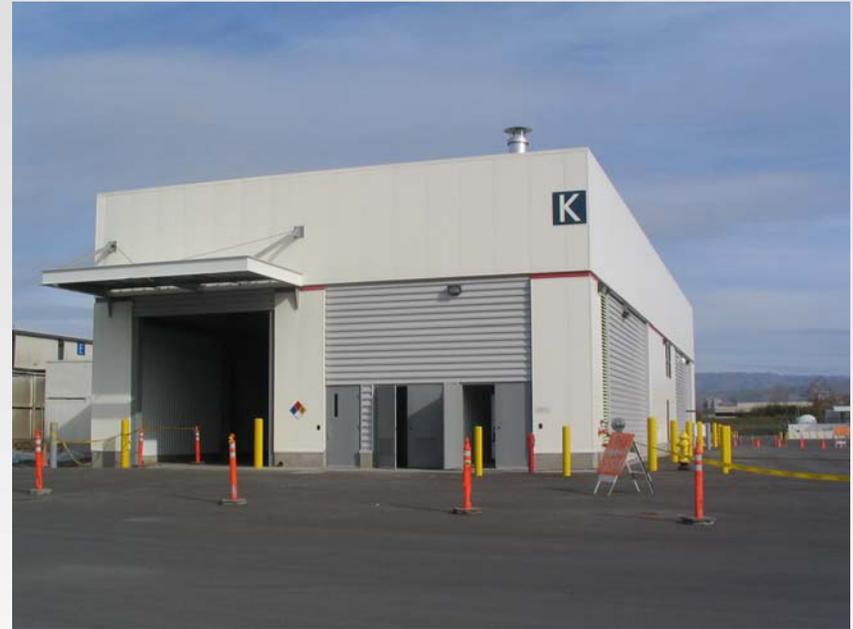
- Bay area limited to two buses
- Separation include major fire wall requirements
- Ventilation system for complete ventilation.
- No air pockets in ceiling
- Hydrogen detection system
 - Internal and external monitoring
- Flame detection system
- Alarms
- Class 1 Div 2 Electrical classification in complete facility
 - Ceiling lighting
 - Fans
 - Fixtures
 - Electrical outlets
 - Heating system
 - Etc.
- Doors
