Appropriateness of Test Procedure TP-201.1, "Volumetric Efficiency for Phase I Systems," on Gasoline Dispensing Facilities Equipped with Aboveground Storage Tanks

California Environmental Protection Agency

Monitoring and Laboratory Division Engineering and Certification Branch Engineering Evaluation Section

Date: April 2013

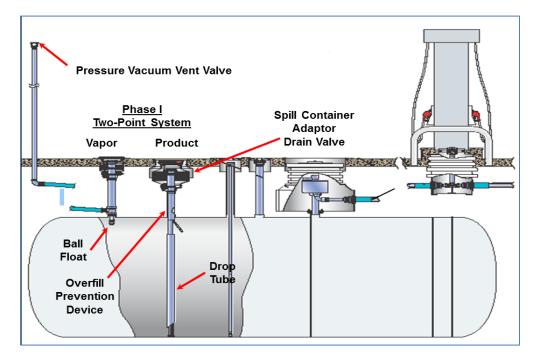
During the transfer of gasoline from the cargo tank into the storage tank, the vapors contained in the headspace (empty space or ullage) of the storage tank are displaced. Rather than allowing these displaced vapors to escape directly to the atmosphere through an open vent line, Phase I components cap the vent line and establish a low resistance pathway which allows the displaced vapor to flow back into the empty compartments of the cargo tank. Phase I EVR systems currently certified by ARB are commonly referred to as a "two point" or "balance" systems. A dedicated adaptor and opening is provided for the fuel to enter the tank. A second dedicated adaptor and opening is provided for the vapors to exit the tank. To capture the vapors during fuel transfer, a flexible vapor return line is connected to the adaptors installed on the storage tank and cargo tank. Phase I components also establish leak tight seals at tank penetrations so that vapors are contained during the idle periods when no transfers take place. Typical Phase I vapor recovery components are illustrated in Figures 1 and 2.

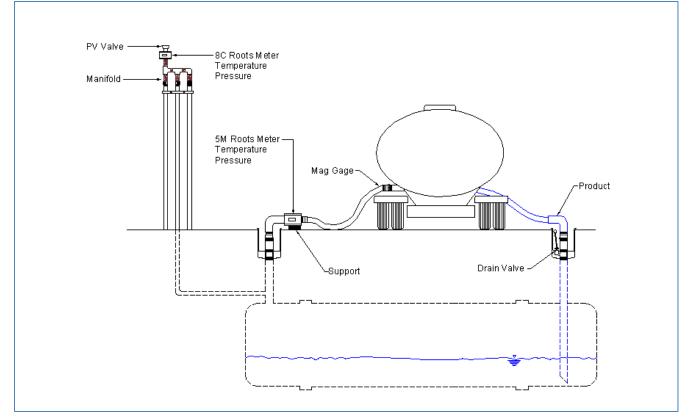
Figure 3: Phase I Efficiency Testing Configuration for a Typical UST

Figure 3 provides a cross sectional view of a Phase I transfer and the equipment installed to measure the volume returned to the cargo tank, and volume lost through the vent line.

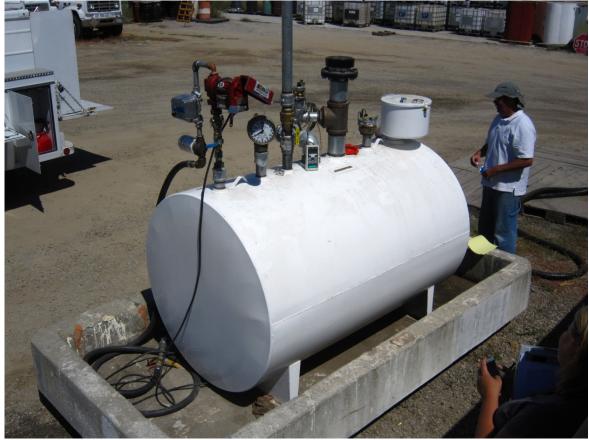
Figure 6: Morrison Brothers Phase I EVR System for Single Wall AST

As indicated in Table 1, on June 22, 2011, a Phase I EVR system manufactured by Morrison Brothers was certified for use with protected ASTs per ARB Executive Order (EO) VR-402-A. In order to gain ARB certification for single-wall AST applications, Morrison Brothers requested certification testing on a 550-gallon single-wall AST located in Ceres, California (See Figure 6). ASTs are commonly classified as either "single-wall" or "protected". Single-wall ASTs are constructed with a primary (single) wall typically made of steel. Protected ASTs are constructed with a primary (inner) tank encased by a secondary (outer) tank, with a layer of insulating material (at least three inches thick) between the primary and secondary walls. The insulating material is usually lightweight concrete or a similar material.

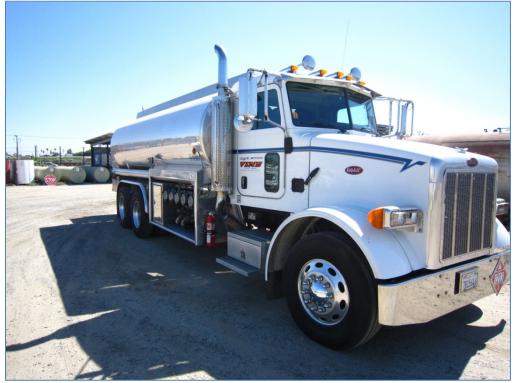
Figure 7: Cargo Tank Used to Fill AST at Morrison Brothers Test Site

At approximately 10:00 AM, ARB staff arrived on-site and installed test equipment (roots meters) on the vapor return from the AST to the cargo tank and on the vent line of the AST. The system was initially set up for a fuel drop of 280 gallons. As the vapor return line was opened and the first 58 gallons was transferred, tank pressure rose dramatically and scaled-out the manometer. The P/V valve cracking pressure was reached and vapor was lost through the vent line.

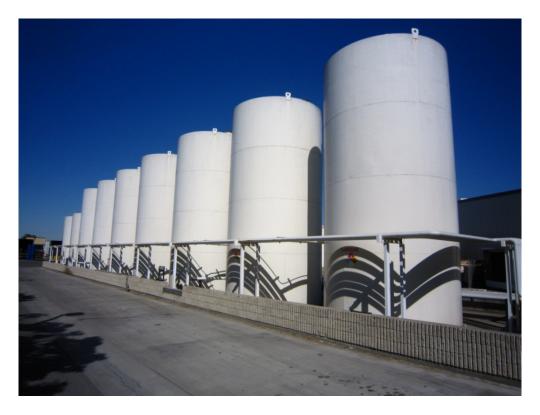
Figure 8: Bulk Plant Tanks located at the Morrison Brothers Test Site

Another trip was made to the test site on September 8, 2011 to run a second Phase I efficiency test. ARB staff arrived at approximately 10:00 AM and set up roots meters on vapor return and vent stack. Staff then joined the empty cargo truck at the bulk plant (see Figure 8) and observed 450 gallons of gasoline being bottom loaded into a 500 gallon compartment (See Figure 9). Staff learned that except for a shared rail space at the top of the cargo tank, vapor is only returned to the compartment utilized during fueling.

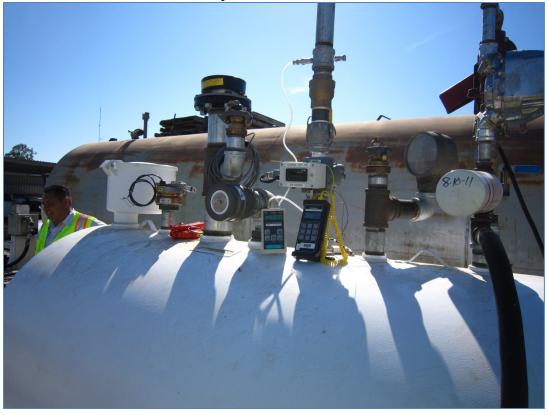
Figure 10: Measurement of Headspace Pressure, Temperature, and Vent Volume after Fuel Delivery at Morison Brothers Test Site

The cargo truck was then driven back to the AST site (approximately 200 feet away) and prepared for a fuel drop of 300 gallons. As soon as the vapor return was opened between the truck and the AST, the manometer was scaled-out and the P/V vent cracked. Approximately 15 cubic feet (112 gallons) of vapor was vented through the P/V valve resulting in an efficiency of 62%. The decision was made to clear the instruments and allow the tanker truck and AST to stabilize before starting the Phase I Efficiency test. Once again, this instantly failed the Phase I efficiency testing, as the test procedure does not allow for equipment to be cleared. (See Figure 10)

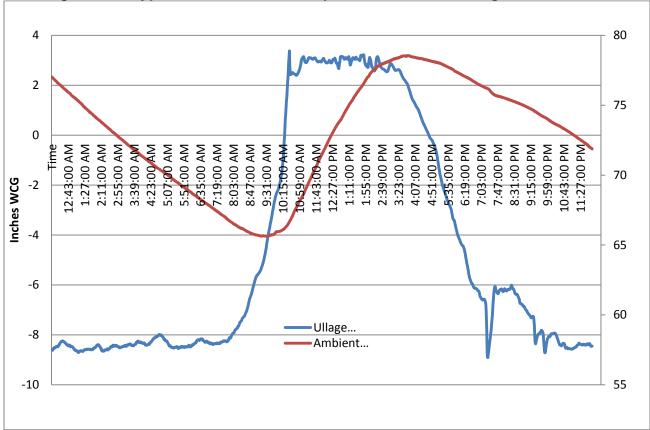
Figure 11: Typical Pressure vs. Temperature Profile of Single Wall AST

On December 15, 2011, ARB staff arrived at approximately 7:00 AM to perform the third Phase I Efficiency Test. Discussion between ARB and Morrison Brothers staff resulted in the hypothesis that direct sunlight as well as ambient and fuel temperature may play a role in the pressurization of the AST during and after the Phase I transfer of fuel to the AST (See Figure 11). The cargo tank was again loaded immediately before the start of the Phase I Efficiency testing, and all certification testing equipment and delivery equipment was connected appropriately. The internal pressure of the AST was allowed to stabilize before the delivery was initiated.

Unlike USTs, which are larger and insulated by backfill material, ASTs typically found at gasoline dispensing facilities are significantly smaller and subject to greater diurnal temperature variations. When the volatile liquid gasoline vaporizes, the smaller AST is

far more likely to be subject to rapid increases in ullage pressure, which results in greater pressure-driven vent line emissions, as illustrated in Figure 11. These diurnal AST emissions are subject to and captured by the separate standards of standing loss control. Therefore, the longer an AST sits idle, the greater the chance of hydrocarbon pressurization and possible vent line emissions. Including the standing loss control vent emissions that occur in the idle period after a delivery biases the Phase I Efficiency test results towards failure.
