# Multi Media Chrome Plating Project

December 2000

**California Environmental Protection Agency**  
**Air Resources Board**  
Compliance Division

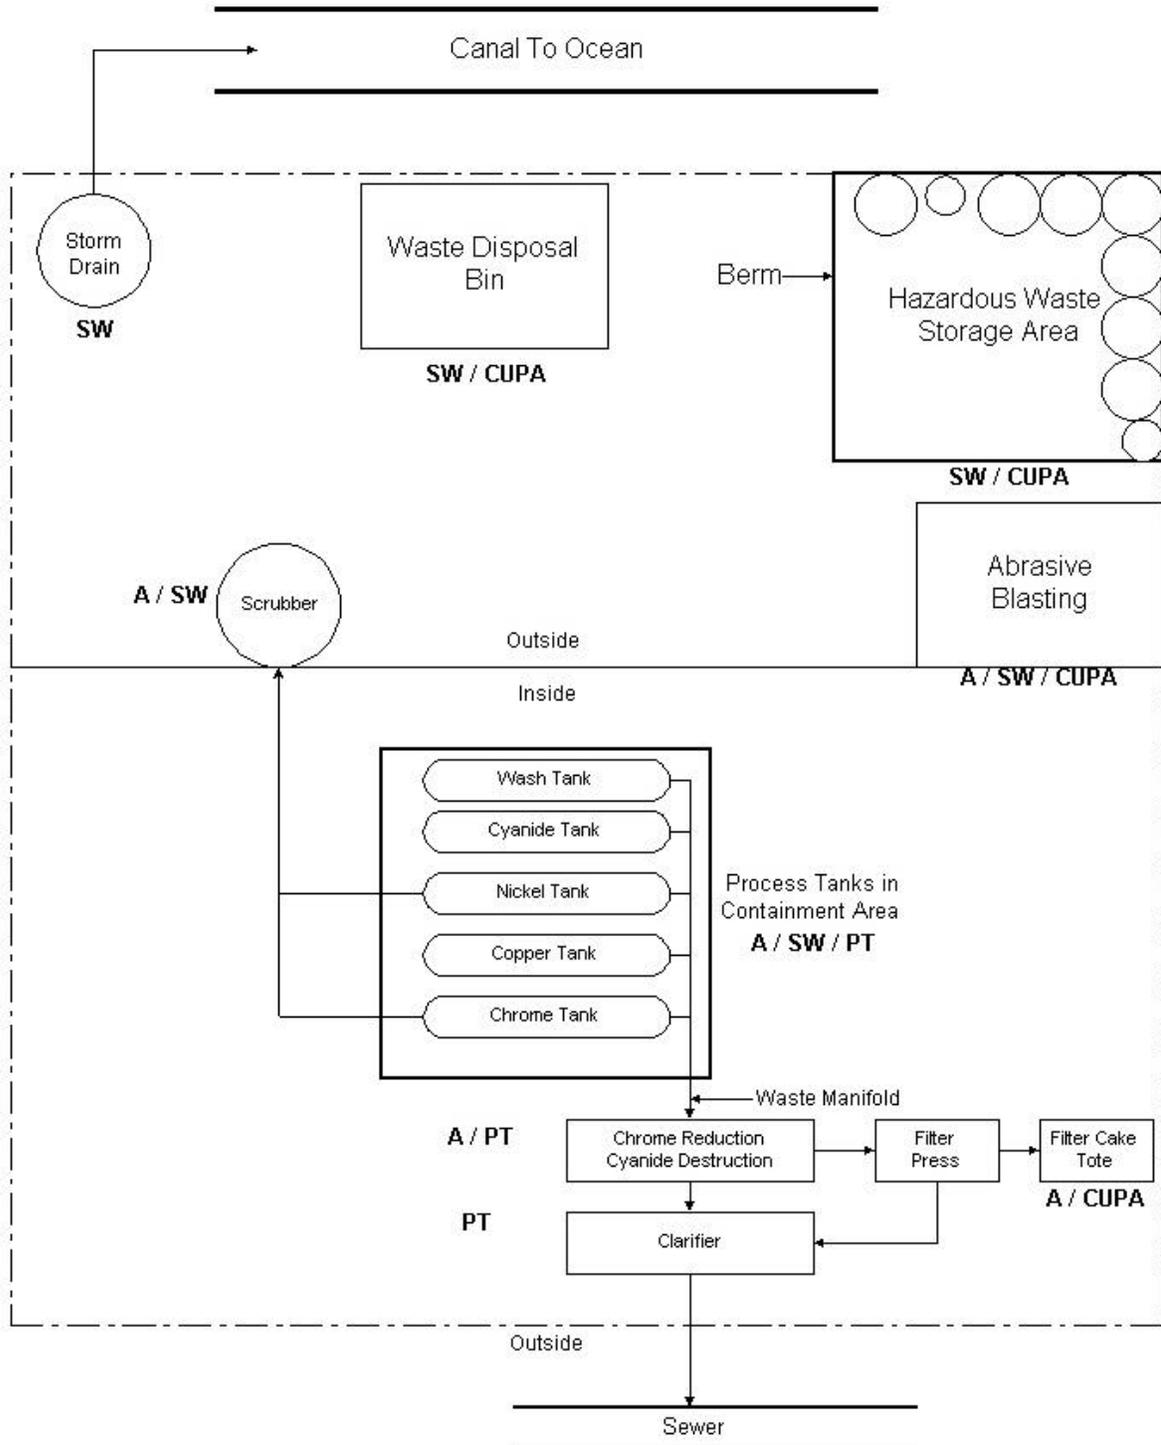
## Chrome Plating Process & Waste Generation Multimedia Jurisdictions

(Air = A / Pre-Treatment = PT / Storm Water = SW / Hazardous Materials = CUPA)

Emissions of pollutants from a typical chrome plating operation can enter the air stream (to atmosphere), water stream (to sewer), or can be manifested out as hazardous waste (solid or liquid). Attachment D is a diagram of a typical chrome plating process showing the multiple nature of waste generation points and the regulatory agencies involved. Production operations at most shops involve manufacturing of the part on site (or receiving it from a vendor), surface preparation (mechanical shot blasting, buffing/polishing or chemically dipping it in a degreaser or acid bath), and electrochemical plating (nickel, chromium, copper, etc.). Control of emissions for each media is governed by a complex set of regulations. The paragraphs below give an idea of the rule requirements in a simplistic form.
