# 06-05

This letter is to provide Healy Systems, Inc. with approval for the 8177 Spout Assembly as an alternate spout assembly that can be used for Model 800 nozzles certified per Executive Order (EO) G-70-191-AA, "Healy Phase II Onboard Refueling Vapor Recovery (ORVR) System."

<b>FIELD REPLACEMENT INSTRUCTIONS</b>	<b>HEALY PART NO. 8177 UNLEADED SPOUT ASSEMBLY</b>
---------------------------------------	--

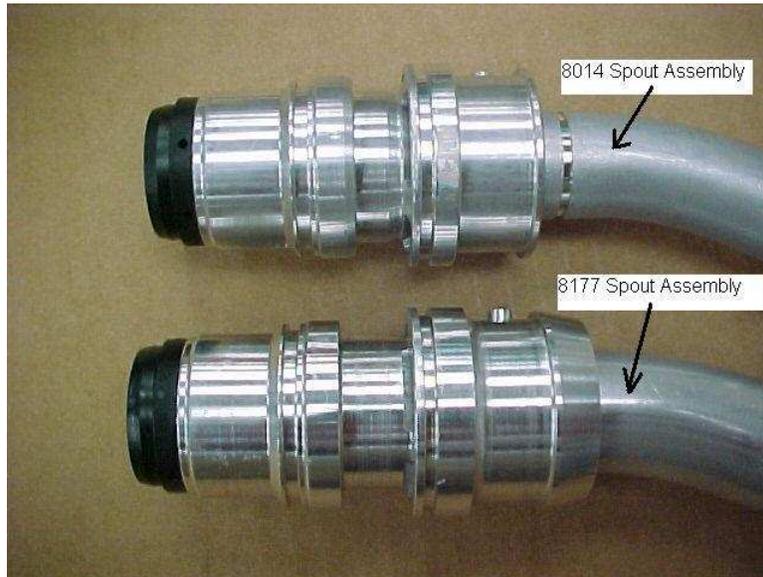
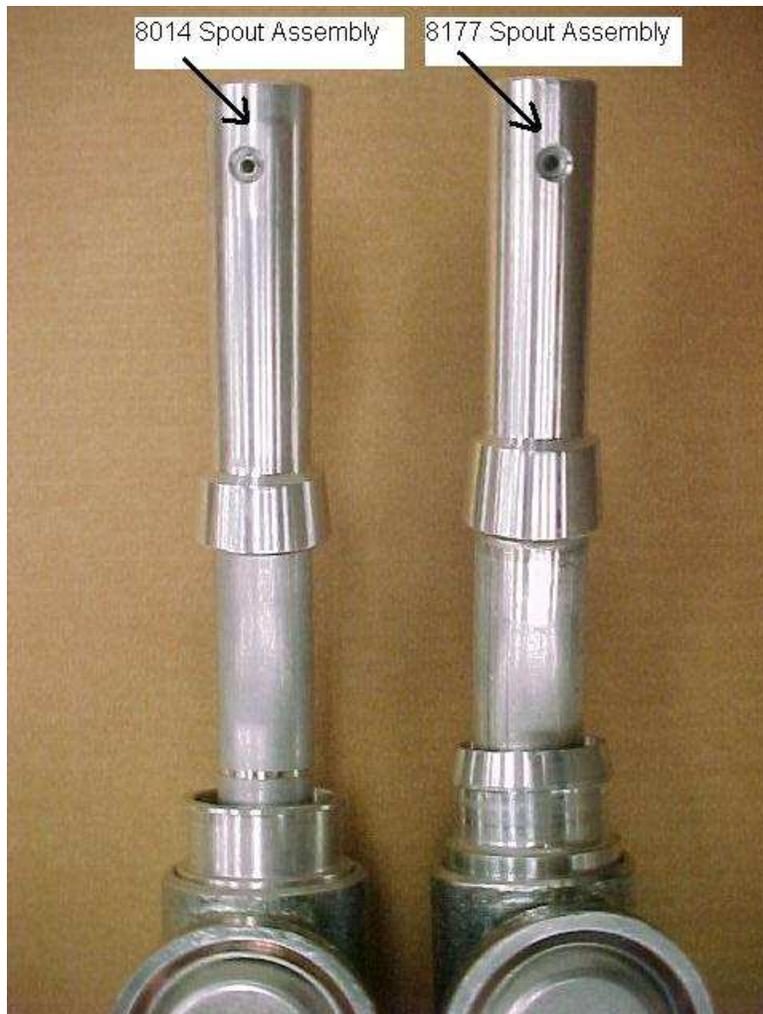
Figure 1

Differences Between 8014 and 8177 Spout Assemblies

As a corrective action, Healy representatives suggested replacing the 8014 spout on the Model 800 ORVR nozzle with a spout assembly that incorporates the design improvements that led to the 8155 spout assembly on the Model 900 enhanced vapor recovery (EVR) nozzle. The new 8177 spout assembly is almost identical to the 8155, except for the insertion interlock feature. By using the 8177 spout assembly, the position of the nozzle boot is brought closer to the tip of the spout thus minimizing the effects of boot fatigue and non-SAE standard vehicle fill pipe configurations (see pictures in Figure 1).
