Monitoring and Laboratory Division  
Engineering and Certification Branch  
Vapor Recovery Certification Section

Evaluation Test Report

PHASE II VAPOR RECOVERY  
BALANCE SYSTEM CHALLENGE MODE STUDY

Project Number: V-05-035

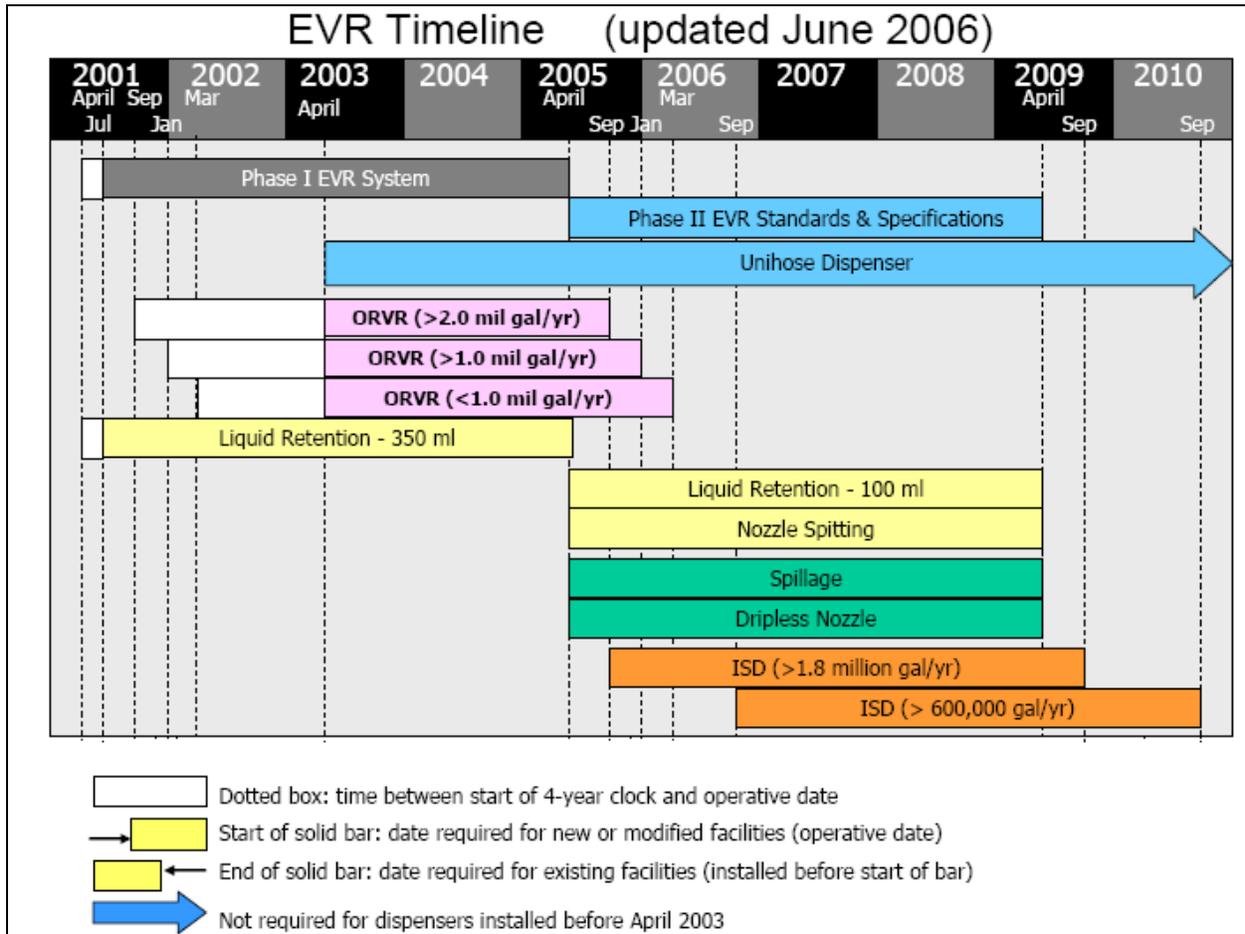
**Figure 2-1: EVR Timeline**

In March of 2000, ARB approved the Enhanced Vapor Recovery (EVR) regulations. The EVR regulations established new standards for vapor recovery systems to further reduce emissions during storage and transfer of gasoline at GDFs that use underground storage tanks for gasoline storage. The EVR standards apply to both new and existing facilities and are being phased in from 2001 to 2010 (see Figure 2-1: EVR Timeline).

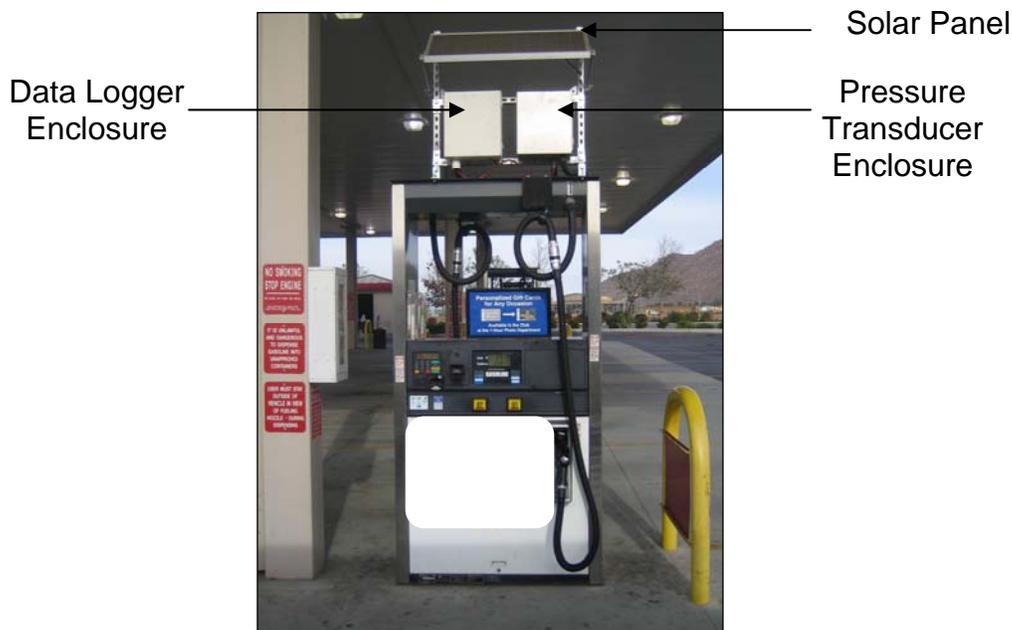
**Figure 7-1: Data Logging System Installed at Riverside GDF Location**

At each site, UST pressure, ambient temperature, and barometric pressure was continuously collected on a data logger designed, built, and installed by ARB. Both data loggers were self contained, solar powered, intrinsically safe, and permanently mounted above a single dispenser at each site. A ¼ inch insulated Teflon line was routed to a UST pressure tap port which was installed above the shear valve of the vapor return piping of the dispenser. Prior to and at the end of the test period, the pressure transducer within each data logging system was checked for accuracy using a NIST (National Institute of Standards and Technology) traceable calibration secondary standard device (see Section 9). During the test period, the pressure transducers were also checked for accuracy in the field using a NIST traceable calibration secondary standard device (see Section 9).

The data loggers were programmed to record 60 second averages of UST pressure, ambient temperature, and barometric pressure, continuously, 24 hours a day. Twice a week, ARB staff downloaded the information via lap top computer and exported the files into an excel spreadsheet. This enabled ARB staff to graph UST pressure profiles and calculate 30-day rolling averages for both daily high and hourly high criteria. Figure 7-1 is a photograph of the data logging system installed at the Riverside GDF:

At each site, UST pressure, ambient temperature, and barometric pressure was continuously monitored by a data logging system designed, built, and installed by ARB staff. The data loggers were programmed to continuously collect and store this information as sixty second averages, 24 hours a day. Data logger “number one” was installed at Riverside GDF, while “number five” was installed at the San Bernardino GDF.

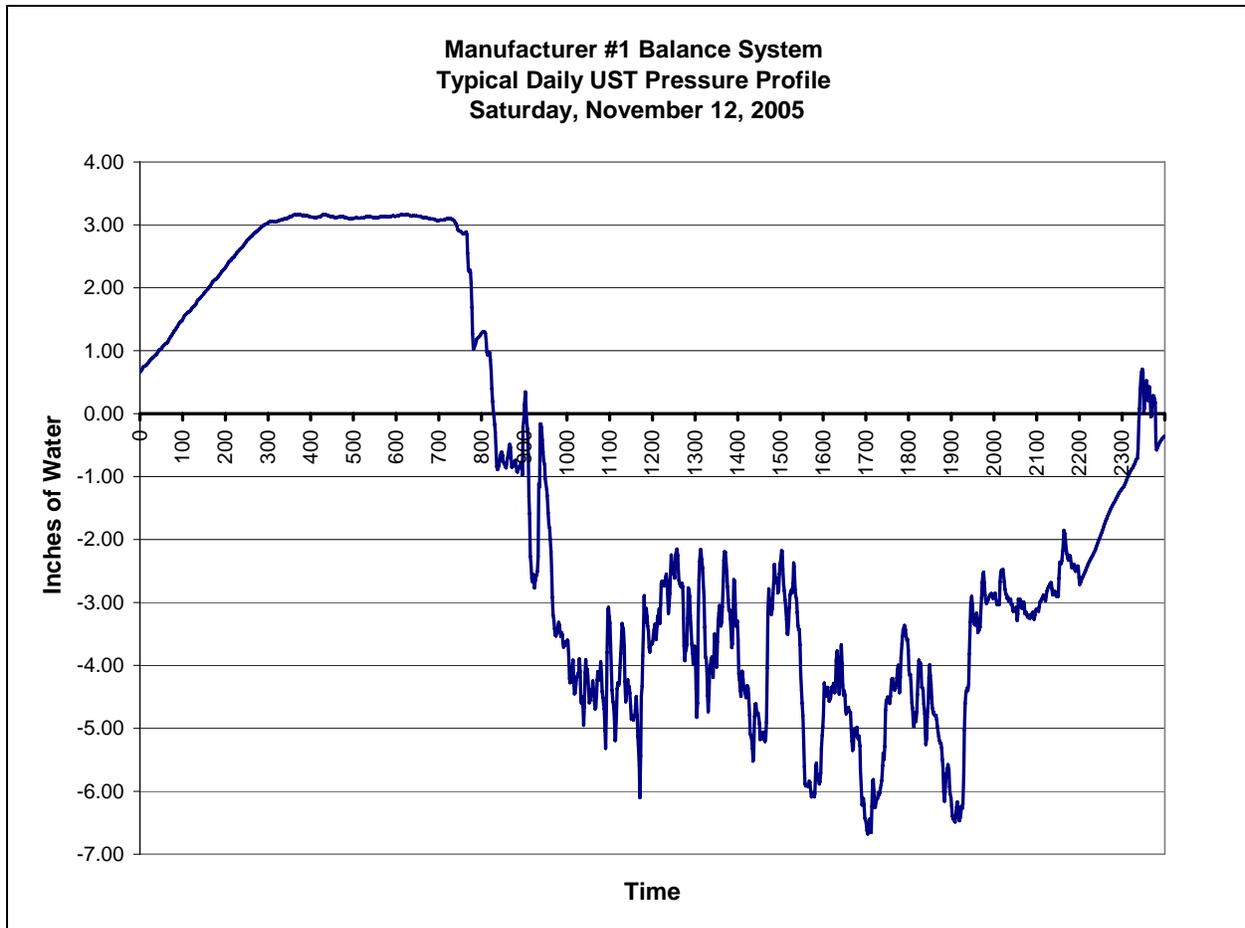
**Figure 8-1: Manufacturer #1 Pressure Profile**

The pressure data indicated that significant vapor growth and pressurization of USTs occurred during the nine hour time frame in which the GDFs were closed (idle period). Daily pressure profiles generated from all three balance systems showed a similar trend of negative pressures during the operating hours and positive pressures during the idle period.

During the idle periods, the vapor growth was sufficient to crack the P/V valve at 3.0 inches of water column pressure for several hours. This phenomenon is represented by a flat line on the pressure profile graph at 3.0 inches of water column pressure.

During the operating hours, the presence of ORVR vehicles drove the UST pressure negative because the volume of fuel removed from the USTs exceeded the volume of vapors being returned. However, unlike the positive pressure profile during idle periods, the three systems achieved slightly differing levels of negative UST pressure during the

The following three Figures (8-1 through 8-3) provide examples of typical daily pressure profiles for each system. Saturdays were selected to minimize the influence of fuel deliveries.

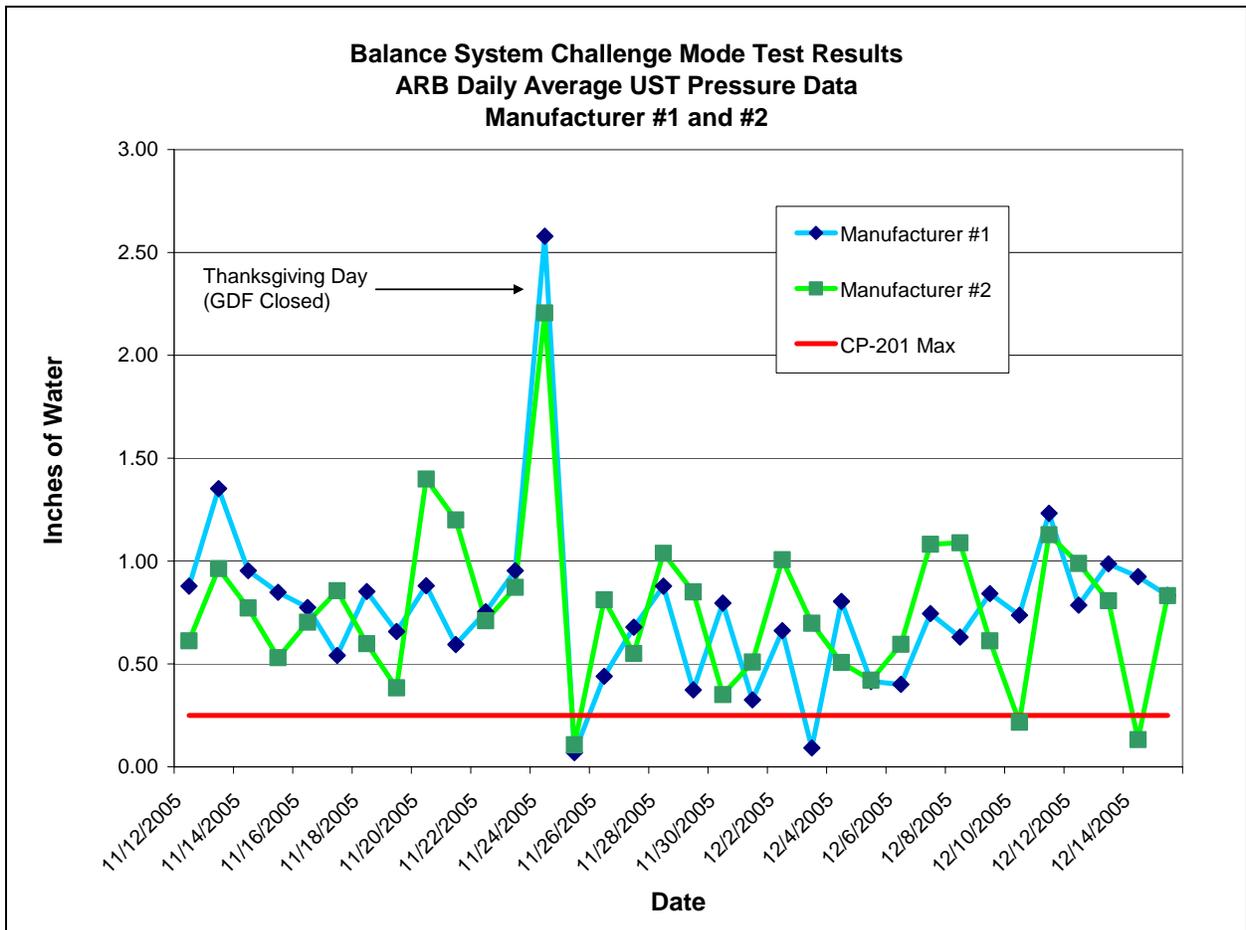
**Figure 8-4: Daily Average Values for Manufacturer #1 and #2 Balance Systems**

As illustrated in Figures 8-4 and 8-5, the UST pressure calculations show that all three systems routinely exceeded the ARB daily average criteria of 0.25 inches of water. The first chart compares Manufacturer #1 and #2 system daily averages, while the second chart illustrates the Manufacturer #3 daily averages. The Manufacturer #3 daily average calculation was based on an incomplete data set (17 days rather than 30). Although the Manufacturer #3 system did not meet the requirements of the protocol, it was included in this report in order to illustrate the same trend as Manufacturer #1 and #2.

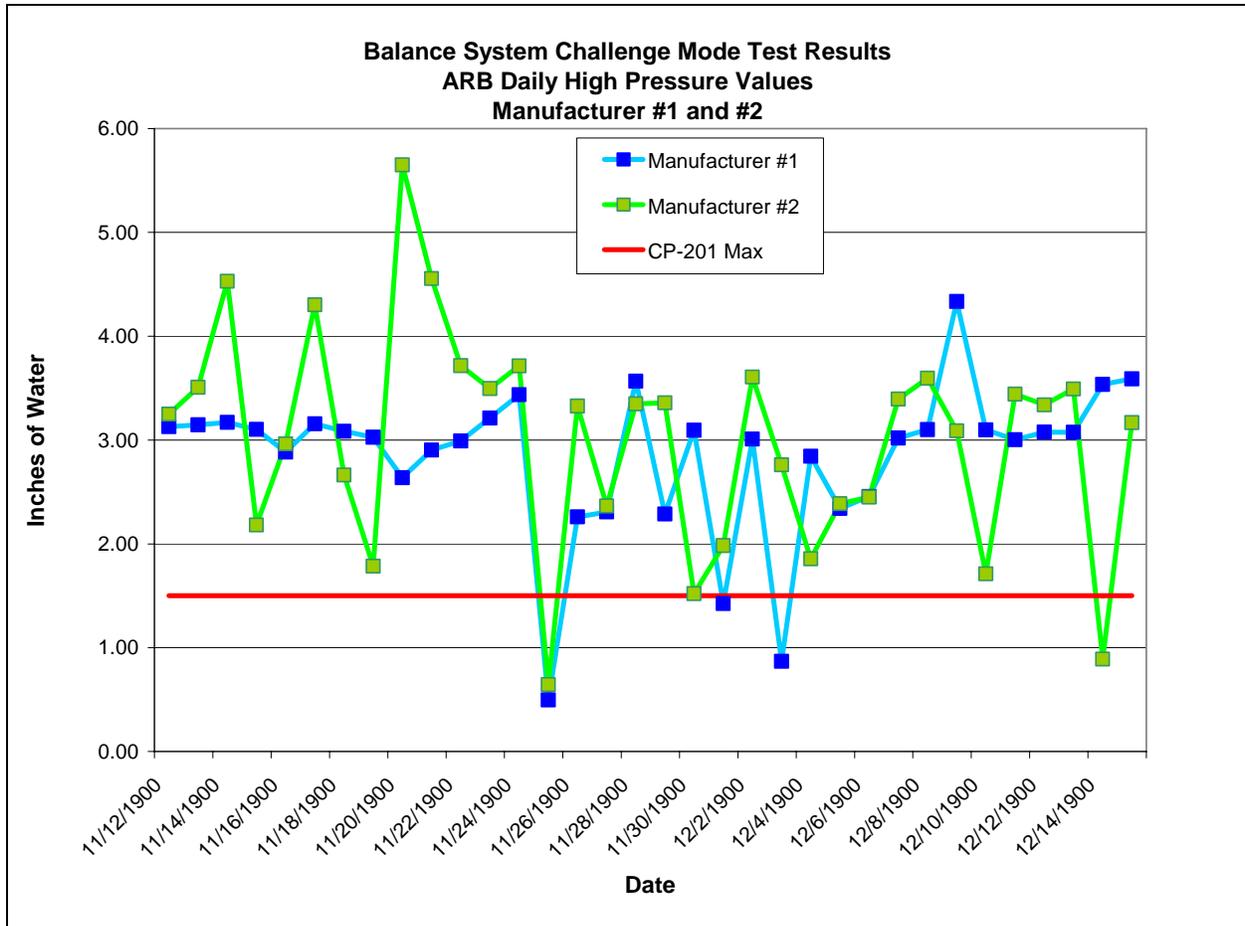
**Figure 8-6: Daily High Values for the Manufacturer #1 and #2 Balance Systems**

As illustrated in Figures 8-6 and 8-7, the daily high pressure criteria for Manufacturer #1, #2, and #3 balance systems were also exceeded on a regular basis. Manufacturer #3 daily high calculation was based on an incomplete data set (17 days rather than 30). Although the Manufacturer #3 system did not meet the requirements of the protocol, it was included in this report in order to illustrate the same trend as Manufacturer #1 and #2.

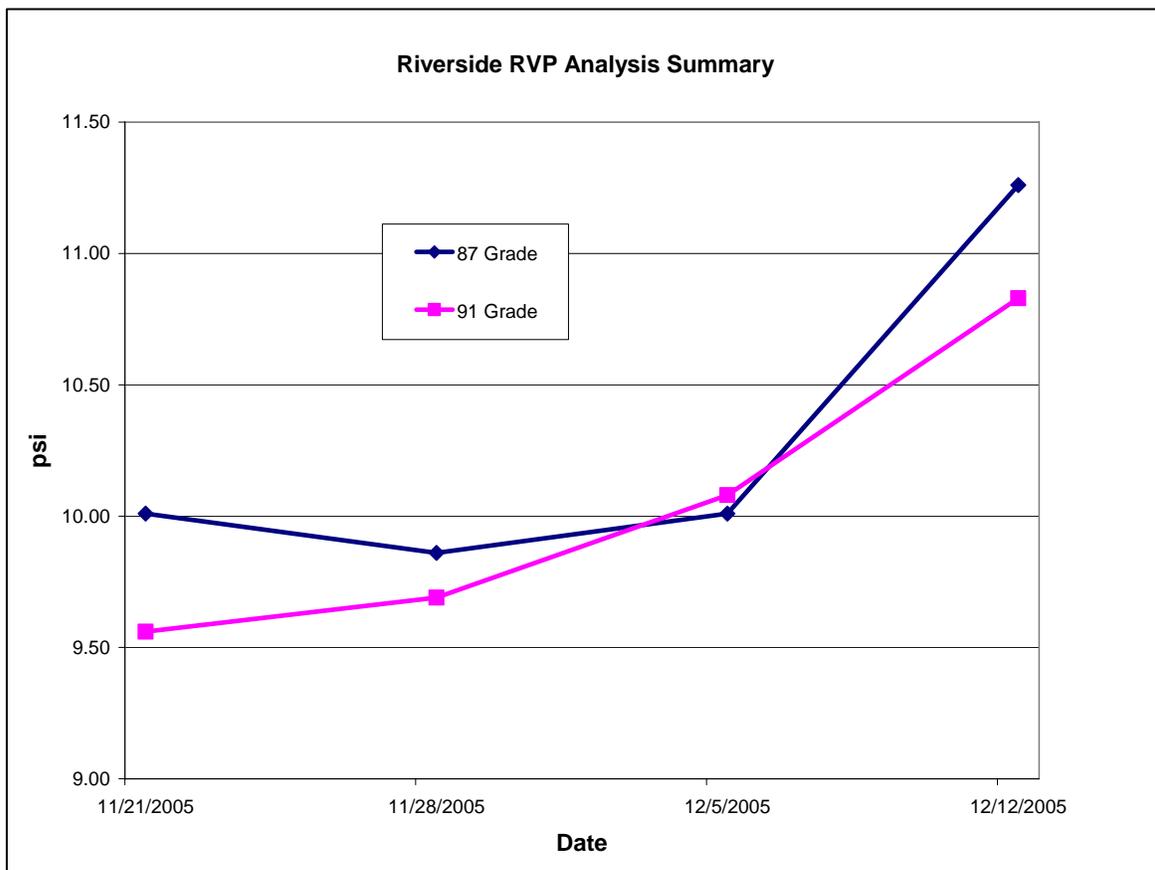
Figure 8-8: Riverside GDF RVP Results

Throughout the five month study period, ARB Enforcement Division staff collected and analyzed samples of 87 grade and 91 grade gasoline at each site. The samples were collected on a weekly basis and immediately transported to the ARB laboratory facility in El Monte, California for RVP analysis using ASTM D5191. As required by the protocol, RVP sampling was necessary to verify that winter fuel (uncontrolled RVP) was in use throughout the study period. Winter fuel or uncontrolled fuel has an RVP of 7.0 psi or greater. Figures 8-7 and 8-8 illustrate that during the study period, both sites experienced upward trends in the RVP. The results also show that uncontrolled fuel was present during the study period. More samples were collected at the San Bernardino location because the site served for two nozzle manufacturers from November through February. RVP at the Riverside site ranged from 9.5 to 11.5 psi. RVP at the San Bernardino site ranged from 9.5 to 12 psi.
