Configuration of VST Membrane Processor to Conduct TP-201.3

Configuration of Veeder-Root Vapor Polisher to Conduct TP-201.3

Configuration of Healy Clean Air Separator to Conduct TP-201.3

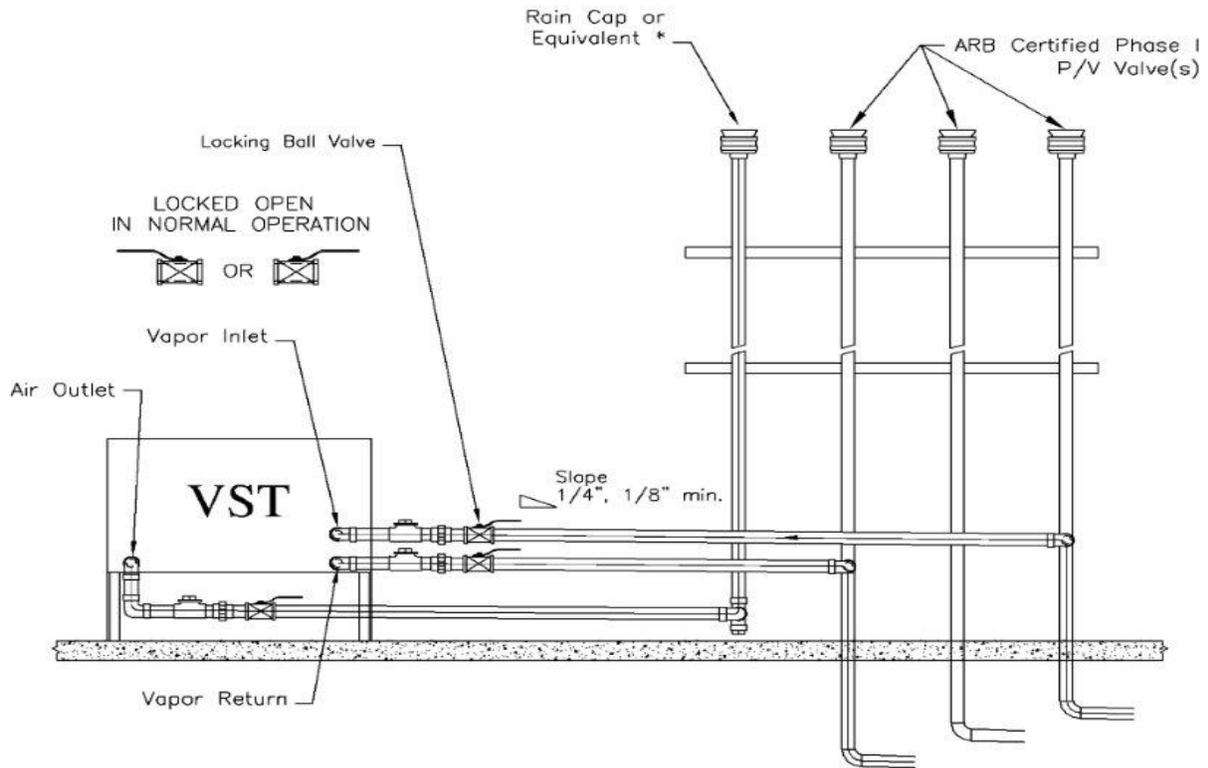
Figure 1

CAUTION: THE HANDLES ON THE LOCKING BALL VALVES MUST NOT BE REMOVED

* If a P/V valve is used, the internal components MUST be removed to allow open venting to the atmosphere.

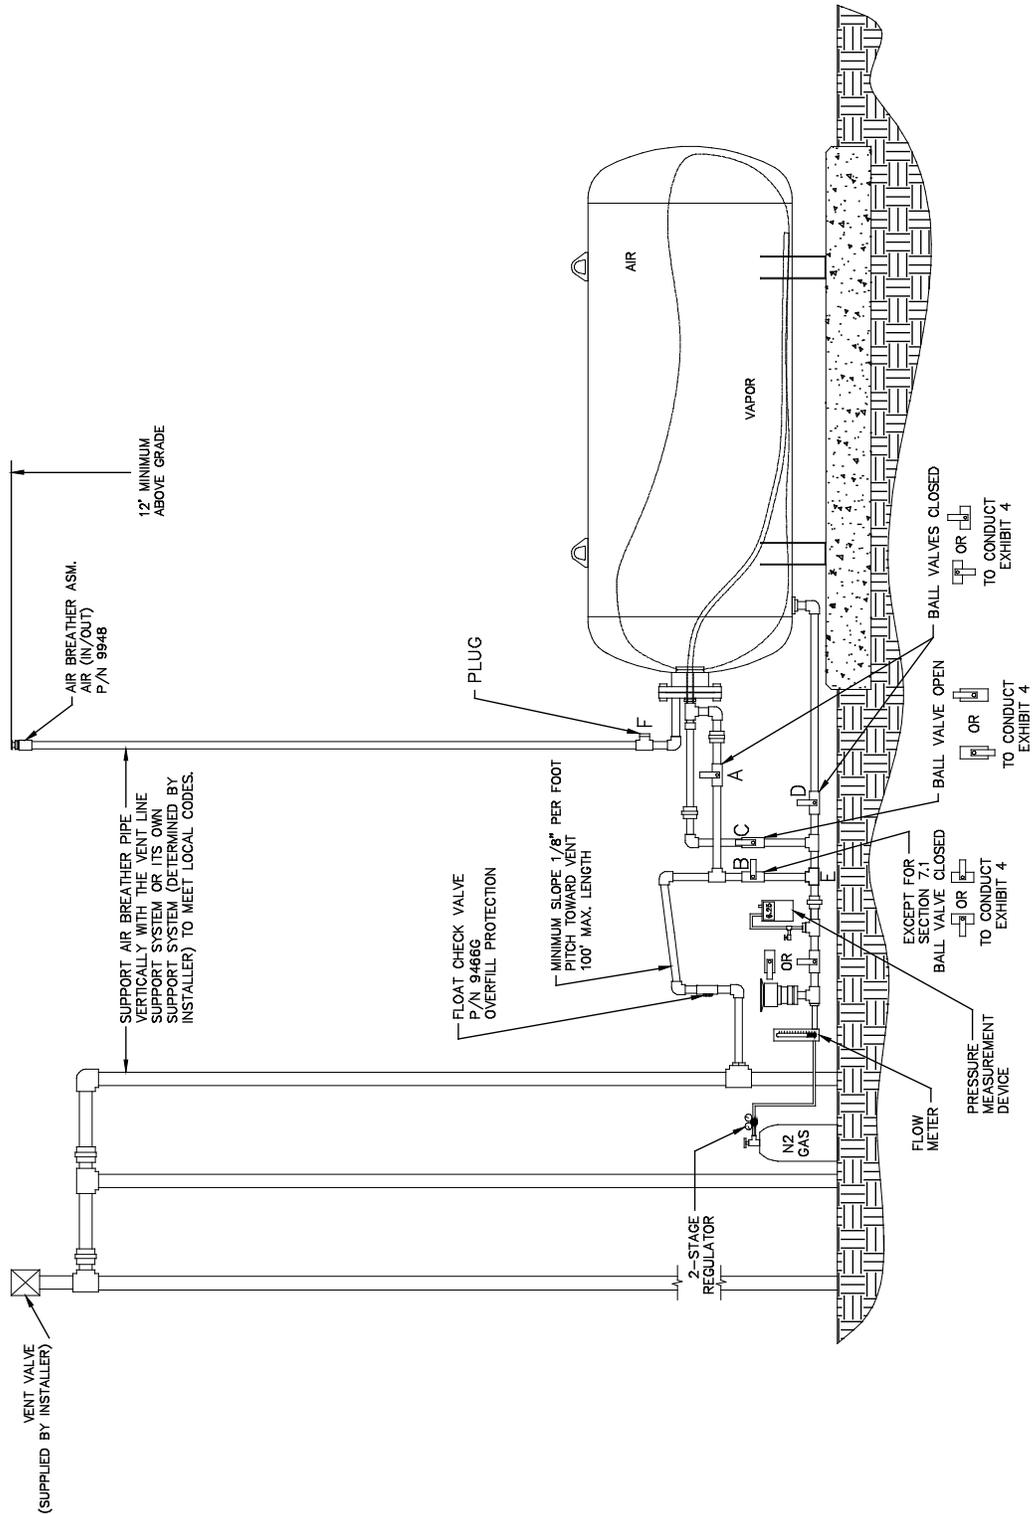
Figure 3H

Configuration of Healy Clean Air Separator to Conduct TP-201.3

1. Prior to conducting TP-201.3, all four ball valves on the CAS shall be closed, as shown in Figure 3 or Figure 3H, to isolate it from the UST system to permit the pressurization of the UST system.
2. After conducting TP-201.3, the four ball valves on the Healy Clean Air Separator (CAS) shall be locked in their normal operating positions as shown in Figure 2B-16 or Figure 2B-16H, Exhibit 2.
