California Environmental Protection Agency

**Gasoline Dispensing Facility (GDF)  
Vacuum-Assist and Conventional Hose  
Permeation Study**

Jason McPhee, P.E.

Stationary Source Testing Branch  
Monitoring and Laboratory Division

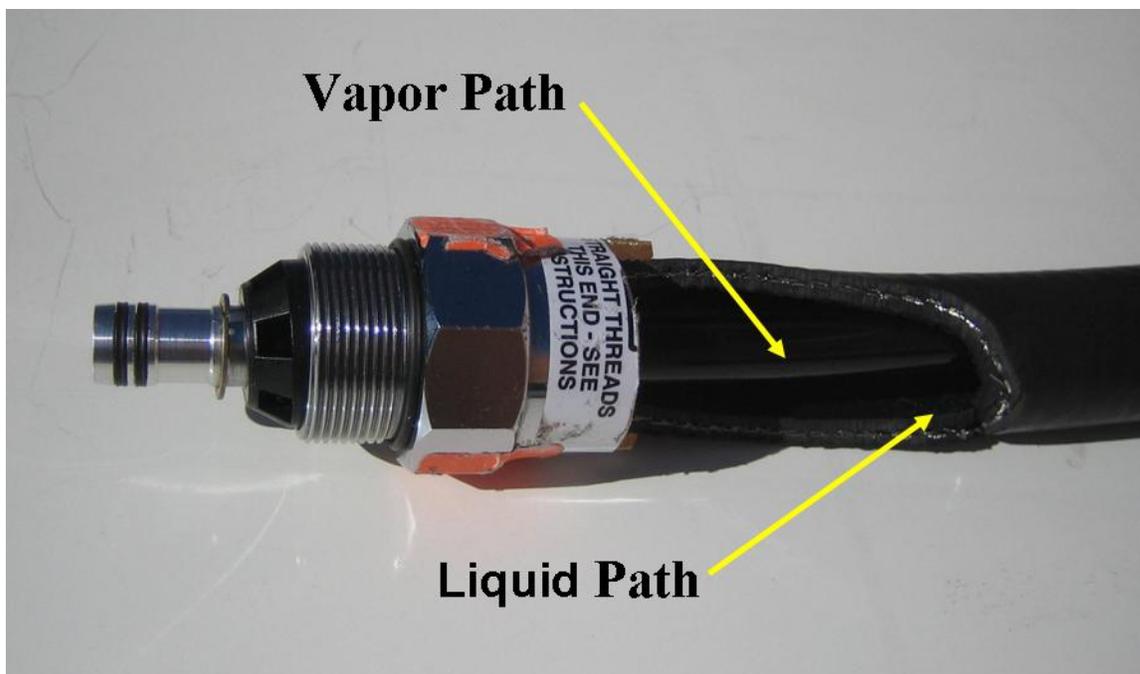
Figure 1 Vacuum assist style vapor recovery GDF hose showing vapor and liquid paths.

California GDFs, which are permitted by the local air pollution control districts, in most cases must use vapor recovery style hose. Vapor recovery hose is different from conventional fuel delivery hose in that it has two paths: one for fuel delivery and the other for vapor return. There are two different styles of vapor recovery hose: balance and vacuum assist. For permeation purposes, vacuum assist hoses are similar to conventional fuel delivery hoses in that the liquid fuel is carried against the inside of the outer hose wall (Figure 1).

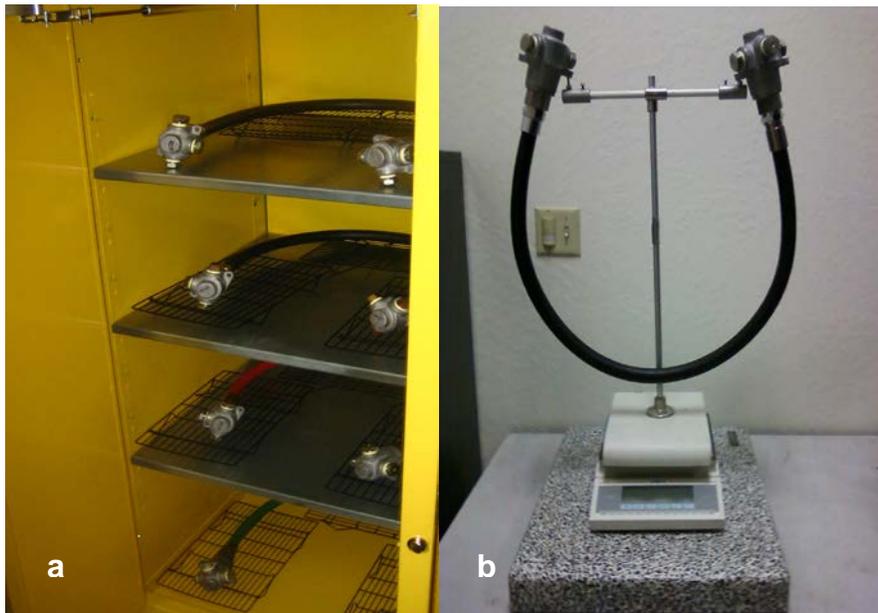
Figure 2 (a) Hoses in testing room. (b) Hose being weighed.

For approximately 60 days, from July 16<sup>th</sup> to September 14<sup>th</sup> of 2009, ARB staff conducted in-house gravimetric permeation testing of 6 vacuum assist style vapor recovery GDF hoses under non-controlled ambient conditions. The hoses were placed on racks within fuel storage cabinets in a fuel storage room throughout the testing (Figure 2). Hoses were removed from this environment daily only for the purpose of recording weight and refreshing fuel (dumping old test fuel in the hose and replacing with fresh test fuel). Time was recorded for all weighings during the test. Permeation rates were attributed to the weigh loss over each time period.

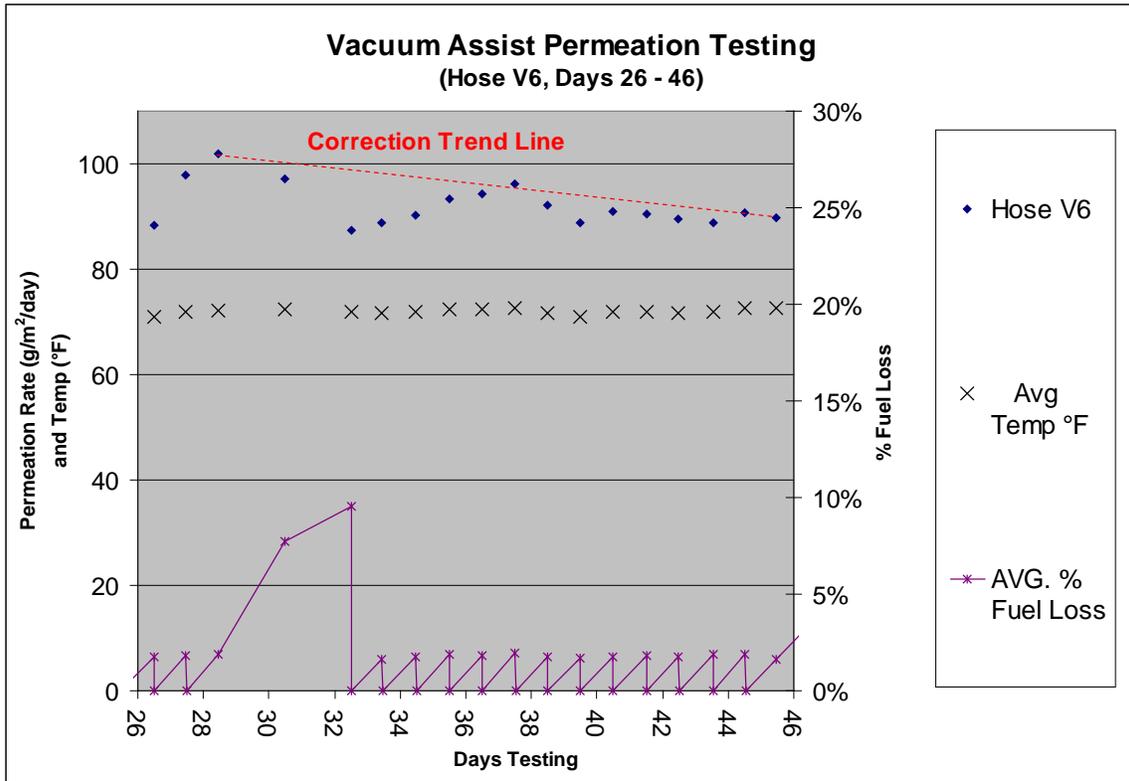
Figure 3 Trend line correction for hose V6 to estimate steady state permeation rate.

Determining steady state for V6 was complicated by a spike in the percent fuel loss from days 29 through 33 (Figure 3). From past testing staff would have expected to see the permeation rate plateau at day 29, where we see the trend from the preceding day peak at approximately 101.9 g/m<sup>2</sup>/day. Staff then expected this to be followed by a slight decline. However, due to resource constraints, staff was not available to perform fuel refreshing at this point, although weighing data was collected. This disturbance in fuel composition due to fuel degradation caused a steep drop in the permeation rate of V6. From the data, staff determined that steady state conditions were best represented for hose V6 from testing days 29 through 46, where except for the spike from days 29 to 33 average fuel mass loss did not exceed 2% and the average daily

temperature varied by 0.5°F (0.3°C). Staff determined that the best way to estimate steady state permeation rate for this period would be to average the rates at the beginning (101.9 g/m<sup>2</sup>/day) and end (89.6g/m<sup>2</sup>/day) of this period. From this method, staff determined that the average steady state permeation rate of hose V6 during this period was 95.9 g/m<sup>2</sup>/day.

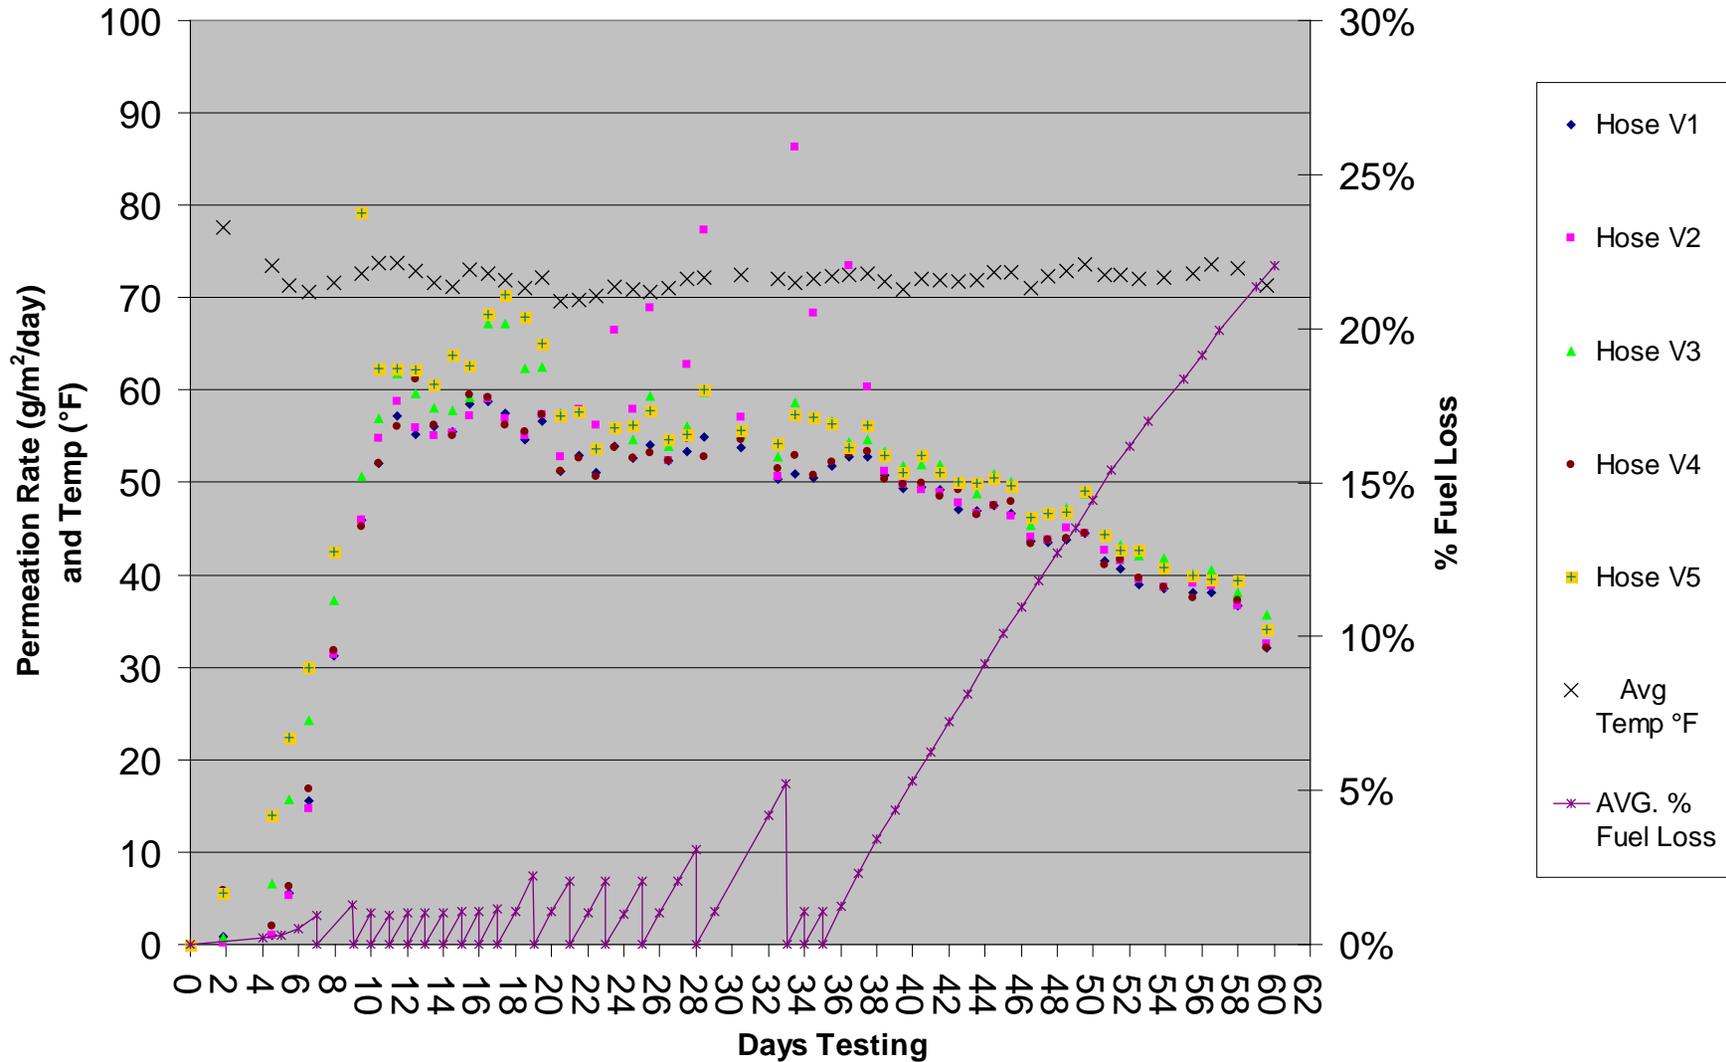
Attachment 2

### Vacuum Assist Permeation Testing (Hoses V1 - V5)

On day 10, strong gasoline odor was detected at the threads for hose sample V5. It can also be observed from the graph (Attachment 2) that hose V5 was losing weight at a much higher rate than the other hoses at this point. Staff tightened the cap threads for V5 which appears to have had the effect of reducing the weight loss from hose V5 back to the levels of hoses V1 through V4.

Staff determined that steady state conditions were best represented for hoses V1 through V5 from testing days 11 through 18, where average fuel mass loss did not exceed 1.2% (Attachment 2) and the average daily temperature varied by 2.5°F (1.4°C). The average steady state permeation rate of hoses V1 to V5 during this period was calculated to be 59.0 g/m<sup>2</sup>/day.

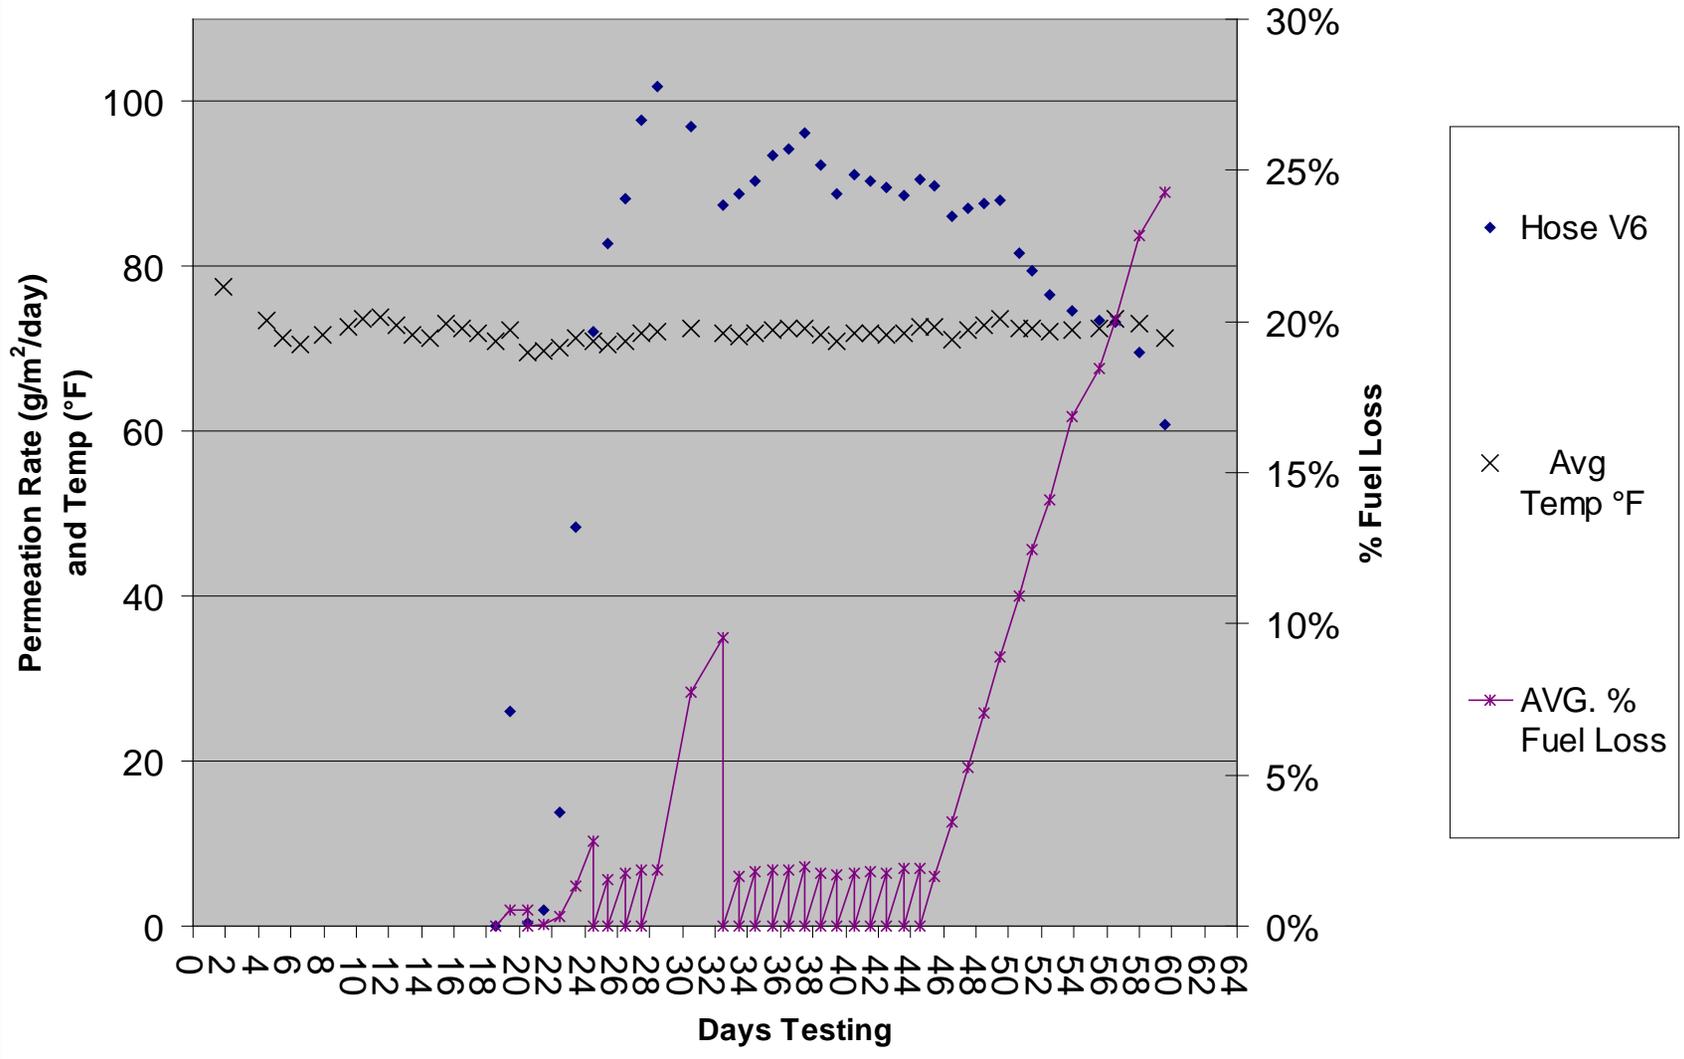
Attachment 3

Vacuum Assist Permeation Testing  
(Hose V6)

On day 20, strong gasoline odor was detected at the threads for hose sample V6. This can also be observed from the graph (Attachment 3) showing a spike in the weight loss data for hose V6 at this point. Staff tightened the cap threads on V6 which resulted in an immediate and significant decrease in weight loss from this hose.
