Overpressure Study

Technical Support Document

Healy Model 900 Assist Vapor Recovery Nozzle  
ORVR Vehicle Recognition Study

November 29, 2017

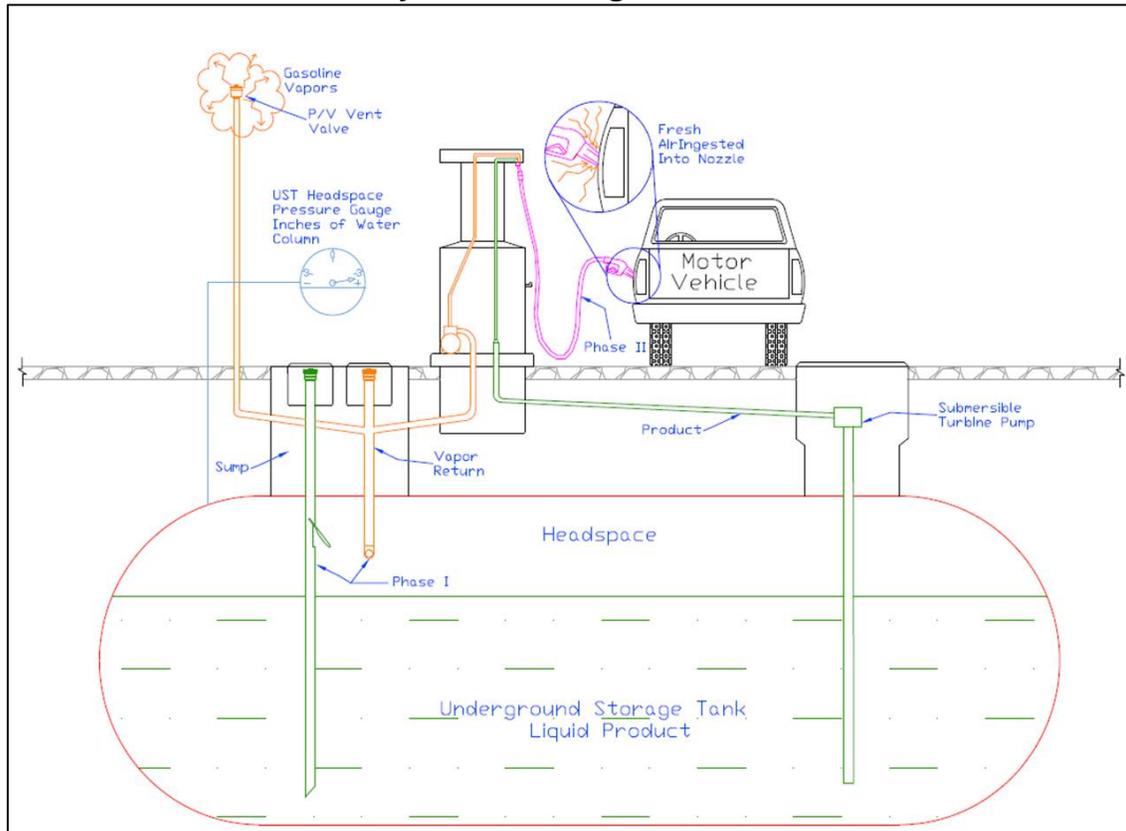
**Figure II-1**  
**Assist System – Air Ingestion at Nozzle**

to the UST, resulting in higher evaporation rates and vapor growth in the UST contributing to OP containment alarms and excess pressure-driven emissions. Figure II-1 provides an illustration of air ingestion by a nozzle at a GDF equipped with an Assist System.

The Assist System is designed to reduce the volume of vapor collected relative to the volume of liquid dispensed when fueling ORVR equipped vehicles. For the Assist System to work properly, the Healy Model 900 nozzle must limit the amount of air ingestion during the fueling of ORVR equipped vehicles. This is referred to as ORVR recognition and relies upon a tight seal being formed at the nozzle and vehicle fill pipe interface. With a tight seal, the vapor volume available for collection by the nozzle is limited and thus a vacuum rapidly develops in the nozzle bellows. This vacuum activates a diaphragm which restricts the vapor return path in the nozzle which drops the vapor to liquid ratio (V/L) below 0.5 when fueling ORVR vehicles. In some instances, an ORVR fueling will result in an elevated ORVR V/L (>0.5) due to excess air ingestion by the nozzle during the fueling process. This excess air will be returned

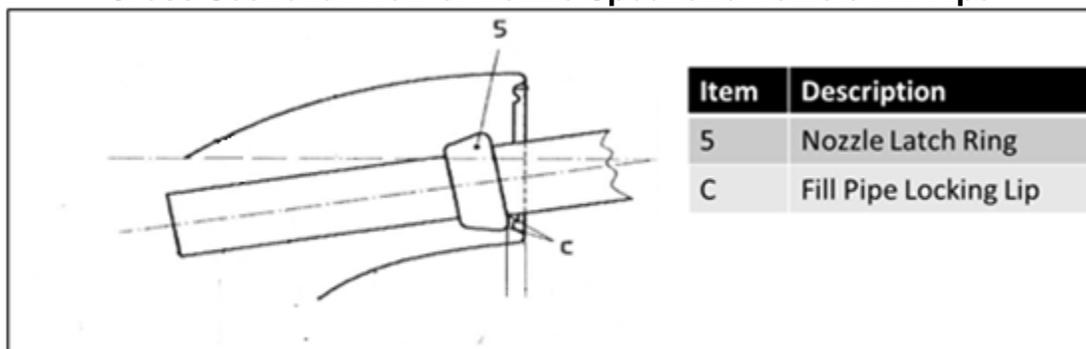
**Figure V-1**  
**Cross Sectional View of Nozzle Spout and Vehicle Fill Pipe**

Analysis of the individual fueling events showed that the Healy nozzle ORVR vehicle mis-identification rate can vary within the same vehicle make, vehicle model, and model year. This suggests that customer behavior may play a significant role with regard to ORVR V/L and the mis-identification rate. This hypothesis led to the finding that air ingestion can vary depending on whether the nozzle was securely or loosely latched within the ORVR vehicle fill pipe<sup>5</sup>. Figure V-1 shows a cross-sectional view of a nozzle spout inside the vehicle fill pipe.

The nozzle spout has a latch ring which needs to securely engage upon the locking lip of the vehicle fill pipe during fueling in order to ensure a secure latch. During the nozzle study and in a subsequent CARB study<sup>5</sup>, field data showed that many different vehicle makes and models were able to be fueled with a

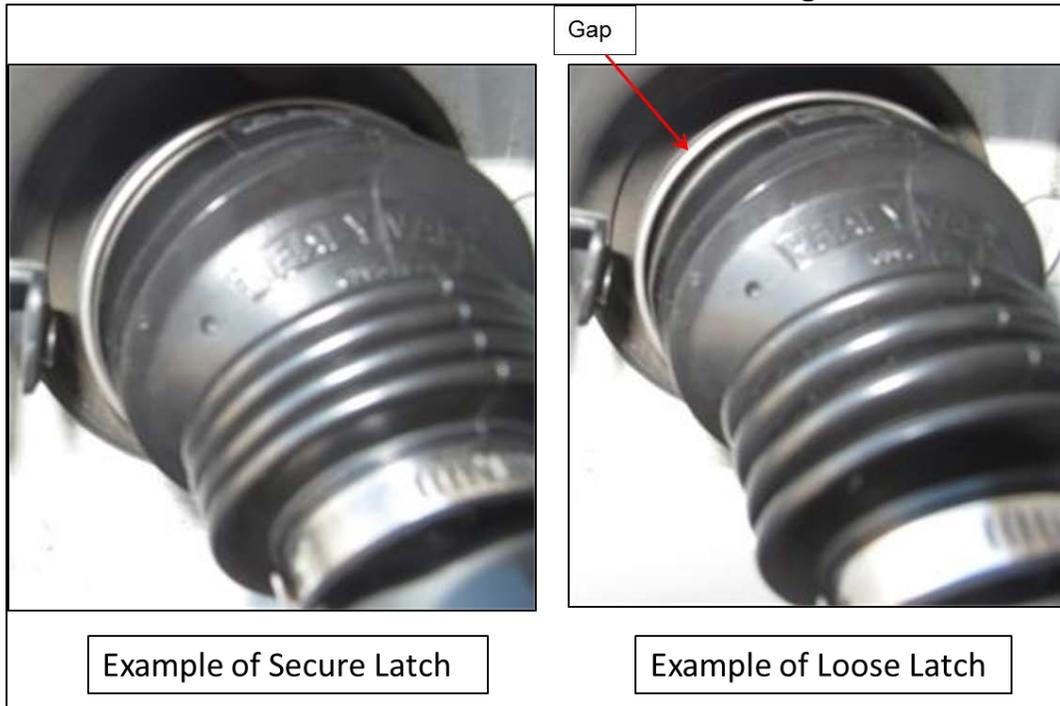
**Figure V-2**  
**Secure Latch vs Loose Latch Fueling**

loose latch. The term loose latch means that the nozzle is not fully engaged or securely connected to the fill pipe locking lip of the vehicle fill pipe. Figure V-2 illustrates an example of a secure and loose latch fueling into an ORVR vehicle fill pipe.

Figure V-2 shows an example of an obvious loose latch during the fueling of an ORVR equipped vehicle. In most cases, the loose latch cannot be visually seen but can be determined by the V/L measurement. This finding prompted CARB staff to conduct a new field study focused on the fueling of ORVR equipped vehicles with the nozzle securely and loosely latched into the vehicle fill pipe<sup>5</sup>. This field study was conducted by CARB staff at a retail GDF in Sacramento. Fueling of ORVR equipped vehicles with a loose latch exhibited a higher V/L ratio measurement due to excess air ingestion at the fill pipe/nozzle interface. The additional air ingested via the fill pipe/nozzle interface increases the evaporation rate and vapor growth within the UST which leads to excess pressure-driven emissions. ORVR equipped vehicles that are fueled with a loose latch will have high V/Ls and thus result in a high mis-identification rate.

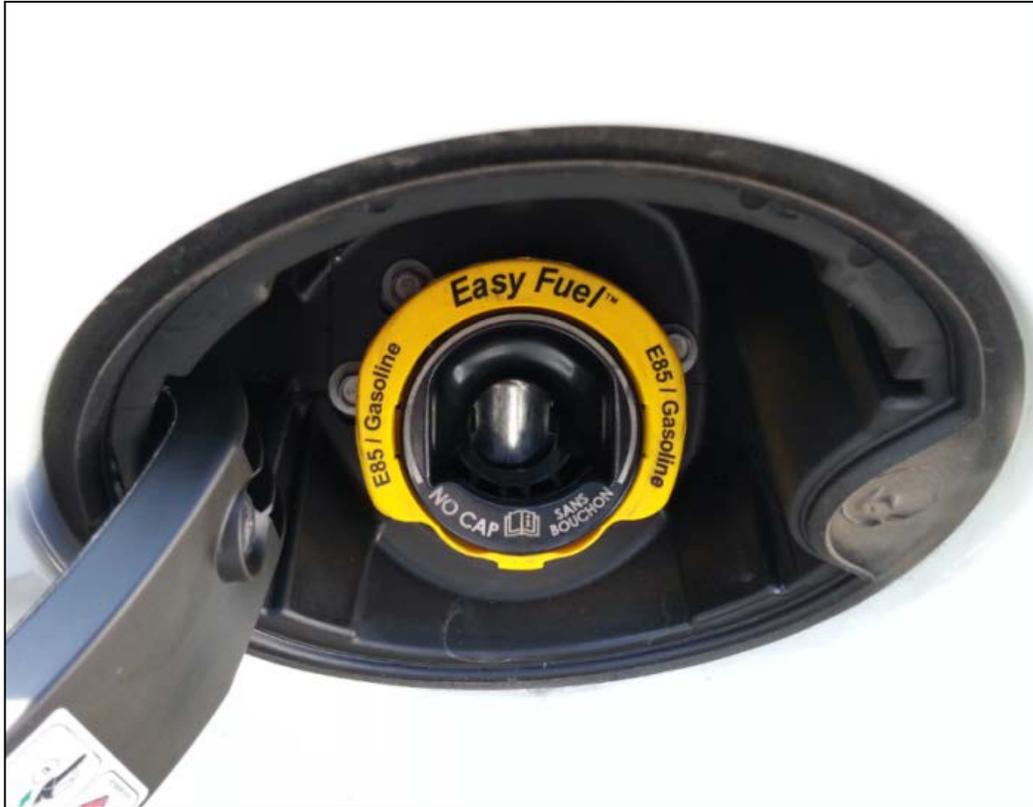
**Figure V-3**  
**Capless Fill Pipe System**

from a traditional capped fill pipe system to a capless fill pipe system. Figure V-3 shows an example of a capless fill pipe system.

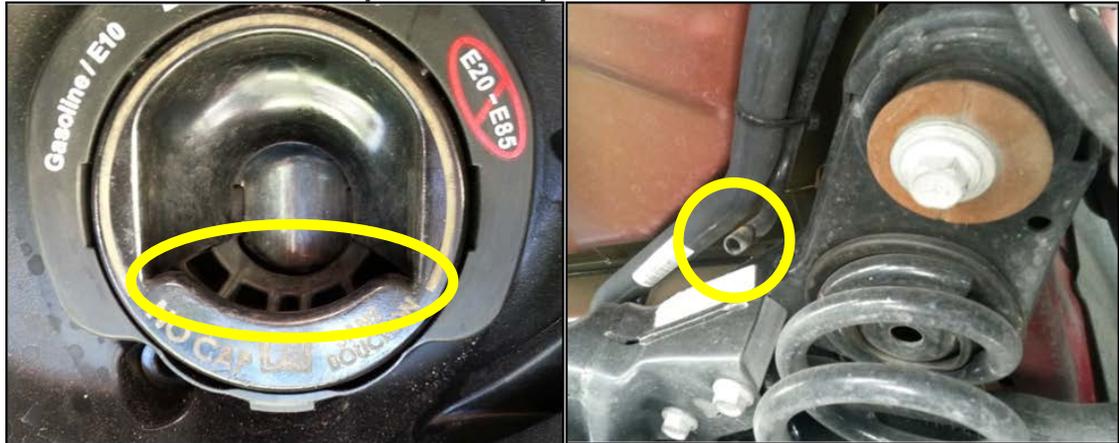
**Figure V-4**  
**Capless Fill Pipe Drain Port**

Some capless fill pipe systems were designed with a drain port that prevents water, dirt, and dust from entering the fuel pipe. The drain port extends from the fill pipe to the bottom of the vehicle. Figure V-4 shows an example of the drain port in the capless fill pipe and at the underside of the vehicle.

When fueling an ORVR equipped vehicle with a capless fill pipe with a Healy nozzle, fresh air is allowed to enter the nozzle bellows from the drain port underneath the vehicle. During this fueling, no vacuum is created in the nozzle bellows and there is no restriction of the vapor path in the nozzle. As a result, a V/L ratio of greater than one may occur. The fresh air that is allowed to enter through the drain port is returned to the UST which increases the pressure in the UST due to gasoline evaporation.

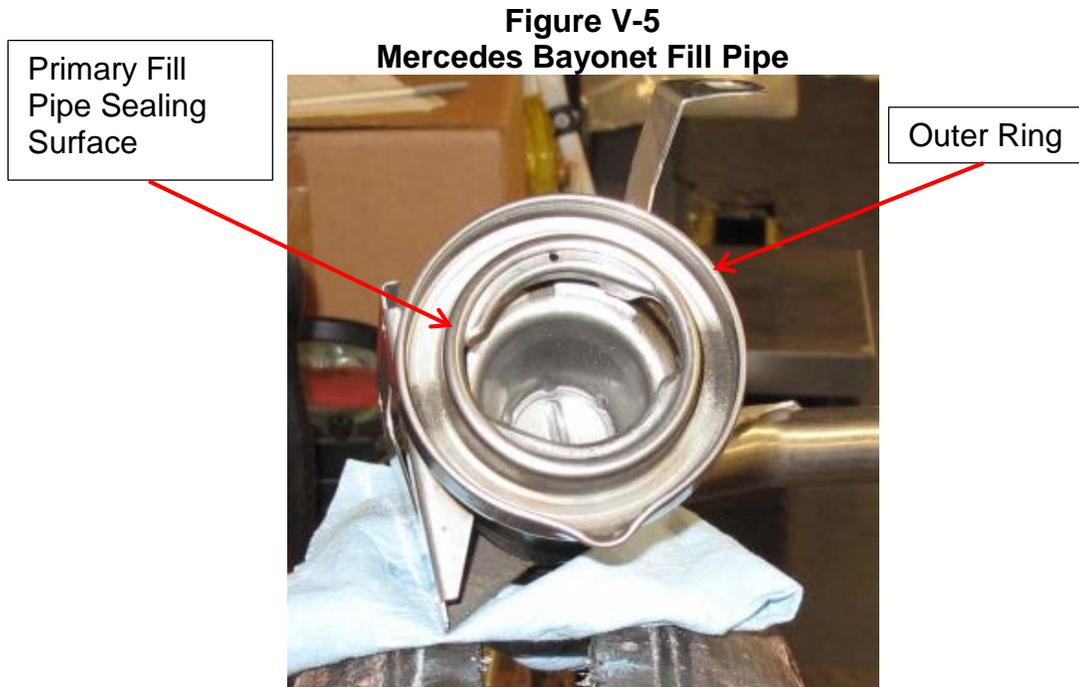
Table IV-4 shows vehicle makes that yielded a high mis-identification rate. Not all the vehicle makes shown in Table IV-4 had a capless fill pipe design yet they still yielded a high mis-identification rate. CARB staff studied the cause of the high mis-identification rate of Mercedes vehicles. The results of the nozzle study showed that approximately 91% of the Mercedes vehicles surveyed were equipped with a bayonet fill pipe design. The Mercedes vehicles with a bayonet fill pipe also had a mis-identification rate of approximately 91%. A picture of the bayonet fill pipe is shown in Figure V-5.

The fill pipe was tested in a lab by using a bayonet fill pipe which was removed from a Mercedes vehicle. The nozzle was then securely latched into the fill pipe. A smoke leak detector was connected to the open end of the fill pipe to determine whether the nozzle/fill pipe interface was a secure or loose latch. The smoke testing revealed that if the nozzle sits on the outer ring of the fill pipe, which is a common occurrence during vehicle fueling, the bayonet fill pipe can inhibit the Healy 900 vapor recovery nozzle from making a good seal at the bottom of the fill pipe sealing surface. The loose latch created during the fueling of a Mercedes vehicle with a bayonet fill pipe is the main cause of the high mis-identification rate for vehicles equipped with this design. Figure V-6 shows the set up used to test the Mercedes bayonet fill pipe for leaks.

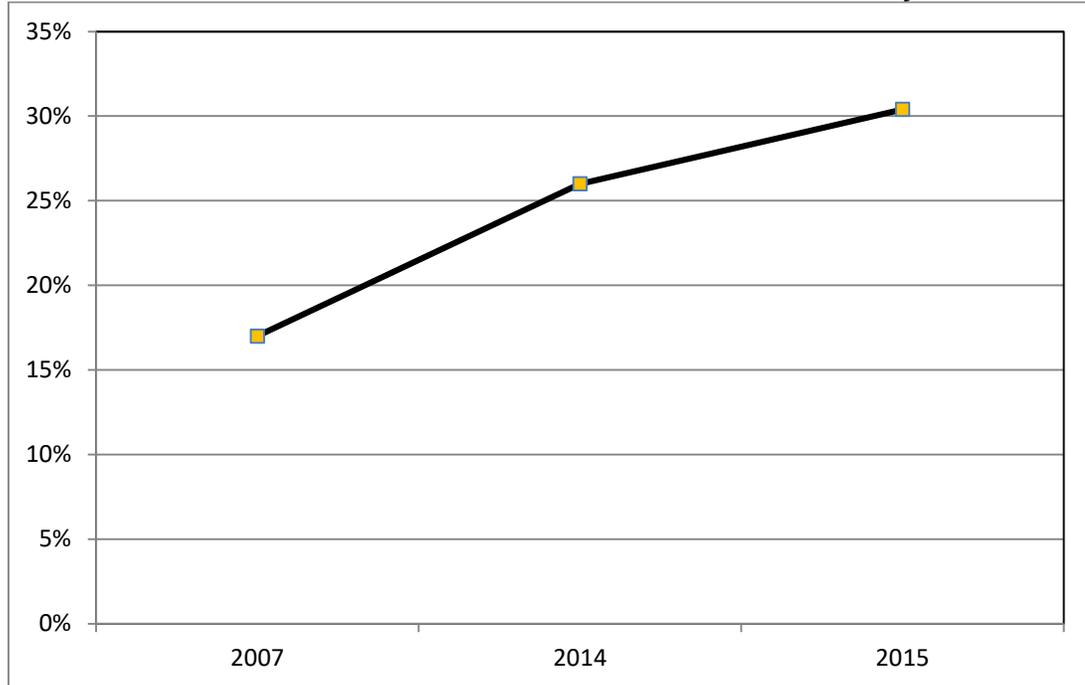
**Figure V-7  
Trends in ORVR Vehicle Mis-Identification Rate of Healy Nozzle**

Over the last eight years, three studies pertaining to Healy nozzle ORVR recognition have been conducted; two collaboratively between CARB and CAPCOA staff and one by San Diego County Air Pollution Control District staff. In each of these three studies, only the fueling of vehicles was observed and customers were not assisted during the fueling process. Figure V-7 shows the increasing trend in the mis-identification rate for the three studies conducted since 2007.

In 2007, CARB and CAPCOA staff conducted an 18 month In-Use ISD Evaluation Field Study on the first ISD system certified by CARB in which the fueling of 547 ORVR equipped vehicles was observed. The results of this study showed that the mis-identification rate for ORVR equipped vehicles at that time was approximately 17%. In June 2014, a small ORVR Recognition Study was conducted by San Diego County Air Pollution Control District staff in which the fueling of 96 ORVR vehicles was observed. The mis-identification rate for this study was determined to be approximately 26%. The small ORVR Recognition Study led to the larger nozzle study conducted in San Diego in January 2015 by CARB and CAPCOA staff. From this latest nozzle study, the mis-identification rate was determined to be approximately 30% (Table IV-2).

Between 2007 and 2015, the percentage of gasoline dispensed to ORVR vehicles has increased from approximately 50%<sup>6</sup> to approximately 78%<sup>7</sup>. As the gasoline dispensed to ORVR equipped vehicles has increased, the mis-identification rate has also increased from approximately 17% to approximately 30%. The ORVR V/L also increased from 0.39, as determined in the 18 month In-Use ISD Evaluation Field Study, to 0.54, as determined in the nozzle study (Table IV-1). The increase in the mis-identification rate and ORVR V/L from 2007 to 2015 at GDFs can be attributed to the increase in the percentage of gasoline dispensed to ORVR equipped vehicles, fueling ORVR equipped vehicles with a loose latch, and fueling into capless vehicle fill pipes that have open ports to the atmosphere. Table IV-3 shows that the overall V/L and mis-identification rate have increased for vehicles manufactured after 2012. This is problematic because this suggests that newer model ORVR equipped vehicles
