Project Number: VR-11-11

OVERPRESSURE STUDY

Technical Support Document

Evaluation of Assist Vapor Recovery Nozzle ORVR Vehicle Recognition
Performance Under Controlled Fueling Conditions

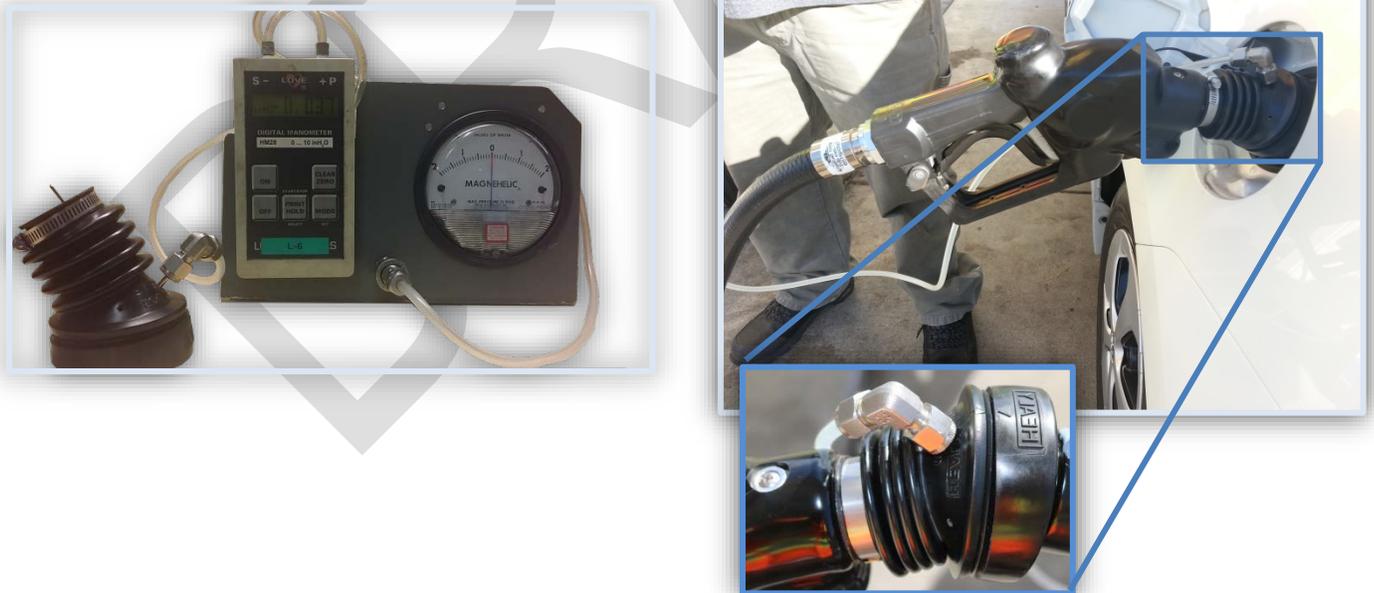
Figure III-4: Measurement of Vacuum at Nozzle and Vehicle Fill Pipe Interface

As shown in the image above (Figure III-4) a flexible line and stainless steel barbed fitting was connected to a mechanical (Dwyer Magnehelic) pressure gauge, as well as a battery operated digital manometer (Love Model HM28). These were used to

measure the vacuum at the nozzle/vehicle fill-pipe interface. The digital manometer was set to record the “MIN/MAX” value as well. The vehicle fueling events were then performed according to the methodology previously described.

In terms of equipment, CARB staff inserted a stainless steel barbed fitting through the boot (not the calibrated pair of holes in the boot as this will affect the V/L of the vehicle) and attached a flexible line to the vacuum gauge. Staff ensured that the insertion of the barbed fitting was well sealed and did not create a leak path.
