CUMMINS B5.9L PROPANE ENGINE

ARB "HD-10" LPG DURABILITY TEST

TRIBOLOGICAL OIL ANALYSIS

December, 1999

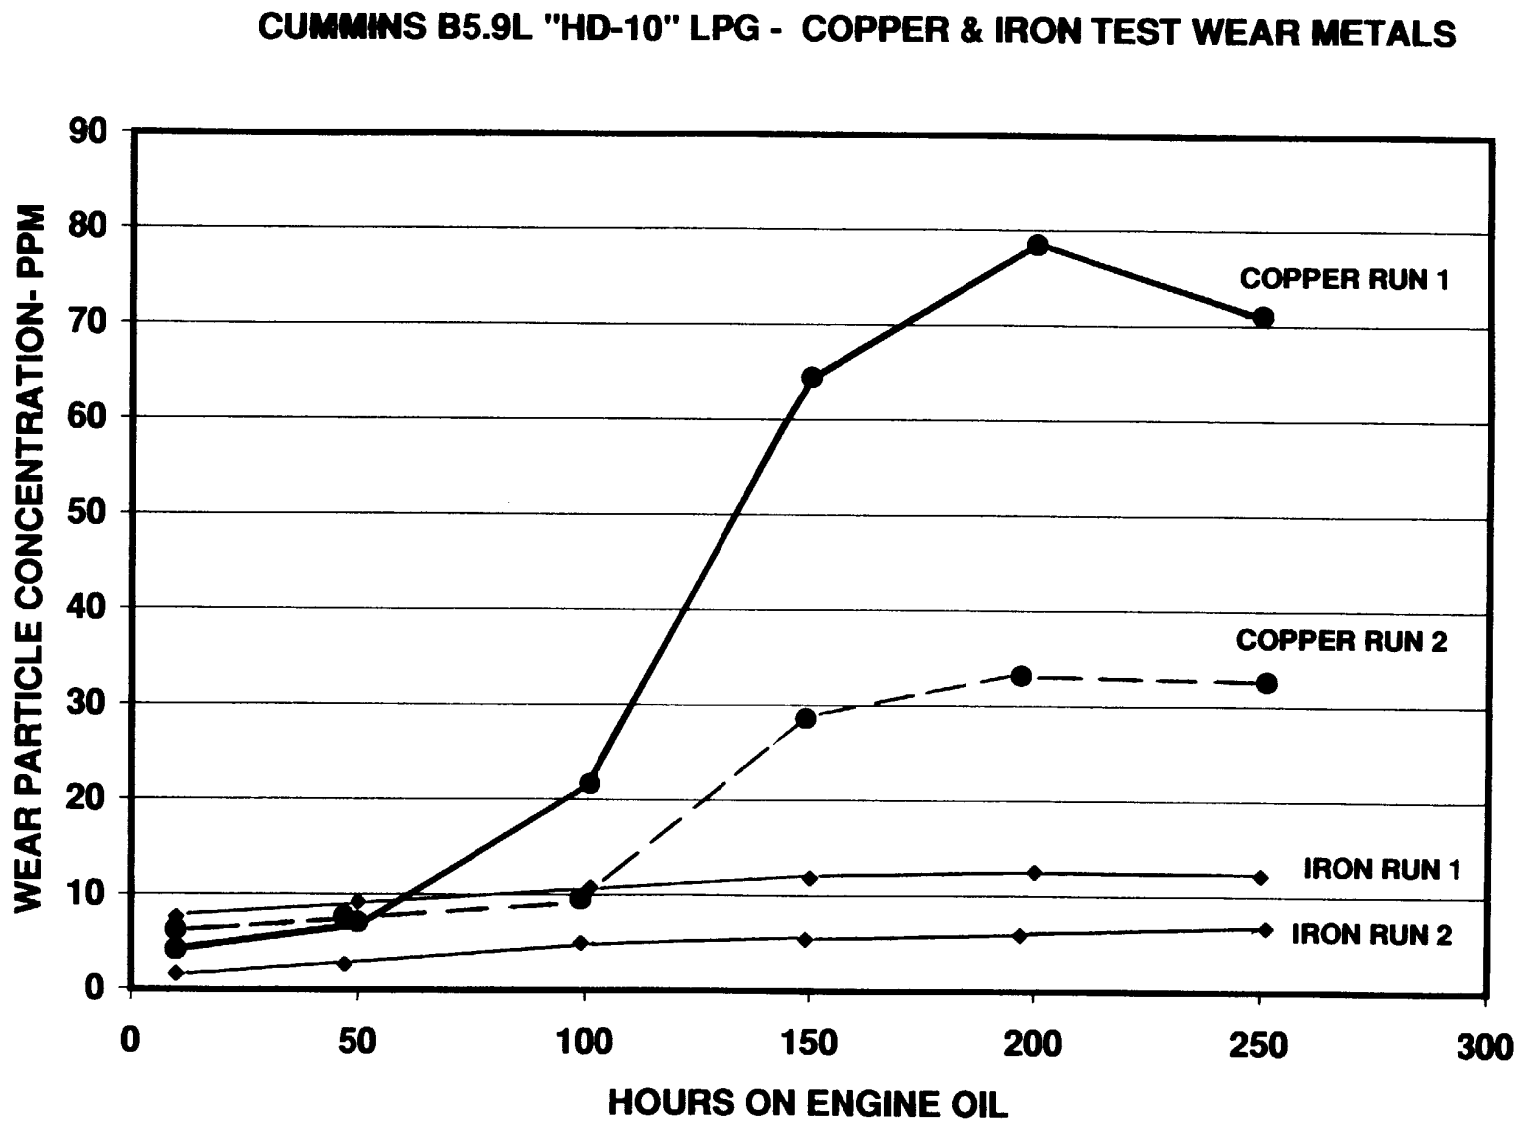
Figure 1- Graph of Spectrometry Copper and Iron concentrations for Runs 1 and 2. Copper peaks at 78.5 ppm in Run-1. The drops in indicated Cu ppm for the last samples in both runs are due to make-up oil dilution of the wear debris. Note the lower Cu concentration (33.2 ppm) in Run-2.

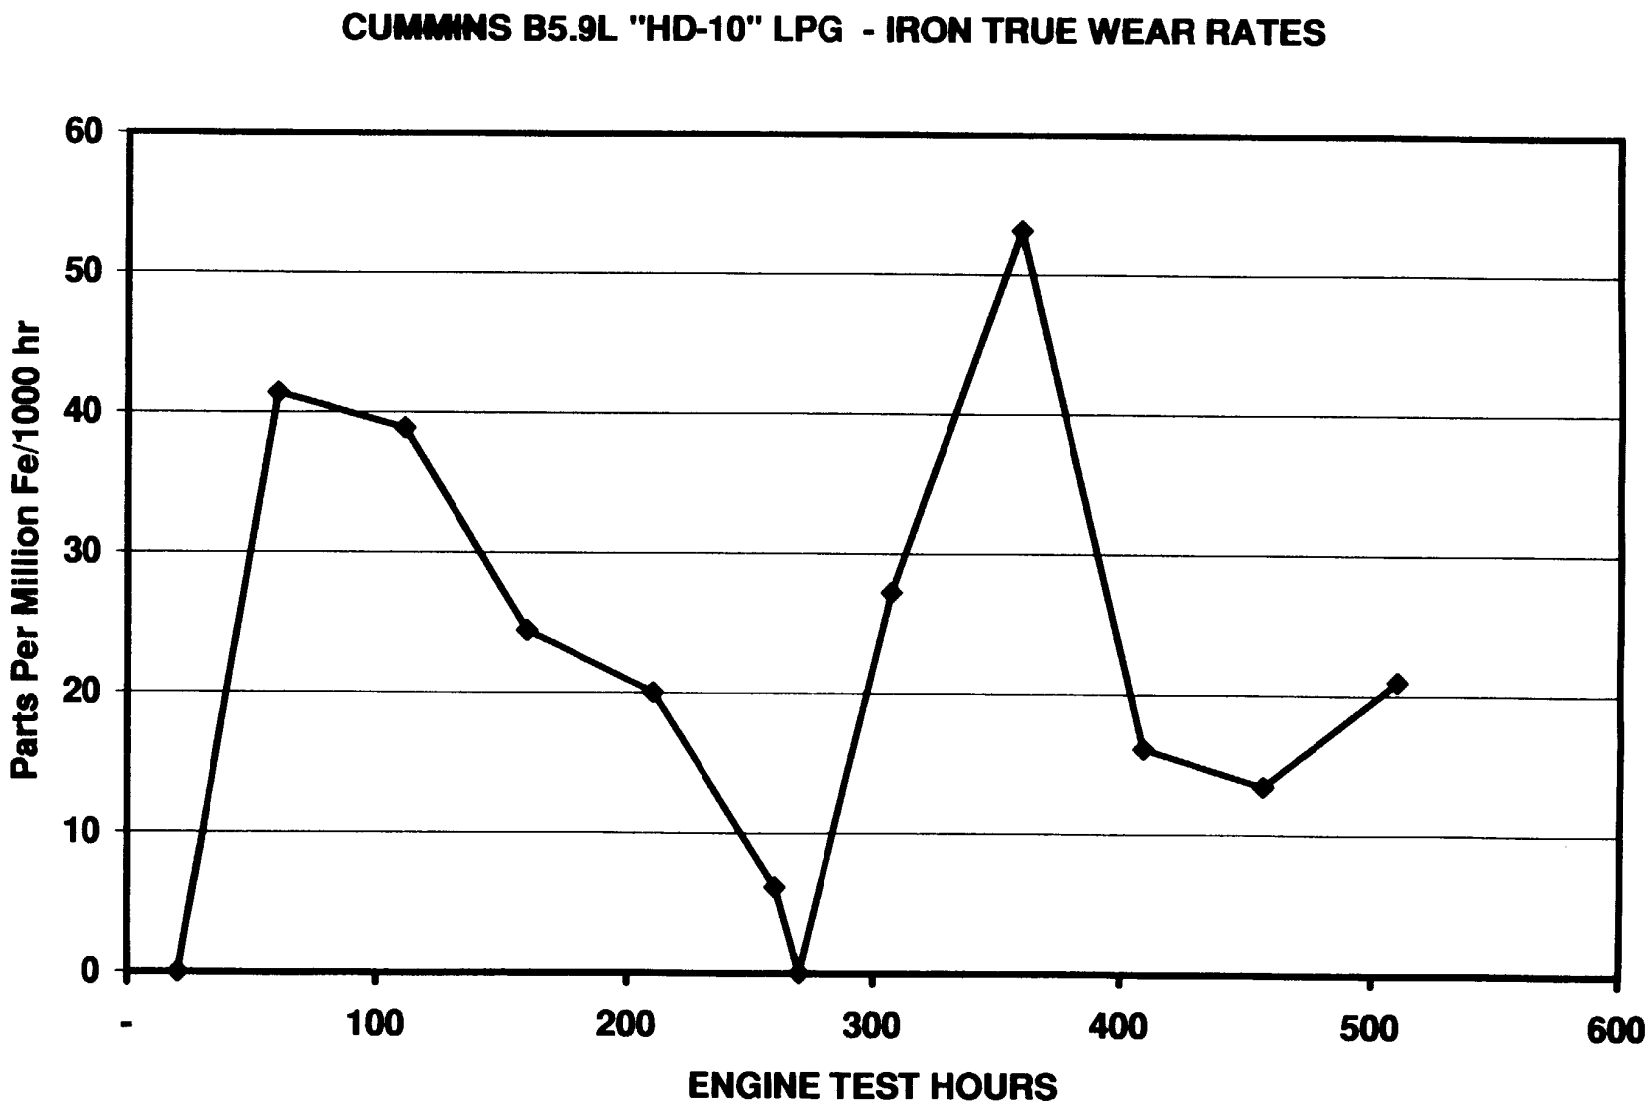
Table IV - "True Wear" Iron particle wear-rates for Runs 1 and 2.
Average Fe wear rate is normal (25 ppm/1000hr), and rises only slightly (3%) in the second run.

Figure 3 – Graph of Fe True Wear Rate versus Engine Hours.
Cylinder wall normal wear particles are the main source of ICPS iron.

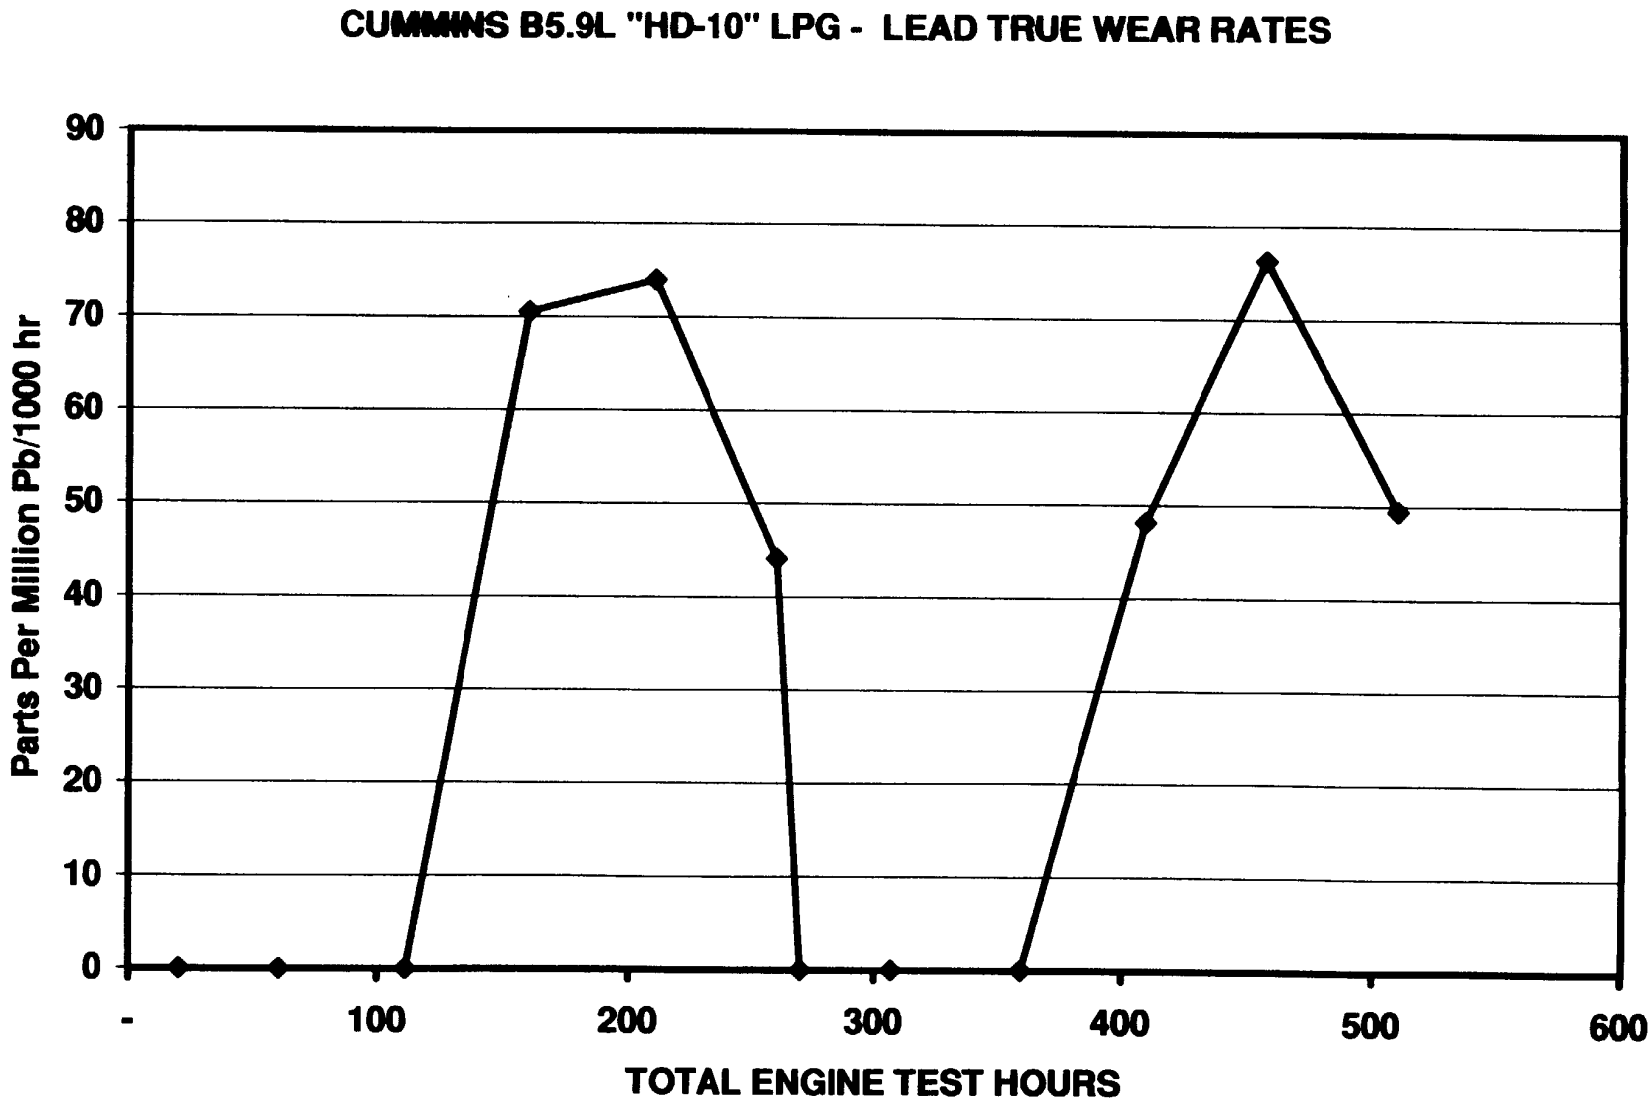
Table V - "True Wear" Lead particle wear-rates for Runs 1 and 2. Lead ICPS detection is more difficult, but averaged about 35 ppm/khr dropping 7% in Run-2.

Figure 4 – Graph of Lead metal True Wear Rate versus Engine Hours.
Babbitt bearing metal would be the main source of this lead, only generated after 100 oil hours in both runs.

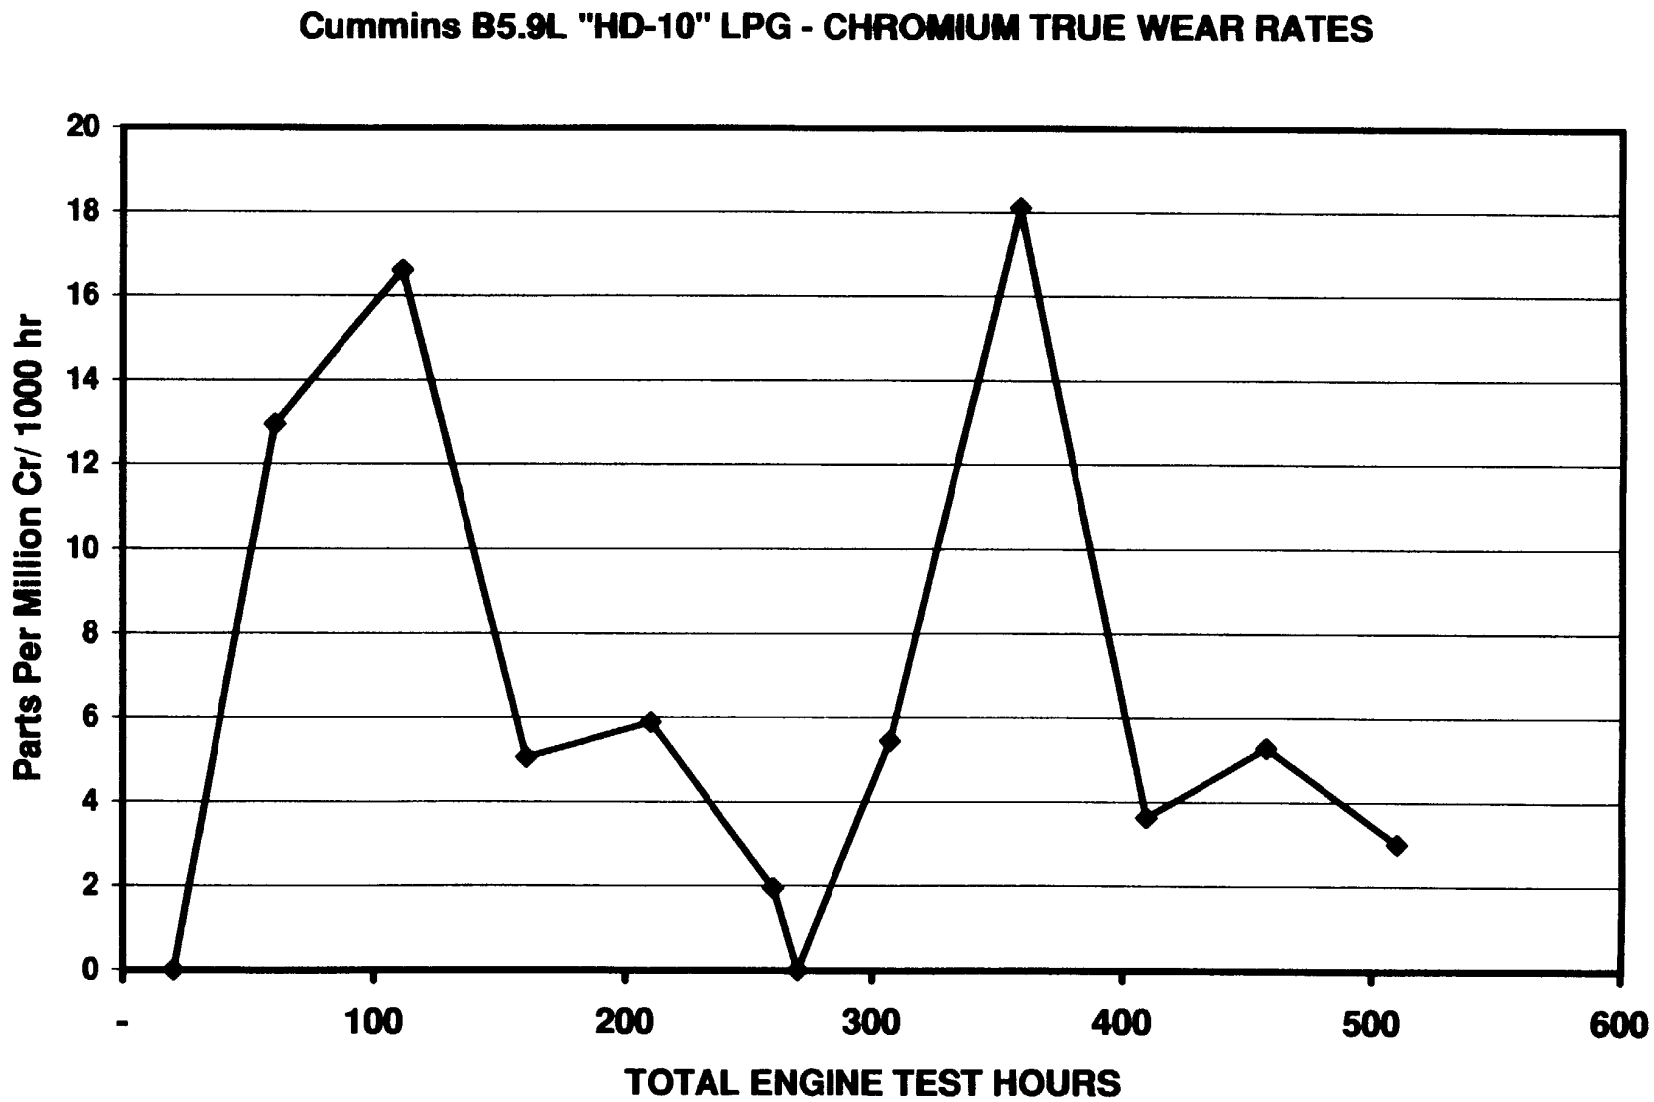
Table VI - "True Wear" Chrome particle wear-rates for Runs 1 and 2.
Chrome wear levels dropped 13%, from 8.0 ppm/khr in Run-1 to 7.0 ppm/khr in Run-2.

Figure 5 – Graph of Chromium true wear rate versus Engine Hours.
Upper piston compression rings are usually the main source of this chrome.

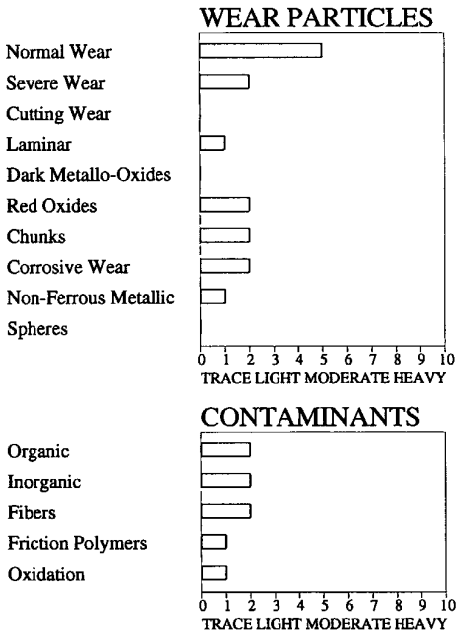
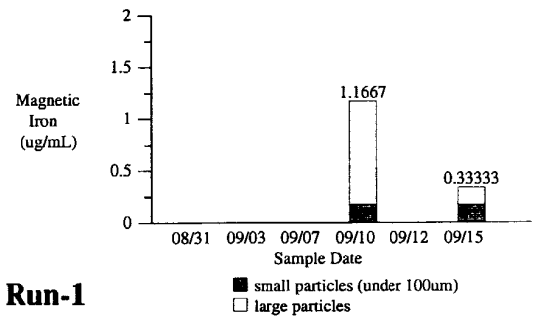
Figure 8 – Ferrographic Analysis at 250 hrs, end of Run-1

Figure 8 – Ferrographic Analysis at 250 hrs, end of Run-1. Debris morphology is similar to 150 hr, mostly low and medium alloy steel. Normal wear still rated moderate at level 5. Magnetic iron has dropped to 0.33 ug/mL, possibly due to oxidation.

Most metal particles are low and medium alloy steel showing rubbing/sliding wear.

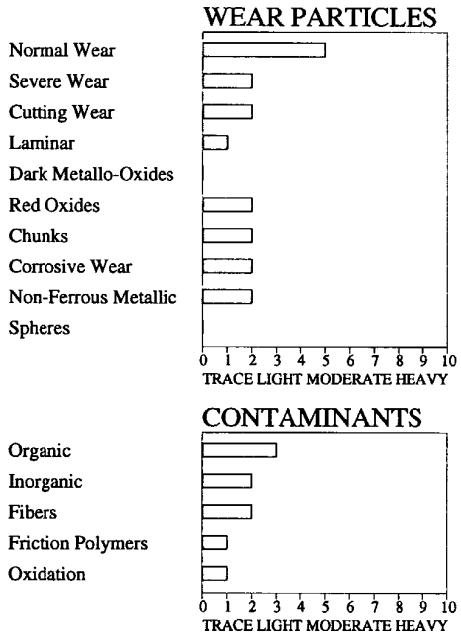
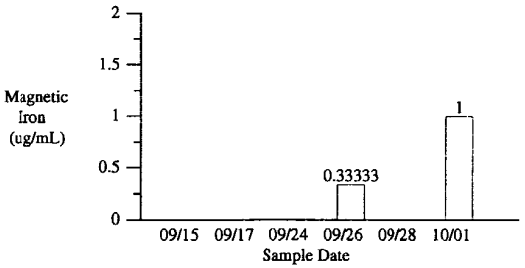
Figure 10 – Ferrographic Analysis at 500 engine test hr, 250 oil hours, end Run-2

Figure 10 – Ferrographic Analysis at 500 engine test hr, 250 oil hours, end of Run-2. Normal wear at level 5, mostly steel showing the usual rubbing/sliding, magnetic iron at 1.0 ug/mL with no large (>100 μm) magnetic particles. Some copper particles, up to 20 μm in size were present as shown in the lower microphotograph.

Most of the metal particles are low and medium alloy steel showing rubbing/sliding wear.

Traces of cutting wear also found in sample.

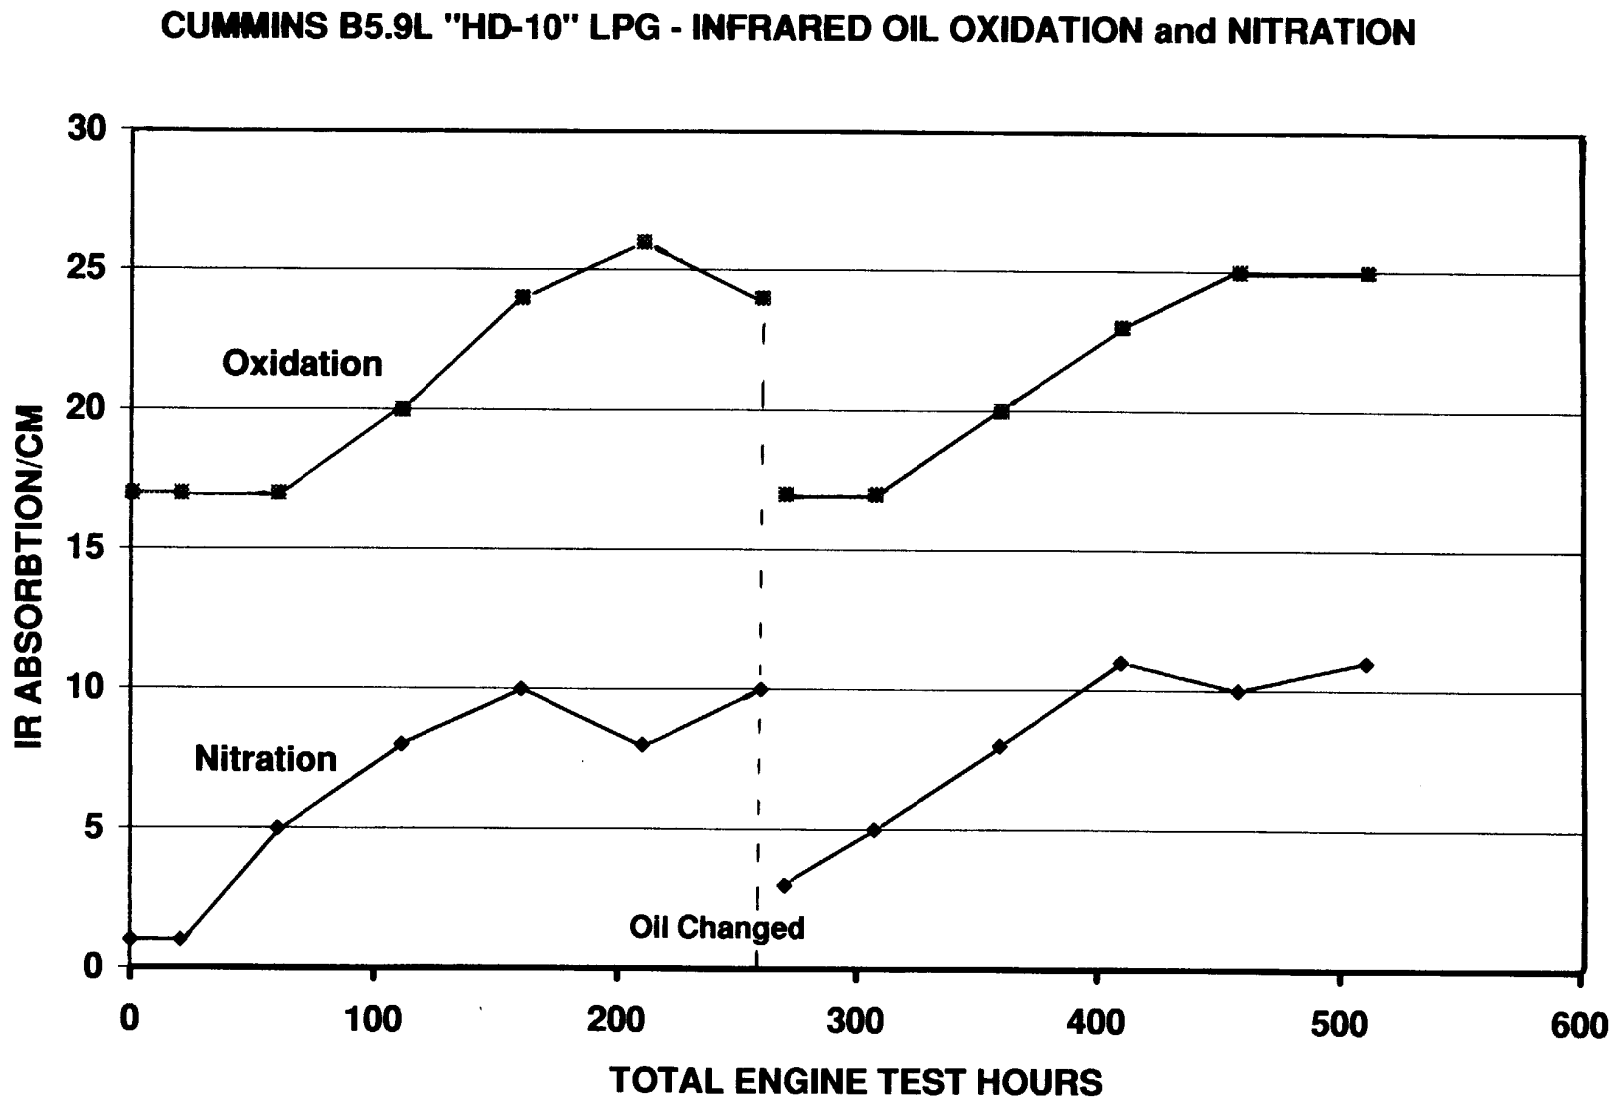
Figure 15 – Graph of Oil Infrared Oxidation and Nitration versus Engine Hours

Figure 15 – Graph of Oil Infrared Oxidation and Nitration versus Engine Hours.
Note the rise in IR absorption with oil hours. The oxidation levels above 25 A/cm are considered unacceptable, but are mitigated by additions of fresh make-up oil.

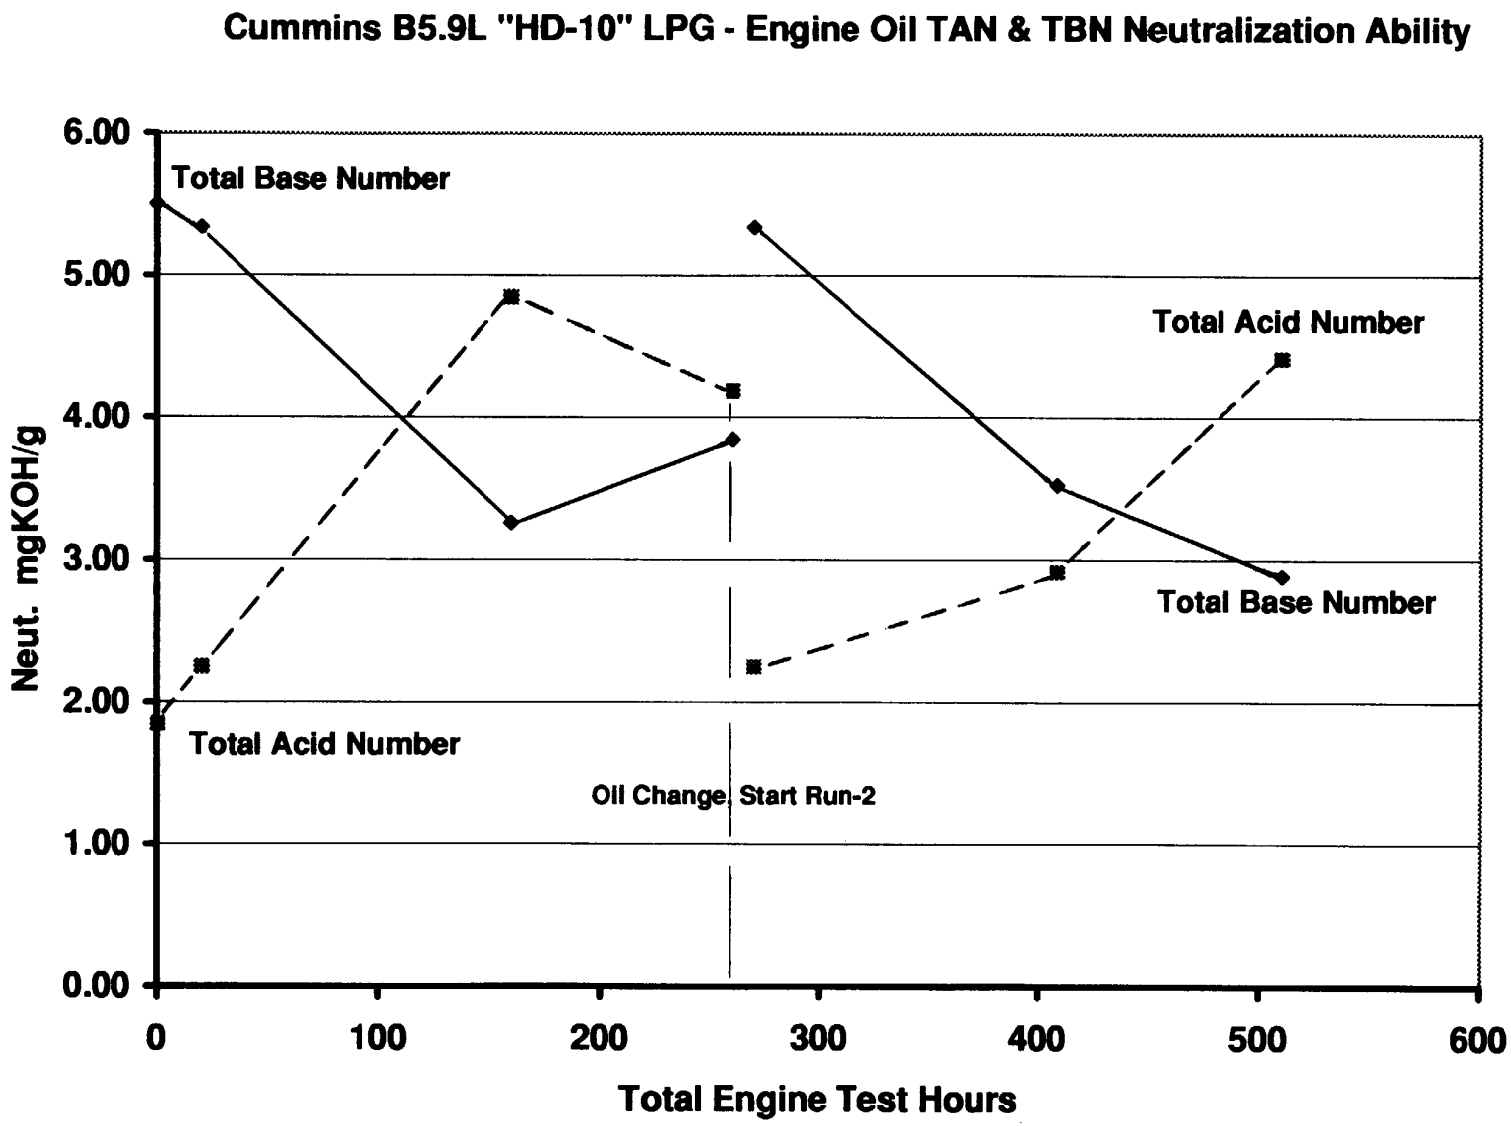
Figure 16 – Graph of Engine Oil TAN and TBN Neutralization Ability

Figure 16 – Graph of Engine Oil TAN and TBN Neutralization Ability.
The Total Base Numbers are depressed with time after each oil change while the oil acidity (TAN) rises to unacceptable high levels beyond 150 oil hours.
