CUMMINS B5.9L PROPANE ENGINE

ARB "HD-10" LPG DURABILITY TEST

TRIBOLOGICAL OIL ANALYSIS

December, 1999

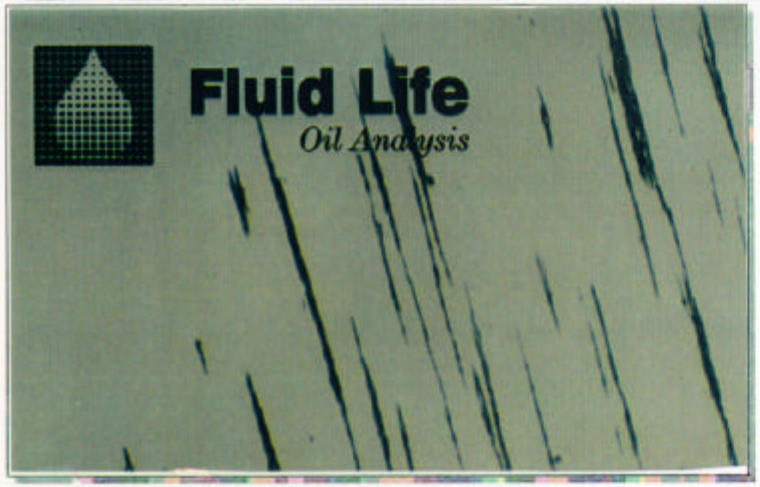
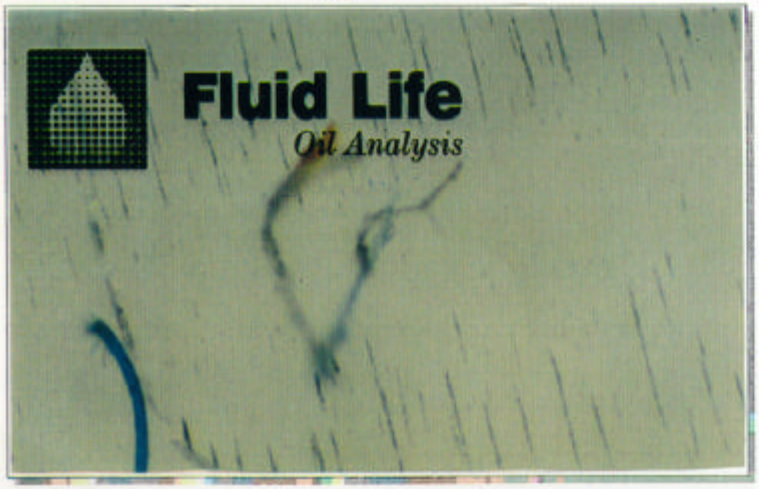
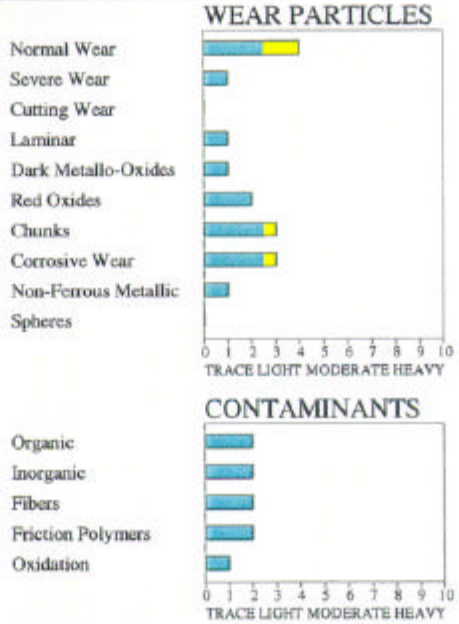
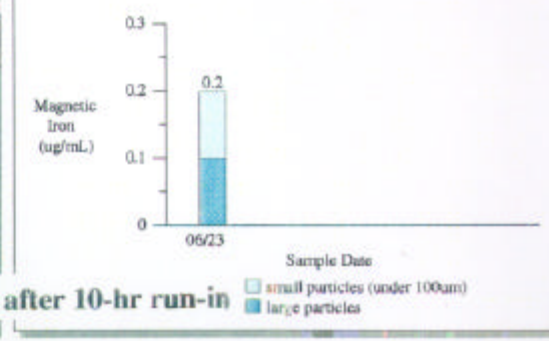
Figure 6 – Ferrographic Analysis of used oil at "0" hours, after 10-hr run-in

Figure 6 – Ferrographic Analysis of used oil at "0" hours, after 10-hr run-in.
Note photographs of low and medium alloy steel debris aligned with magnetic field. Traces of copper/copper alloy particles up to 65 μm (0.0026 in.) in size were detected. Magnetic Iron was at 0.2 ug/mL. Morphology of other wear and contaminant particle classes and concentrations are shown by the centrally located bar graphs.

Most metal particles are low and medium alloy steel showing rubbing/sliding wear.

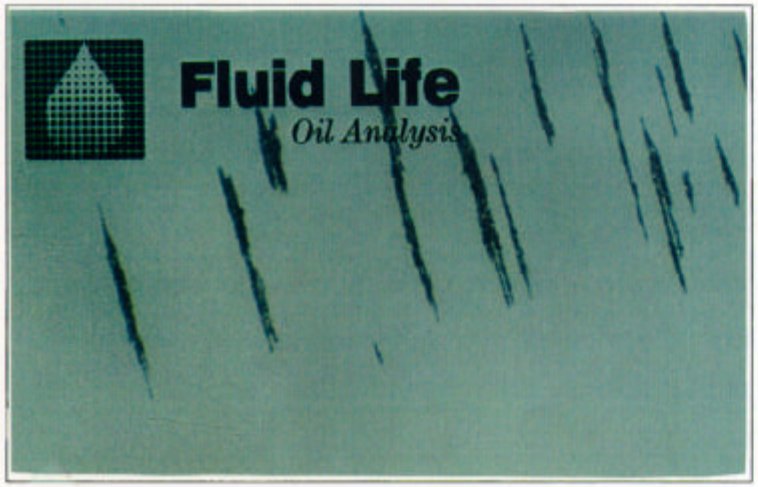
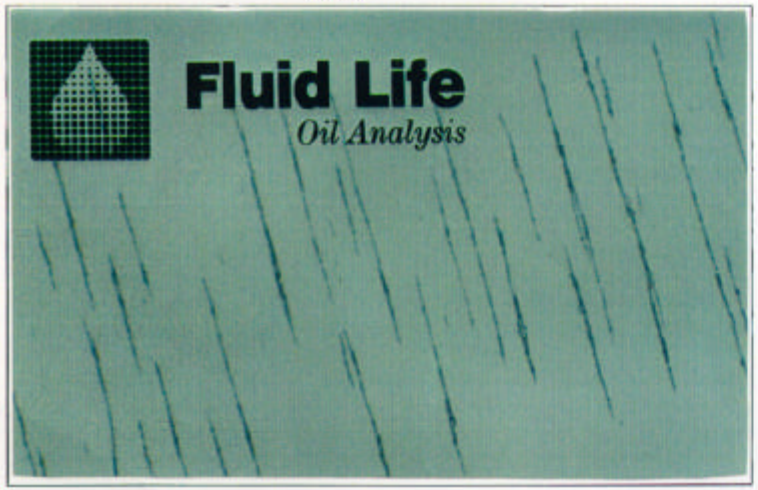
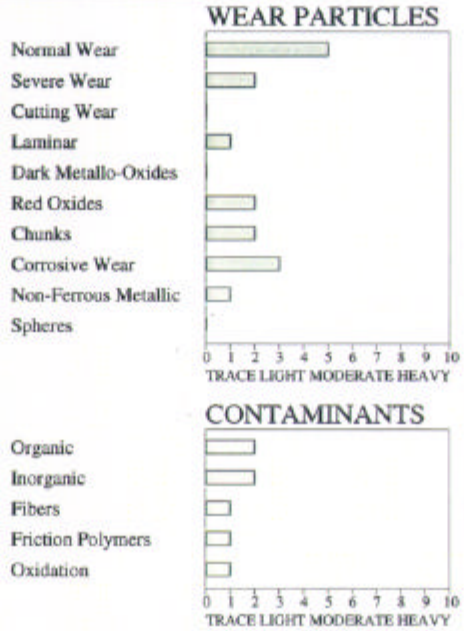
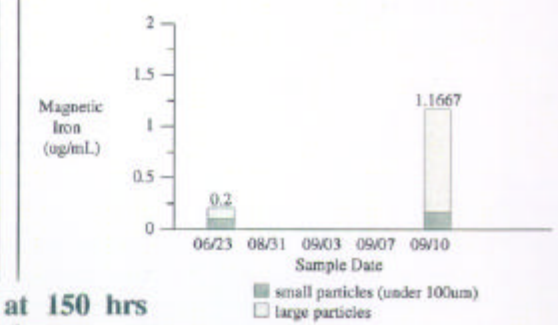
Figure 7- Ferrographic Oil Analysis during Run-1 at 150 hrs under full load. Normal wear particles of low and medium alloy steel show rubbing/sliding, rated at level 5 (moderate). Traces of bearing babbitt up to 30 μm in size were found. Magnetic iron was now measured at 1.17 ug/mL.

Most metal particles are low and medium ally steel showing rubbing/sliding wear.

Traces of babbitt (up to 30 microns) found in debris.

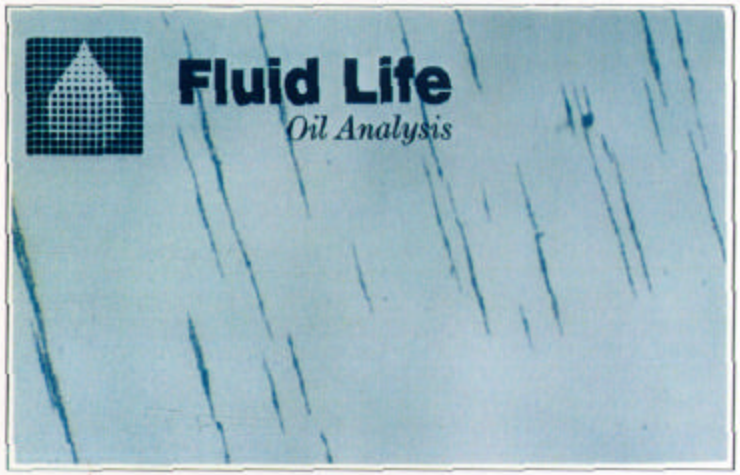
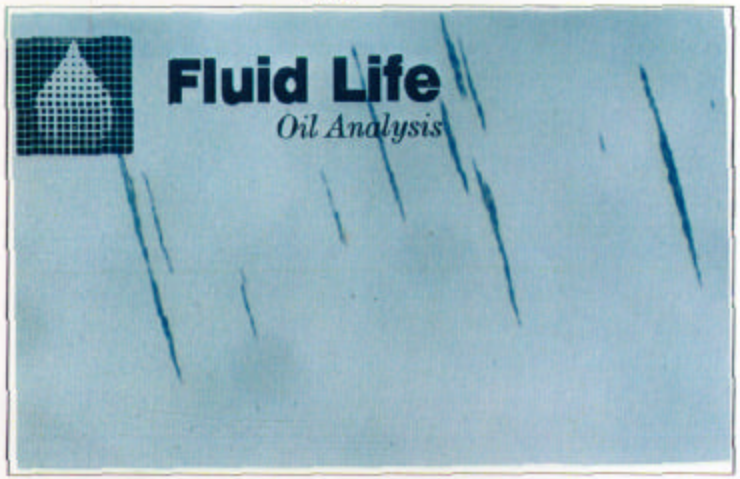
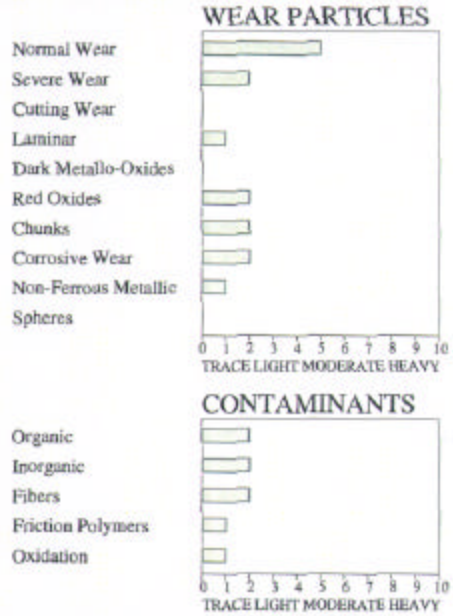
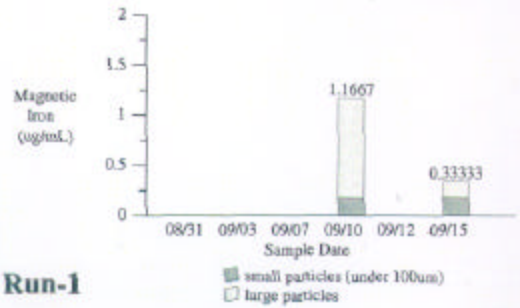
Figure 8 – Ferrographic Analysis at 250 hrs, end of Run-1

Figure 8 – Ferrographic Analysis at 250 hrs, end of Run-1. Debris morphology is similar to 150 hr, mostly low and medium alloy steel. Normal wear still rated moderate at level 5. Magnetic iron has dropped to 0.33 ug/mL, possibly due to oxidation.

Most metal particles are low and medium alloy steel showing rubbing/sliding wear.

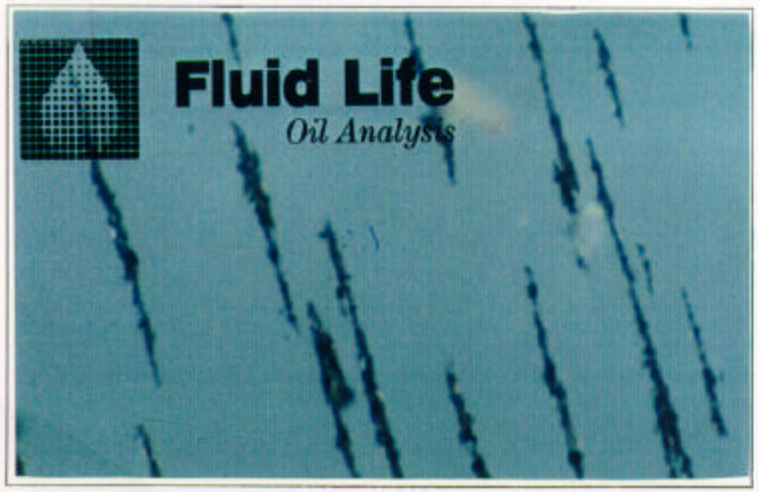
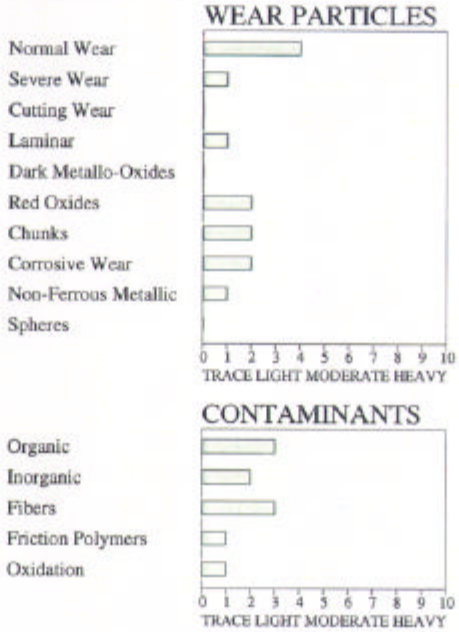
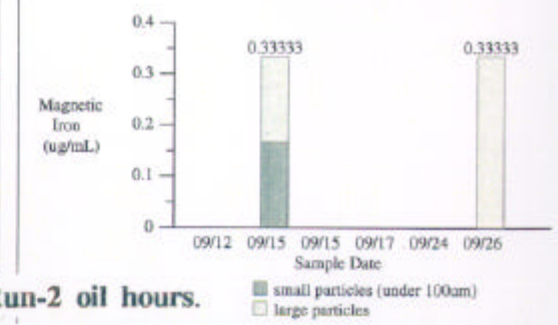
Figure 9 – Ferrographic Analysis at 400 engine test hr or 150 Run-2 oil hours. Normal wear is at level 4, identified as mostly rubbing/sliding low and medium alloy steel. Traces of 20 μm babbitt particles were also present.

Most metal particles are low and medium alloy steel showing rubbing/sliding wear.

Traces of babbitt material to 20 microns found in debris.

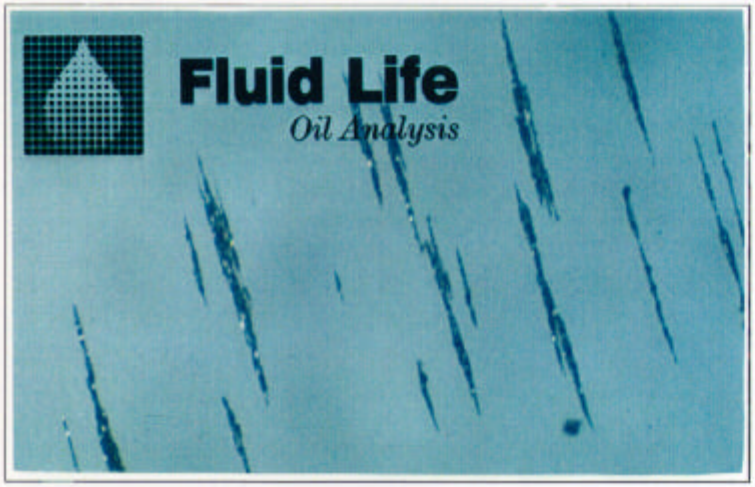
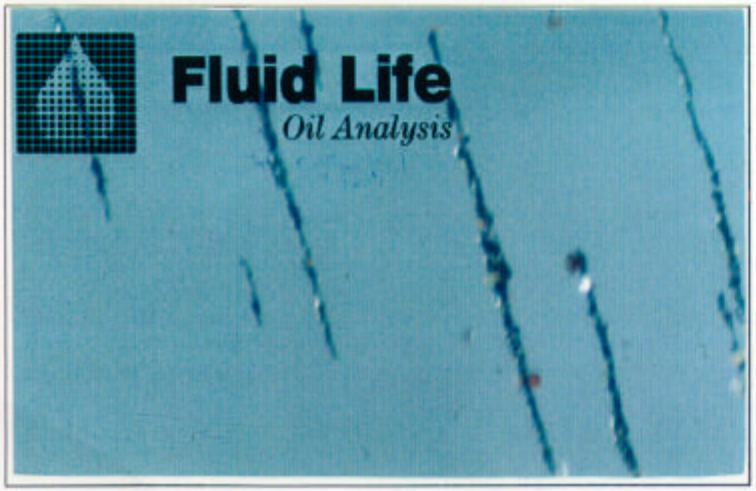
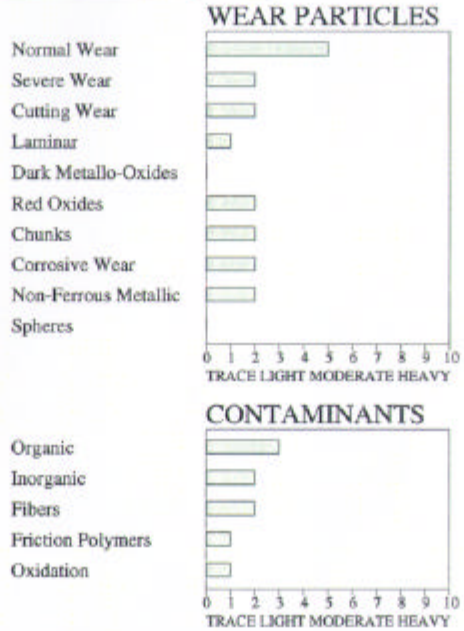
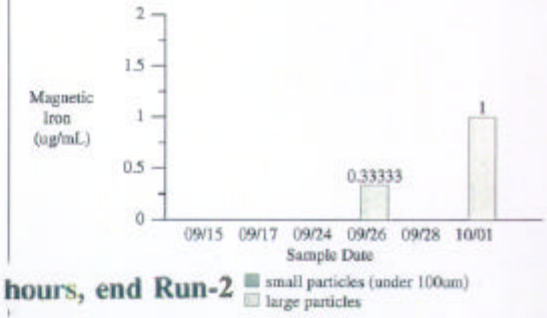
Figure 10 – Ferrographic Analysis at 500 engine test hr, 250 oil hours, end Run-2

Figure 10 – Ferrographic Analysis at 500 engine test hr, 250 oil hours, end of Run-2. Normal wear at level 5, mostly steel showing the usual rubbing/sliding, magnetic iron at 1.0 ug/mL with no large (>100 μm) magnetic particles. Some copper particles, up to 20 μm in size were present as shown in the lower microphotograph.

Most of the metal particles are low and medium alloy steel showing rubbing/sliding wear.

Traces of cutting wear also found in sample.

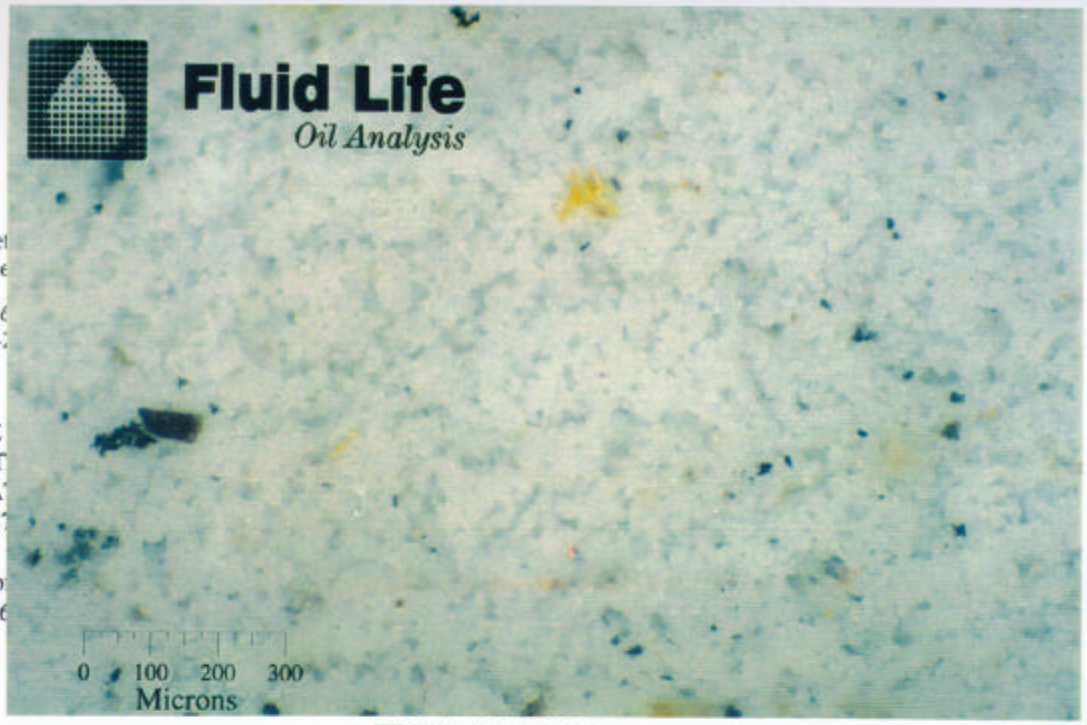
Figure 12 – Filter report and debris photos for "0" hours, after 10 hour run-in. Note presence of 180 μm size iron and 25 μm copper particles, with dirt, fibers, and rust.

SAMPLE ID:	AD 5.9 filter; 1999/06/24-158
SAMPLE DATE:	June 23, 1999
MAJOR CONTAMINATION:	Dirt/dust Fibers Dark metallo-oxides
MINOR CONTAMINATION:	Iron particles up to 180 microns Copper/copper alloy particles up to 25 microns Rust
SPECTROGRAPHIC ANALYSIS:	Silicon, iron, and traces of aluminum, copper and tin. Additive type metals include zinc, phosphorous and calcium.

The fibers in debris matched those found in new filter debris.

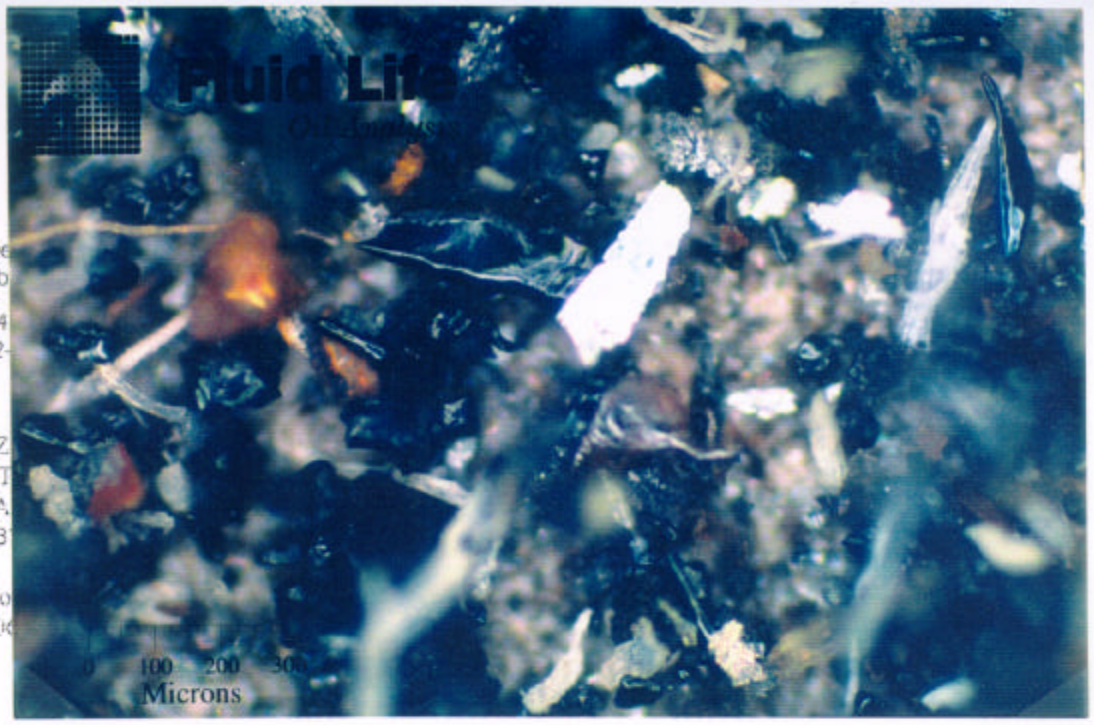
SAMPLE ID:	AD 5.9 filter, 250 hrs; 1999/09/17-320
SAMPLE DATE:	September 17, 1999
MAJOR CONTAMINATION:	Dirt/dust Carbon/soot deposits
MINOR CONTAMINATION:	Iron particles up to 220 microns Copper/copper alloy particles up to 85 microns Fibers
SPECTROGRAPHIC ANALYSIS:	Silicon, iron, copper and traces of lead and tin. Additive type metals include zinc, phosphorous and calcium.

Iron particles (up to 220 microns) show both sliding and laminar wear.

Several large copper/copper alloy (up to 85 microns) show laminar wear.

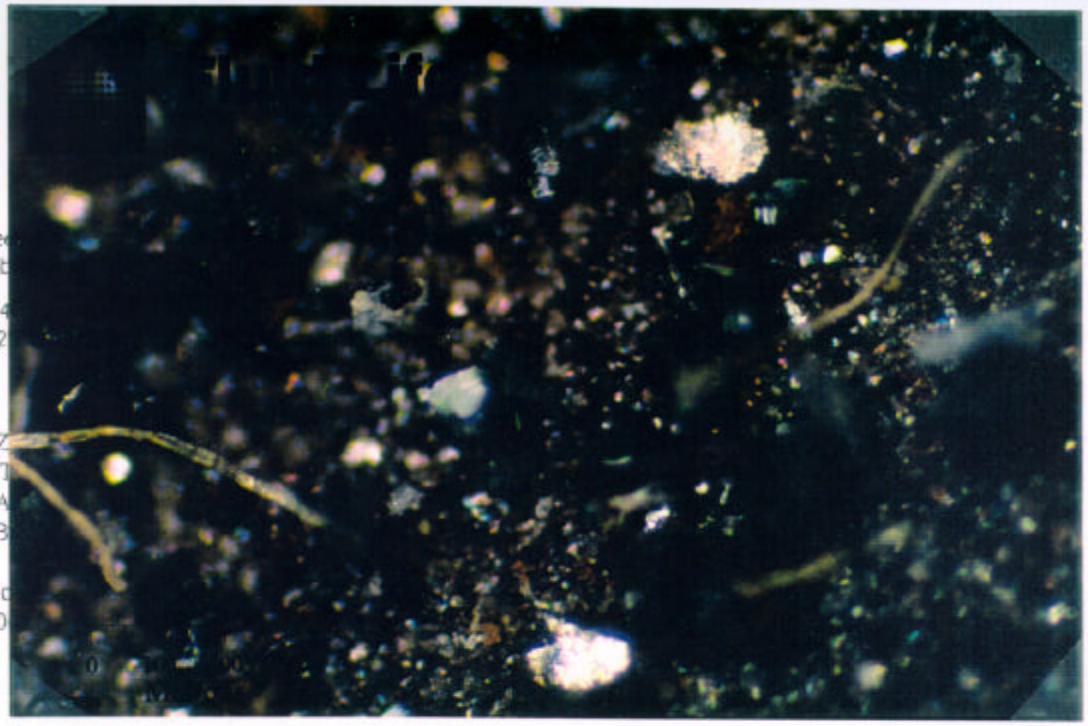
Figure 14 – Filter report and debris photos for 500 hours, end of Run-2. Note dirt/dust, higher carbon/soot deposits, and darker brown coloration. Iron particles up to 250 μm, some chrome indicating potential ring wear, more iron particles but no large copper particles.

SAMPLE ID:	AD 5.9 filter, 500 hrs; 1999/10/08-425
SAMPLE DATE:	October 7, 1999
MAJOR CONTAMINATION:	Dirt/dust Carbon/soot deposits
MINOR CONTAMINATION:	Iron particles up to 250 microns Fibers
SPECTROGRAPHIC ANALYSIS:	Silicon, iron, copper and traces of lead,tin, and chrome. Additive type metals include zinc, phosphorous and calcium.

Iron particles (up to 250 microns) show both sliding and laminar wear. Chrome is detected in latest filter possibly indicating ring wear.

The number of iron particles has increased while large copper/copper alloy particles were not found in this filter.
