SUBJECT: ON-BOARD DIAGNOSTICS II (OBD II) REGULATORY REVIEW

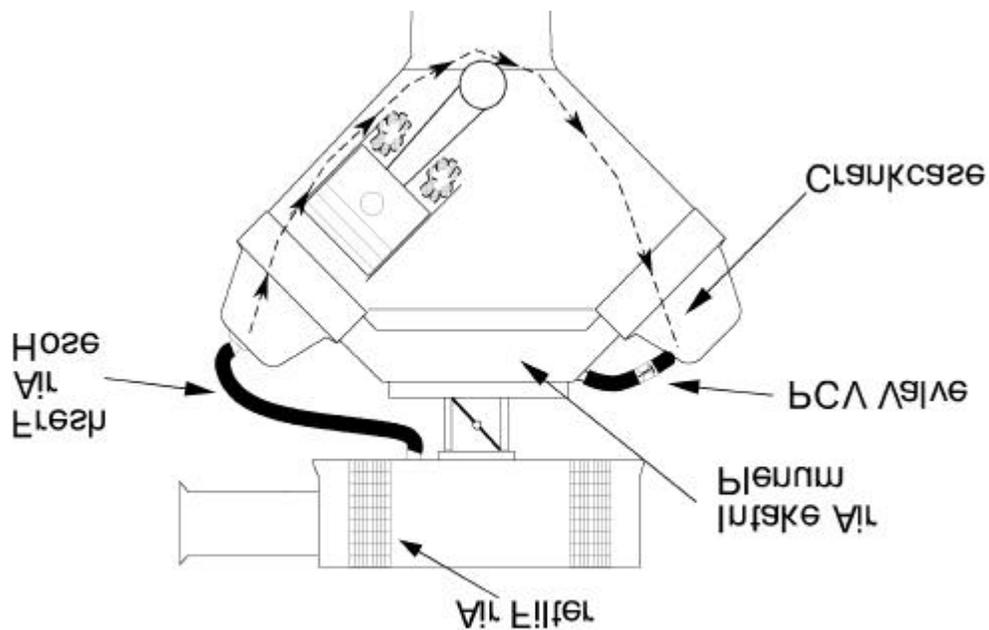
Typical PCV System

The staff's proposal targets only the failure modes that would most likely result in direct venting of emissions to the atmosphere, namely, disconnection in the system between the crankcase and the intake manifold on the PCV valve side of the system (refer to diagram below). Failure modes of this type are the most likely to cause a substantial increase in emissions (i.e., 1.2 g/mi HC). Other PCV system failure modes include a disconnected fresh air line or a plugged PCV valve but the staff is not recommending that these failure modes require monitoring. This is because disconnection of the fresh air line between the air cleaner and the crankcase may not result in a serious emission problem since most crankcase emissions would still be purged through the PCV valve (an operational PCV valve would cause a negative pressure in the crankcase, resulting in aspirating fresh air through the fresh air line rather than release of crankcase vapors). Further, plugging of the PCV valve will not result in direct venting to the atmosphere unless the fresh air line is also disconnected since pressure build up in the crankcase would likely force vapors through the fresh air line into the air cleaner which would then be inducted into the engine (i.e., this is a closed system). Recognizing the difficulty in detecting a disconnected fresh air line and the limited probability of both malfunctions occurring at the same time, the ARB's proposal would not require detection of this dual component failure.

Accordingly, the regulation would require only the detection of a disconnection in the system between either the crankcase and the PCV valve (crankcase vapors would escape directly through the opening in the crankcase system), or between the PCV valve and the intake manifold (crankcase vapors would exit through the PCV valve outlet). In terms of effectively monitoring for such occurrences, the latter failure mode will result in a significant intake air leak that should be identifiable with the existing monitoring strategies for the idle air control system or the fuel system. The staff's proposal would not require the stored fault code to specifically identify the disconnection, provided service information generated by the manufacturer directs technicians to examine the connection as a possible cause of the fault. On the other hand, a disconnection in the system between the crankcase and the PCV valve would be significantly more difficult to detect with existing monitors, and may require added hardware to verify integrity (e.g., a pressure switch to ensure flow between the crankcase and the PCV valve). However, in order to facilitate compliance, the staff's proposal would exempt manufacturers from detecting disconnection between the crankcase and the PCV valve if the PCV valve is fastened securely and directly to the crankcase or valve cover (e.g., a threaded connection). This is because such disconnections often occur during service operations wherein technicians will likely remove the PCV valve and hose assembly together if the valve is easily removed from the crankcase (normally through a grommet located in a valve cover). If the technician finds disconnection of the PCV hose from the valve itself much easier because the PCV valve is securely fastened, then the most likely event is a hose disconnection rather than a valve disconnection. Failure to reinstall a hose, however, can be readily detected with existing monitoring strategies whereas failure to reinstall the PCV valve may not be as easily detected. Therefore, slip-on PCV connections via grommets, or other quick release designs would not be exempted.

Currently, the OBD II regulation does not contain specific requirements for the detection of PCV system failures and monitoring is not required under the comprehensive component monitoring section of the regulation (Section (b)(10)) because PCV systems generally do not use electronic components. However, certain failure modes of the PCV system can cause a substantial increase in emissions by venting crankcase emissions directly to the atmosphere (e.g., disconnection of the system or leakage between the crankcase and the PCV valve). In-use studies conducted relative to vehicles failing I/M tests cite failure rates of up to 5 percent for the PCV system. Further analysis of the data suggests that only a portion (up to 1 percent) of the vehicles tested would result in significantly increased in-use emissions (i.e., in only approximately 1 of 5 of the PCV system incidents would the failure mode result in crankcase emissions being vented to the atmosphere). Nonetheless, with a per vehicle emission increase of approximately 1.2 g/mi HC, at a 1 percent failure rate, the 2003 fleet average standard of 0.062 g/mi HC would be raised by 0.012 grams per mile, nearly a 20 percent increase. To address these excess in-use emissions, staff is proposing to add a PCV system monitoring requirement to the OBD II regulation.
