**SURVEY OF HEAVY-DUTY DIESEL
ENGINE REBUILDING, RECONDITIONING,
AND REMANUFACTURING PRACTICES**

CALIFORNIA AIR RESOURCES BOARD
CONTRACT #A4-152-32

August 1987

Sierra Research, Inc.
1521 I Street
Sacramento, CA 95814
(916) 444-6666

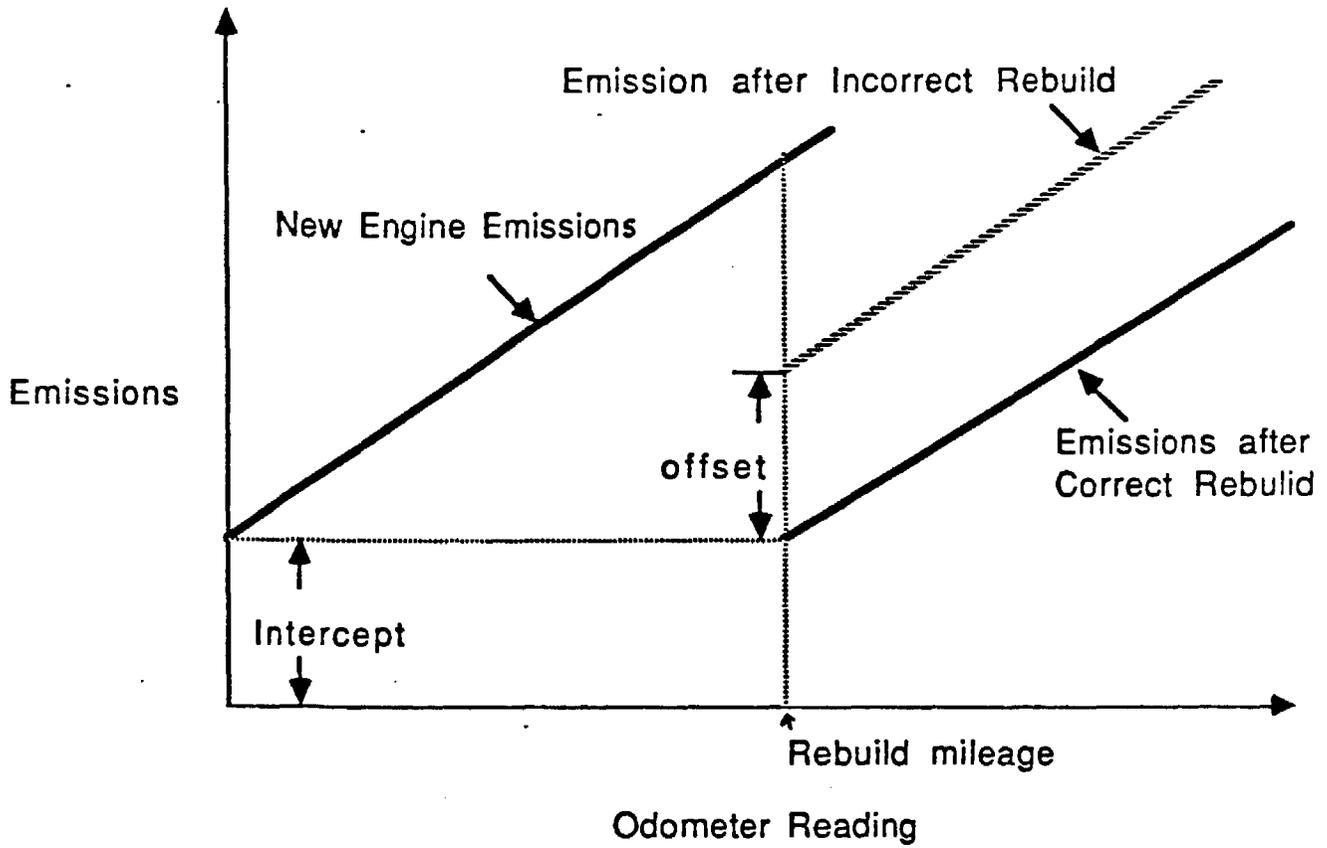
Figure 6-1
 Illustration of Emissions Impact
 of Correct and Incorrect Rebuild

resulting in an emission "offset", this term referring to a constant increment in emissions that is independent of odometer. The intercept term in the emission factor is defined as the zero-mile emission level. The degree of "offset" thus represents the difference in emissions improvements between properly and improperly rebuilt engines. A pictorial representation of these effects is provided in Fig. 6-1.
