# Advisory

Number 398

August 2013

## UNCERTIFIED VST BREAKAWAYS IN CALIFORNIA

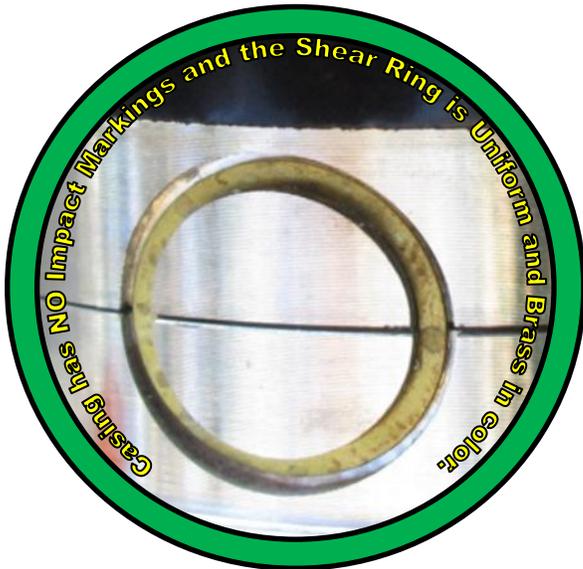
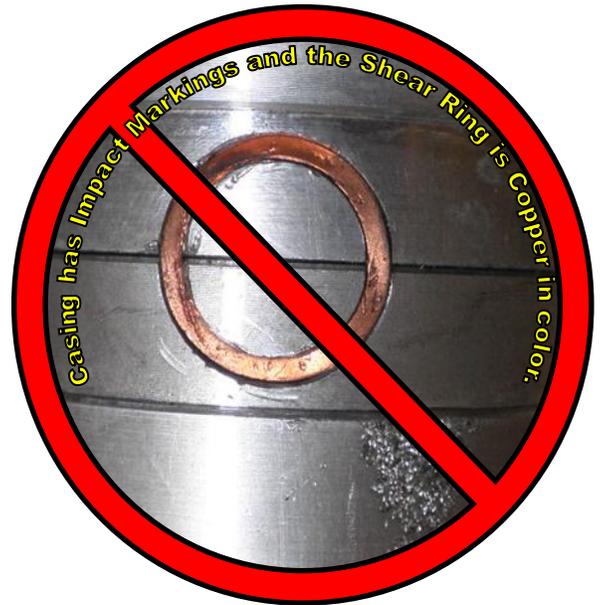
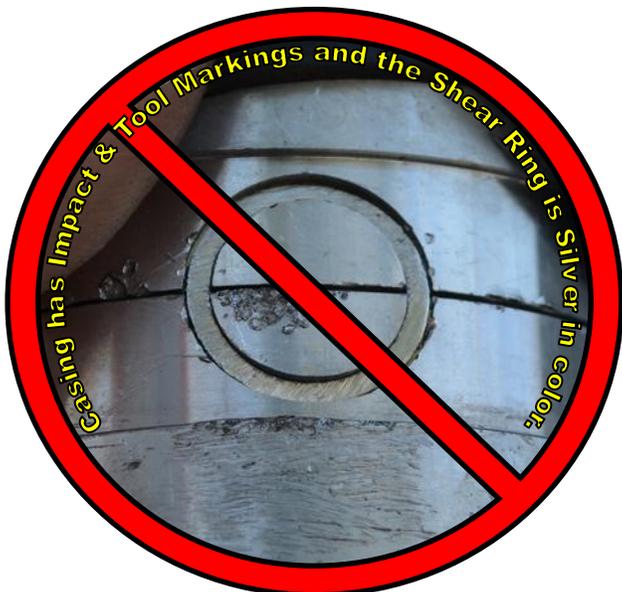
- a. Missing or incorrect black cover band around the connection
  - b. Different color shear ring or shape of the shear ring (should be uniform and brass in color, not copper or silver); see attached color picture

- a. Missing or incorrect black cover band around the connection
  - b. Different color shear ring or shape of the shear ring (should be uniform and brass in color, not copper or silver) ; see attached color picture

If any uncertified VST breakaway is found within your Air District, we ask that you take enforcement action according to the regulations and rules established by the state and your Air District. Issue an NOV and lockout/tagout the uncertified component(s), or take the appropriate enforcement action for your Air District; request the maintenance records including invoices for repairs related to any drive-off incidents and any breakaway-related maintenance.
