CONTROL OF HEAVY-DUTY DIESEL PARTICULATE EMISSIONS USING CATALYZED CERAMIC TRAPS

EXECUTIVE SUMMARY

Prepared for
California Air Resources Board
P.O. Box 2815
Sacramento, CA 95812

By
Terry L. Ullman

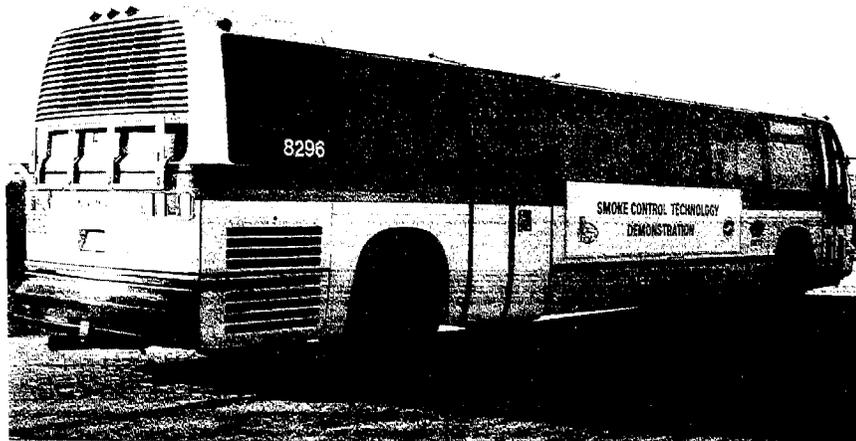
The bus supplied to SwRI by Southern California Rapid Transit District (SCR TD), on behalf of the California Air Resources Board, was a 1980 GMC RTS II 04 transit coach, 40 feet in length. Bus No. 8296, shown in Figure 1, had accumulated approximately 100,000 miles on a 1980 DDAD 6V-92TAC engine/power-pack installed in the bus chassis in 1983. The bus was taken from service and evaluated for performance and smoke on a chassis dynamometer at SCR TD. During that evaluation, it was apparent that full power performance was poor.

FIGURE 1. GMC RTS II 04 SUPPLIED BY THE SCRTO TO EVALUATE THREE CATALYZED CERAMIC PARTICULATE TRAPS

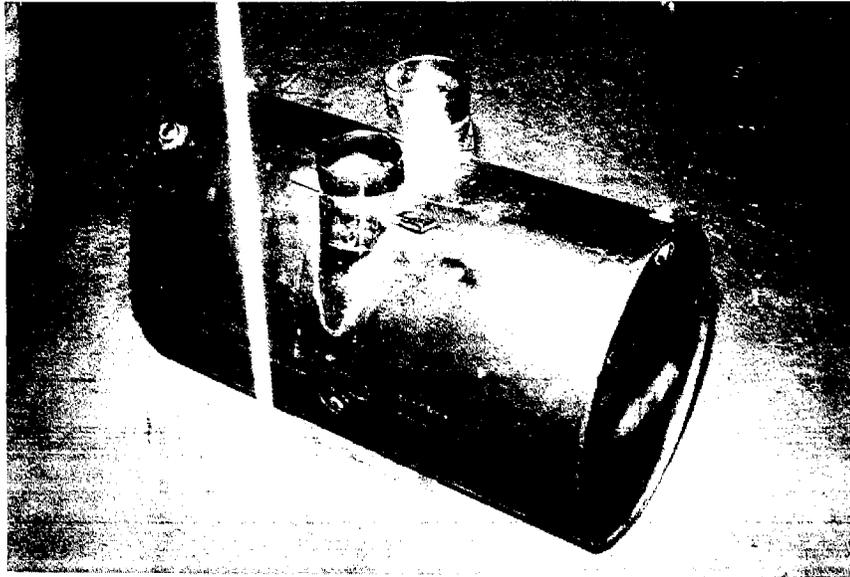
Based on the bus selected and the resulting constraints on space available for placement of a ceramic trap assembly, the existing muffler location was chosen. A preliminary trap design was established by SwRI on the basis of projected exhaust flows, material availability, and space limitations for the application of a ceramic filter within the engine compartment of the bus. The design allowed the exhaust gases to enter a common plenum formed between two pieces of ceramic trap substrate, and held in place by a wall of a common container. The exhaust gases passed through the ceramic substrates, to an outer container, and around, to the outlet. The inlet and outlet of the trap assembly were planned so that the exhaust piping could be changed to accommodate experimentation with the trap in the before and after turbocharger positions without actually relocating the trap assembly. The completed ceramic trap assembly is shown in Figure 2.

FIGURE 2. CERAMIC TRAP ASSEMBLY FOR THE HEAVY-DUTY DIESEL TRANSIT BUS

Several porosities of Corning ceramic diesel exhaust filter material were used on the basis of filter efficiency, backpressure characteristics, and potential interaction with various catalyst coating. After proving the design concept using the first assembly, Trap No. 1, three additional ceramic trap units were assembled using ceramic filter elements of varying porosity, with different catalyst coatings. The four trap assemblies tested in this program were as follows:

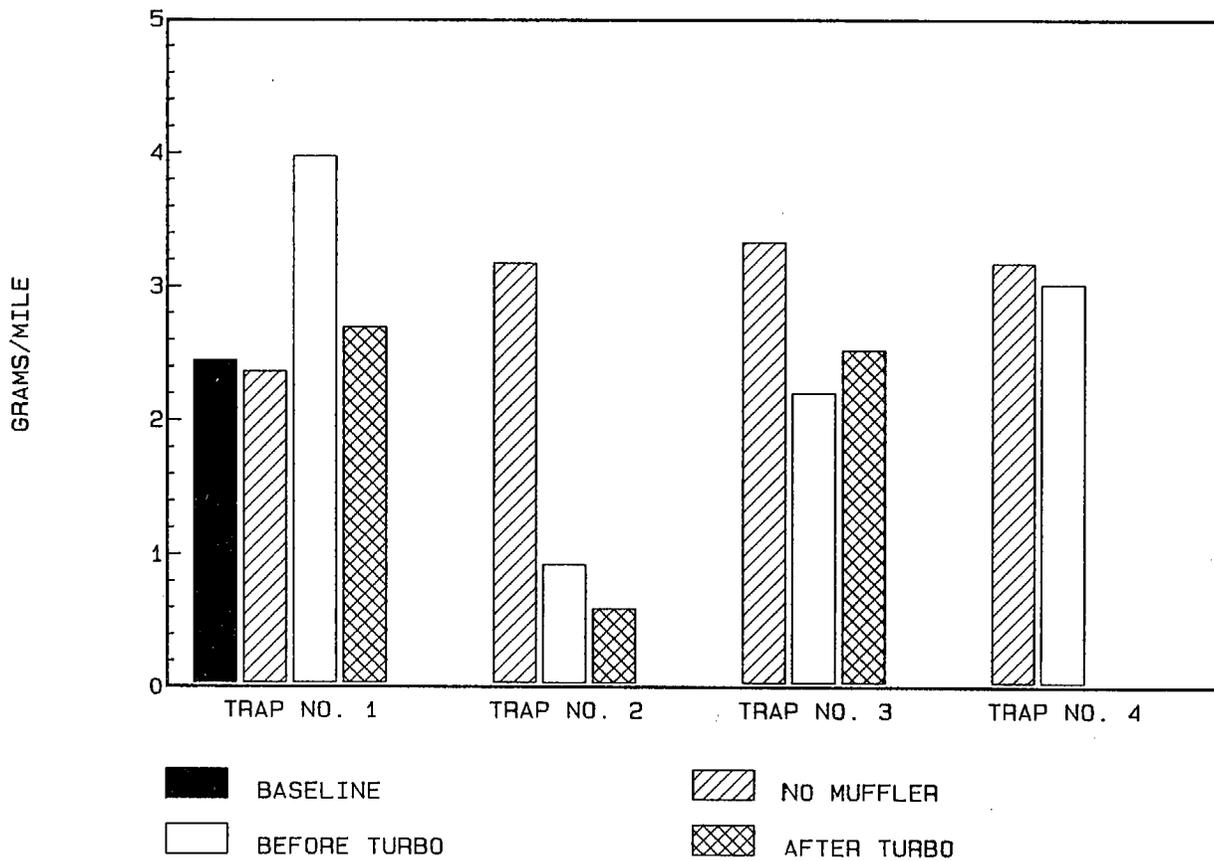
Bus cycle emissions of HC, CO, and particulate for baseline and with all four trap assemblies are shown in Figures 3, 4, and 5, respectively. Changes to NO_x emissions were minor. Periodic testing of the bus without a muffler or trap assembly in place indicated that baseline emissions (determined with the muffler in place) of HC, CO and particulate increased during the conduct of this program as indicated in Figures 3, 4, 5, and 6. For perspective, heavy-duty diesel particulate standards of 0.60 g/hp-hr for 1987 and 0.10 g/hp-hr for 1991 correspond to bus particulate emissions of 2.1 and 0.36 g/mile (assuming an engine brake specific fuel consumption of 0.500 lb fuel/hp-hr and a vehicle fuel economy of 4.0 miles/gallon). Smoke and total particulate are related in that the relative level of smoke opacity indicates the relative level of particulate. The absence of smoke, however, does not indicate the absence of particulate. Smoke levels measured during simulation of the bus pulling away from a stop are given in Figure 6. Trap assembly Nos. 1, 2, and 3 were evaluated before and after the turbocharger. Trap No. 4 was evaluated only before the turbocharger.

FIGURE 3. BUS CYCLE HC EMISSIONS

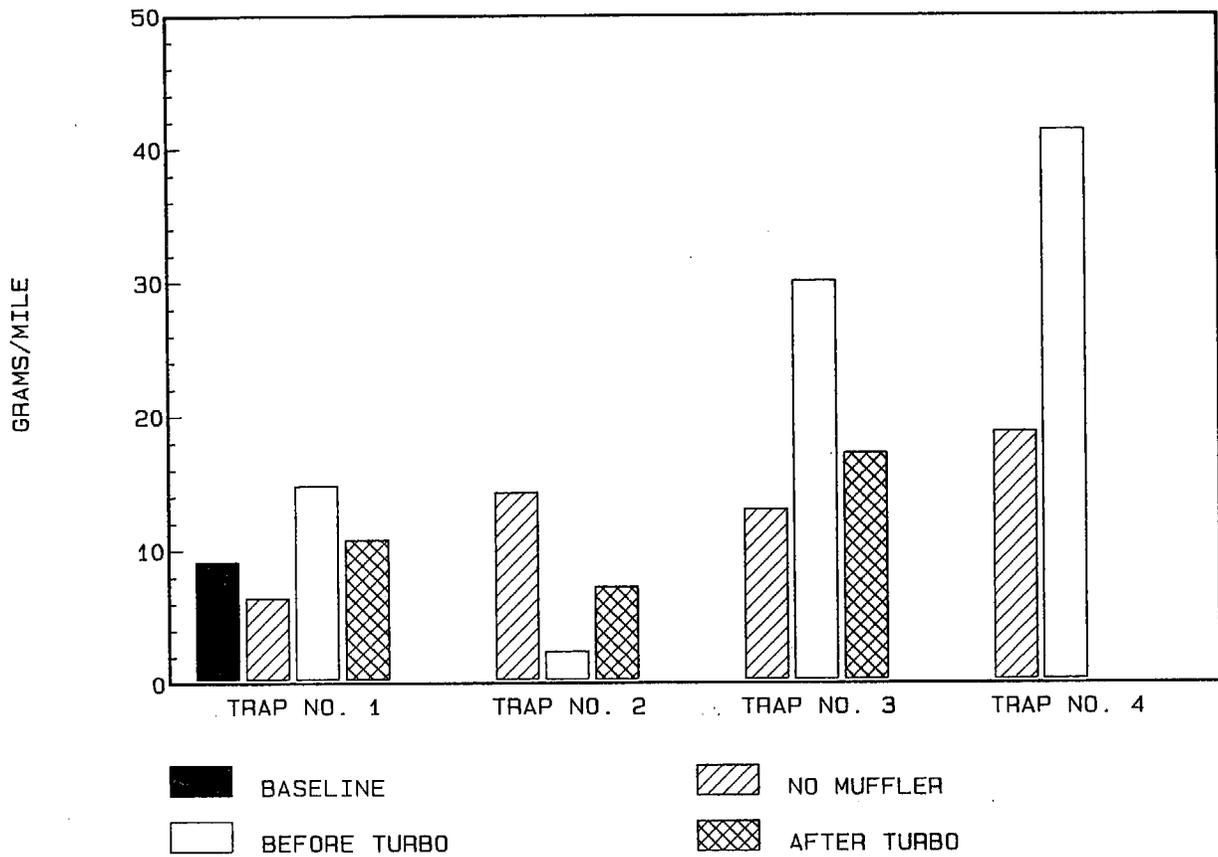
FIGURE 4. BUS CYCLE CO EMISSIONS

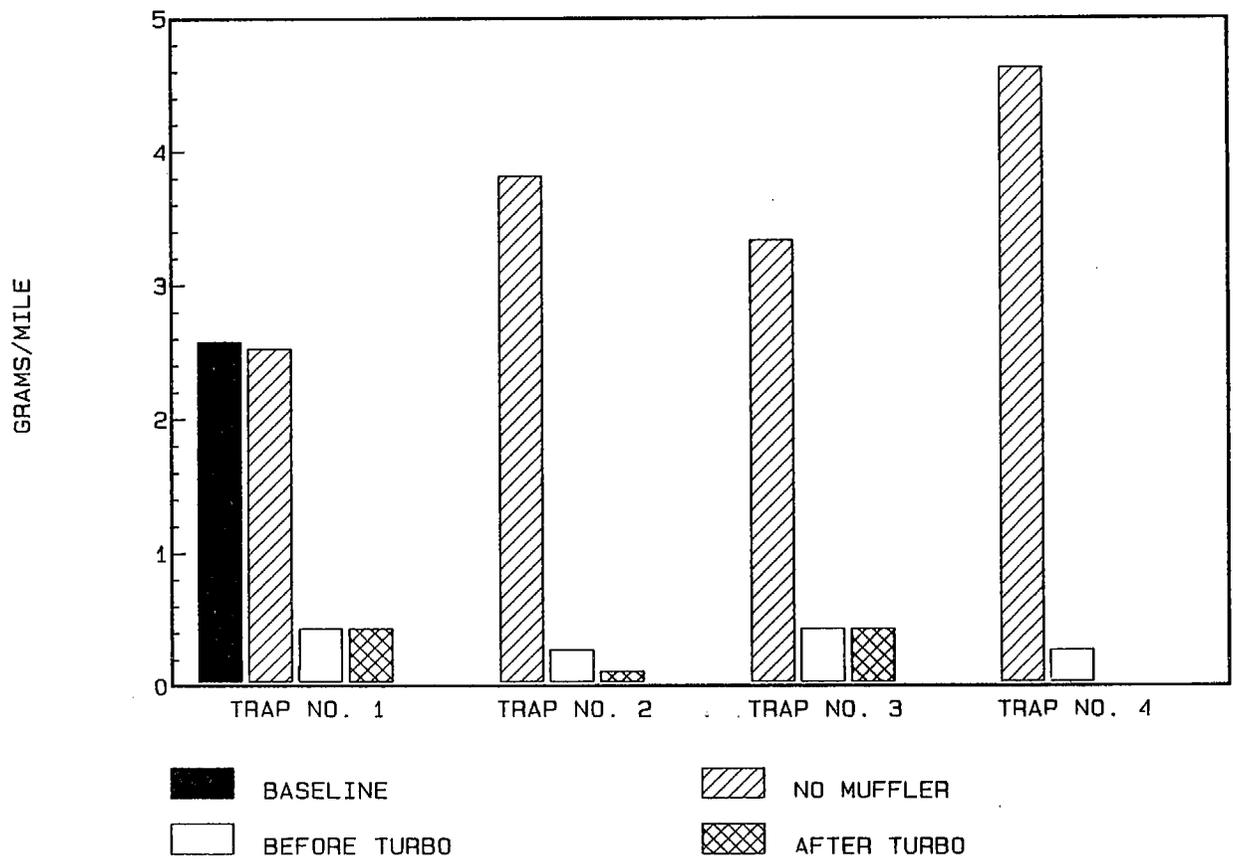
FIGURE 5. BUS CYCLE PARTICULATE EMISSIONS

Particulate trapping efficiency of Trap No. 1 was good, such that no visible smoke (≤ 5 percent opacity) was emitted during experimentation, and measured particulate was reduced by more than 70 percent. Regeneration of the first unit was accomplished using an acetylene torch to achieve exhaust gas temperatures of 550°C. Trap No. 2, built using EX-66 and a proprietary catalyst coating similar to that used on the Mercedes diesel car, showed good reduction of HC and CO, along with an average 90 percent reduction of particulates. Virtually no visible smoke was observed from the bus when this unit was used. No low-temperature regeneration of Trap No. 2 was apparent during test work conducted on the road or dynamometer.

Trap No. 3 consisted of Corning EX-54 substrates coated with a different catalyst formulation. This unit did not reduce HC and CO emissions, but did provide greater than 80 percent reduction in total particulate emissions. No visible smoke was noted with this trap, whether located after or before the turbocharger. Noticeable regeneration took place only when the trap substrate temperatures reached 510 to 550°C. The maximum substrate temperature noted during test work with Trap No. 3 was 830°C. Damage to the substrate can occur near 1000°C.

Trap No. 4 was fabricated using Ex-47 ceramic substrates catalyzed with formulation "C." This fourth trap assembly reduced particulate emissions on the bus cycle by about 90 percent. No visible smoke was noted during any portion of the chassis dynamometer test work with the unit positioned before the turbocharger. Regeneration required substrate temperatures between 510 and 550°C (almost the same as the first uncatalyzed trap).

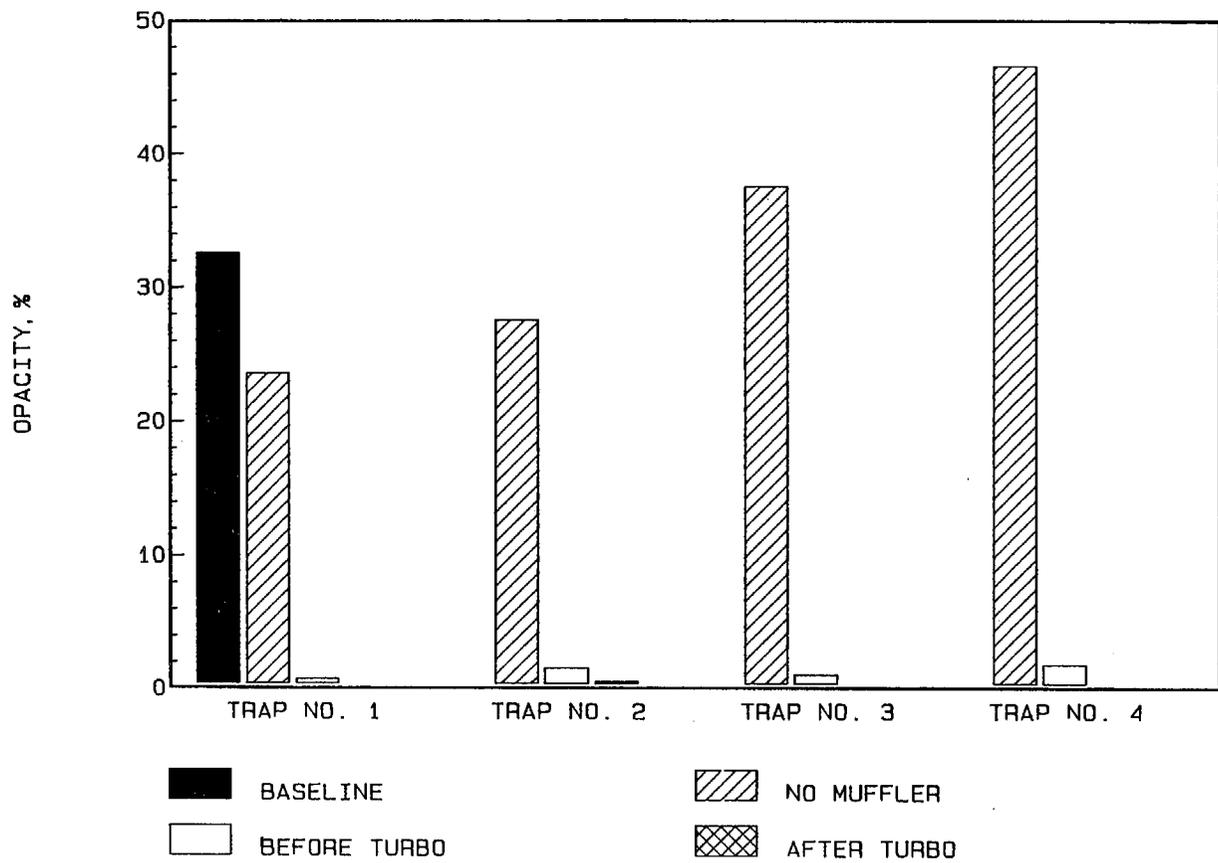
FIGURE 6. SMOKE EMISSIONS DURING SIMULATED PULL-AWAY OPERATION
